INSPECTION INFORMATION

Standard Home Inspection

Single Family Dwelling

51 Years

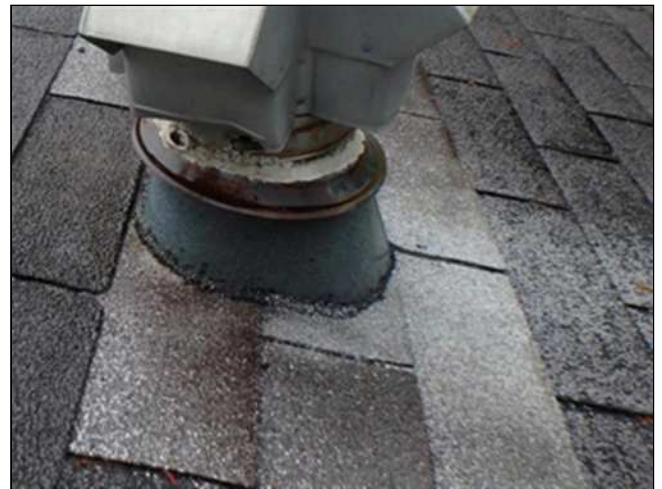
1.2 (2) CORROSION OBSERVED AT VENTILATOR COVER(S). *Prolonged exposure to corrosion may result in premature wear / failure of affected components. Also note location of materials.*

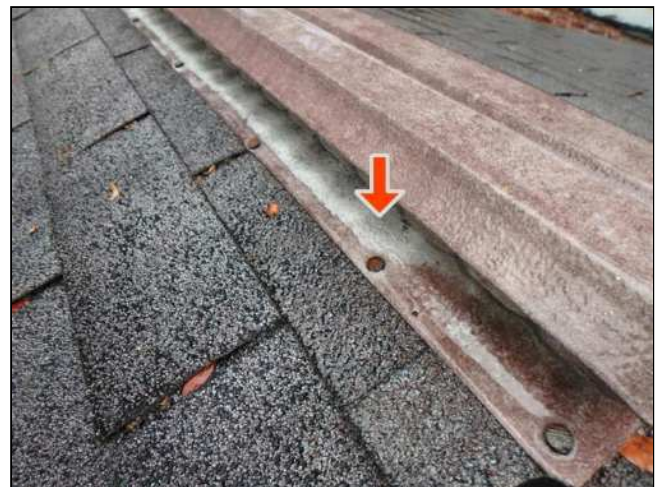
1.2 (3) EXPOSED AND/OR CORRODED HARDWARE OBSERVED AT ROOF FLASHING MATERIALS. *Exposed hardware can result in corrosion due to weather conditions which can lead to water intrusion, possibly causing hidden damage. Hardware needs to be sealed in order to maintain roofing / flashing integrity.*

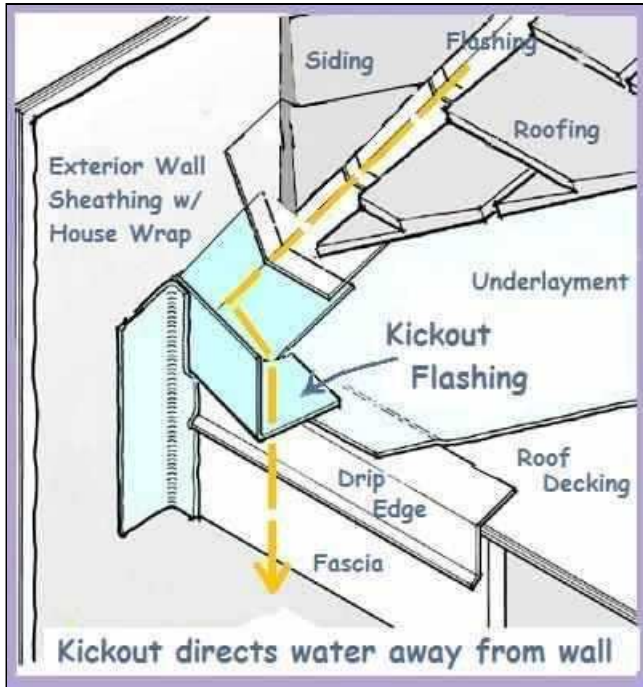
1.2 (4) LACK OF KICK-OUT FLASHING OBSERVED AT THE EXTERIOR SIDING (CHIMNEY) / ROOF LINE INTERFACE. *Condition may allow roof drainage / rainwater to drain onto underlying materials, which may lead to moisture related damage. Condition of latent materials was not visible & could not be fully inspected. Hidden damage may exist.*

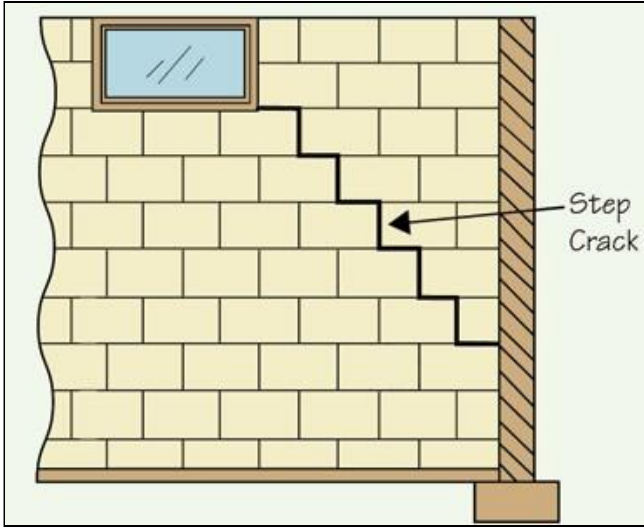
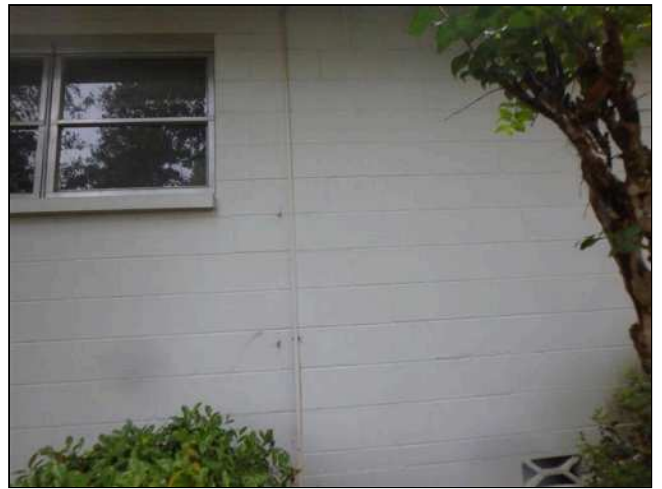
2.0 (3) STAIR-STEP CRACKING OBSERVED AT THE EXTERIOR SIDING MATERIALS. CRACKING IS MAINLY FOLLOWING MORTAR LINES & MEASURES LESS THAN 1/8" IN WIDTH. *Cracking of this size / type is not usually structurally significant; however, condition of latent materials was not visible & could not be fully inspected. Hidden damage may exist. Pictures are a representative number of affected areas. All similar areas should be addressed accordingly.*

RECOMMEND HAVING A LICENSED HANDYMAN OR CONTRACTOR EVALUATE / REMEDY AS NEEDED.

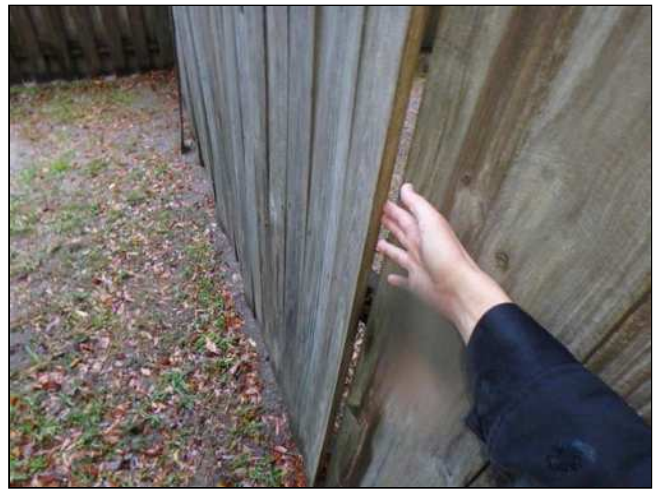
3.2 (2) WOOD DECAY AND/OR DAMAGE OBSERVED AT FENCING MATERIALS. *Wood decay / damage may deteriorate the integrity / rigidity of affected materials over time.*

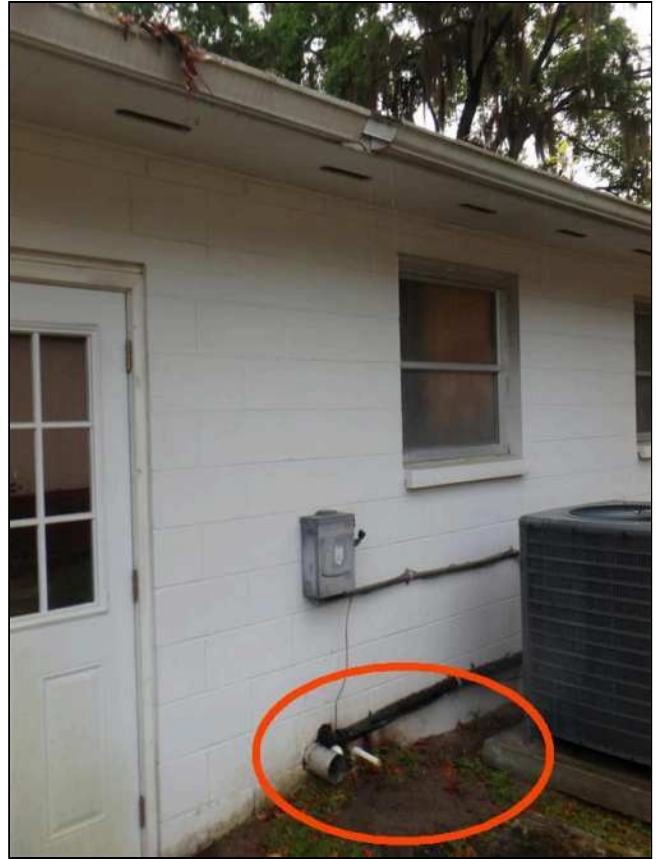
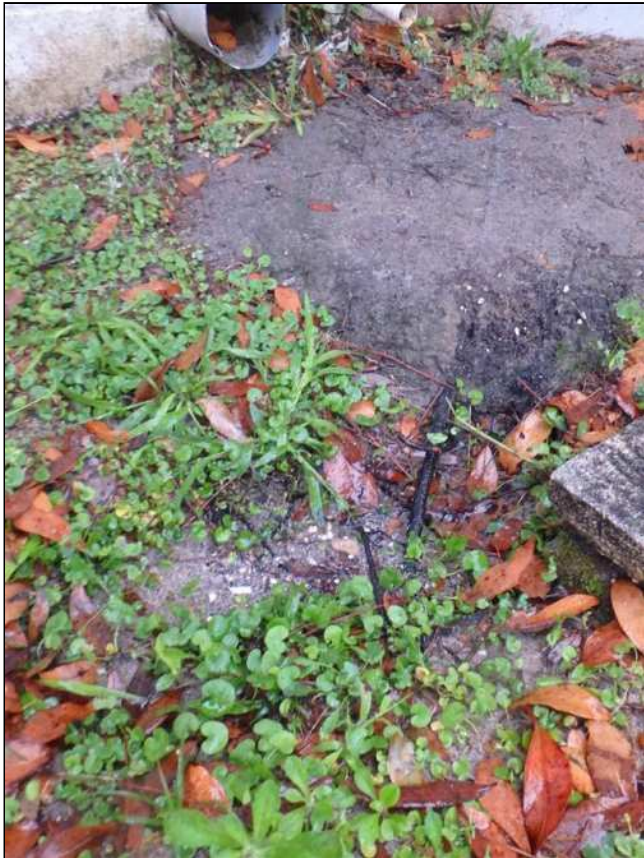
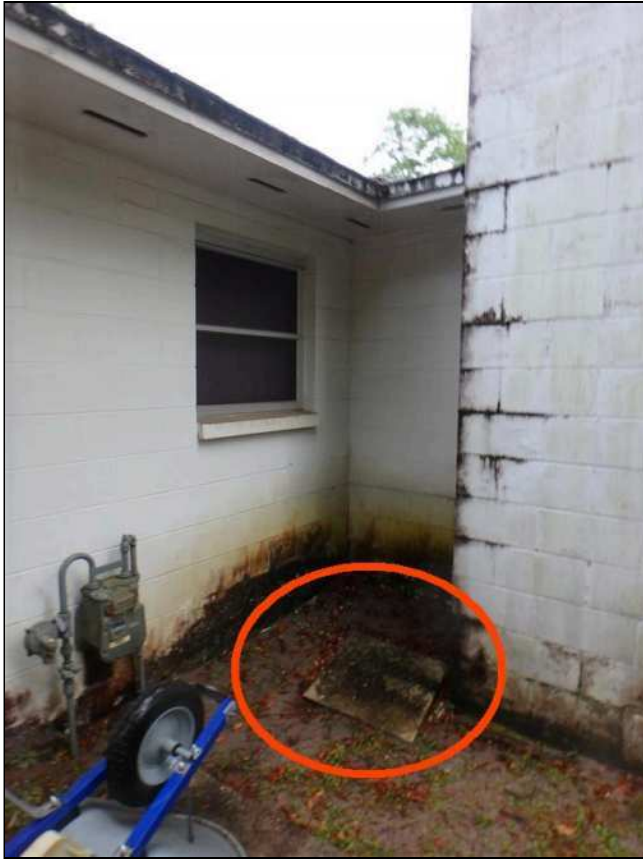
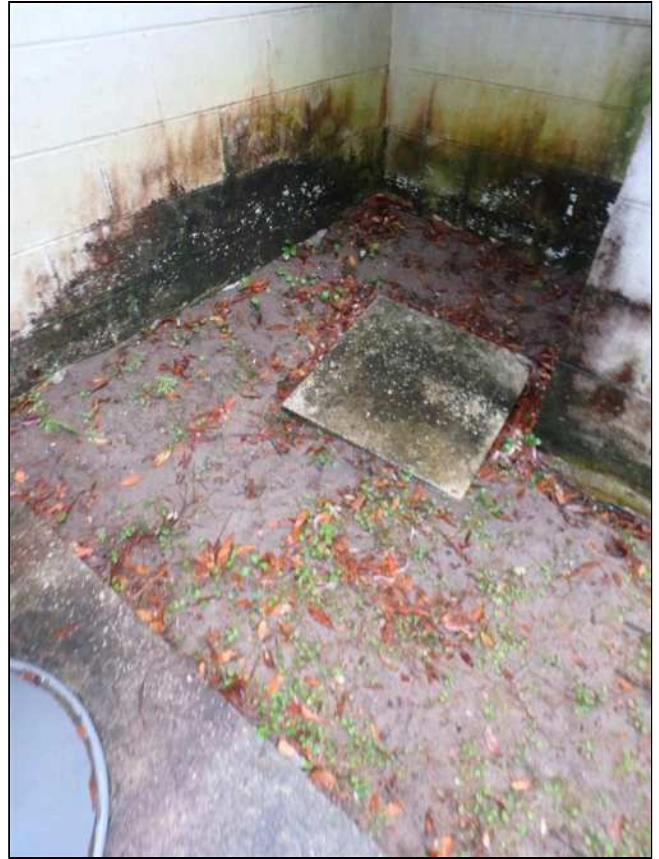
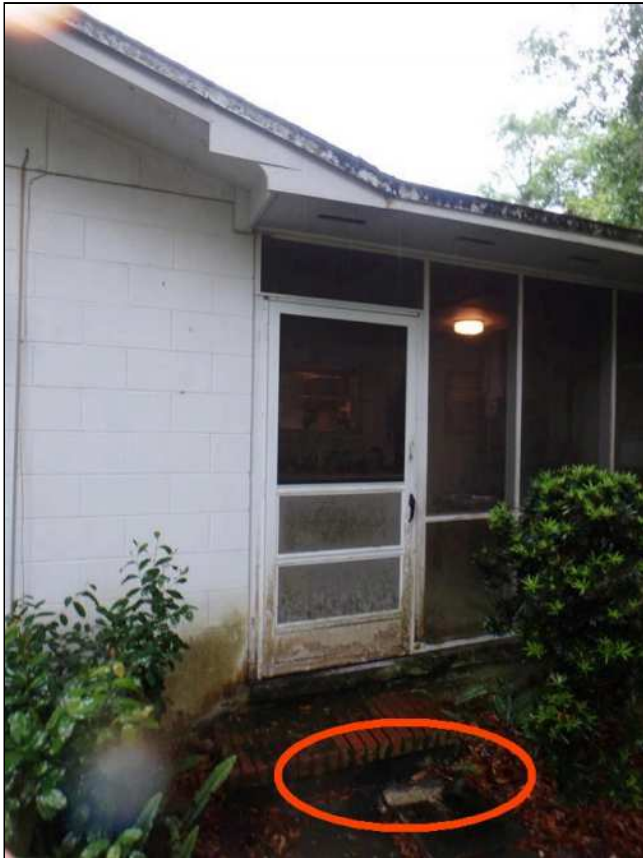
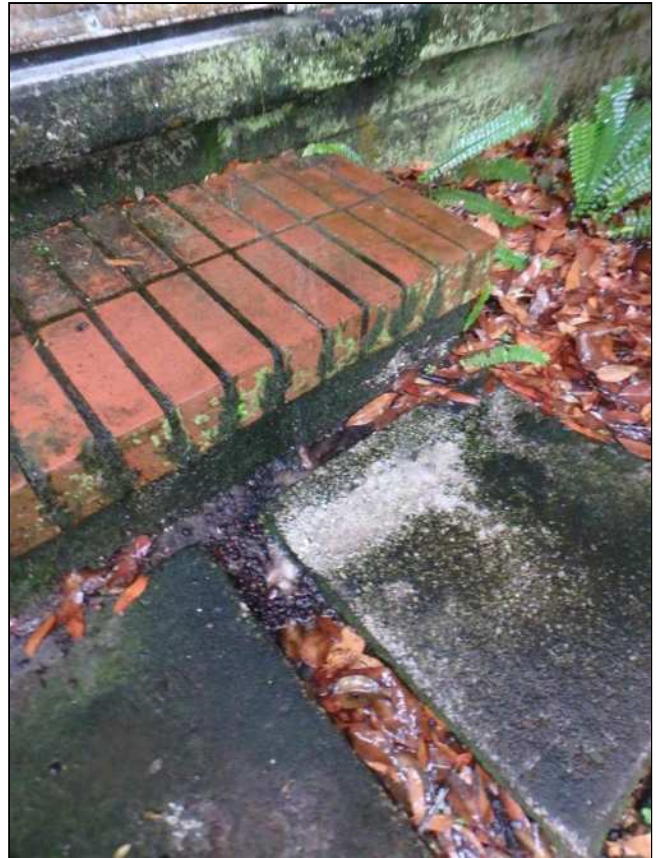
3.4 (1) GRADING EROSION OBSERVED AT THE PERIMETER OF THE ROOF LINE. *Evidence is indicative of roof rain water run-off. Over time, erosion may begin to affect / damage the adjacent exterior foundation walls / related elements. Pictures are a representative number of affected areas. All similar areas should be addressed accordingly.*

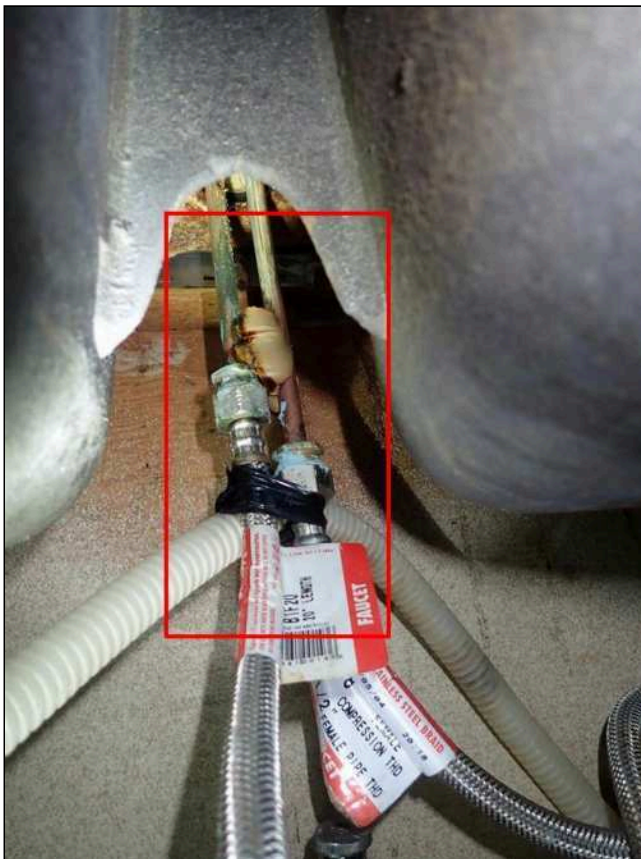
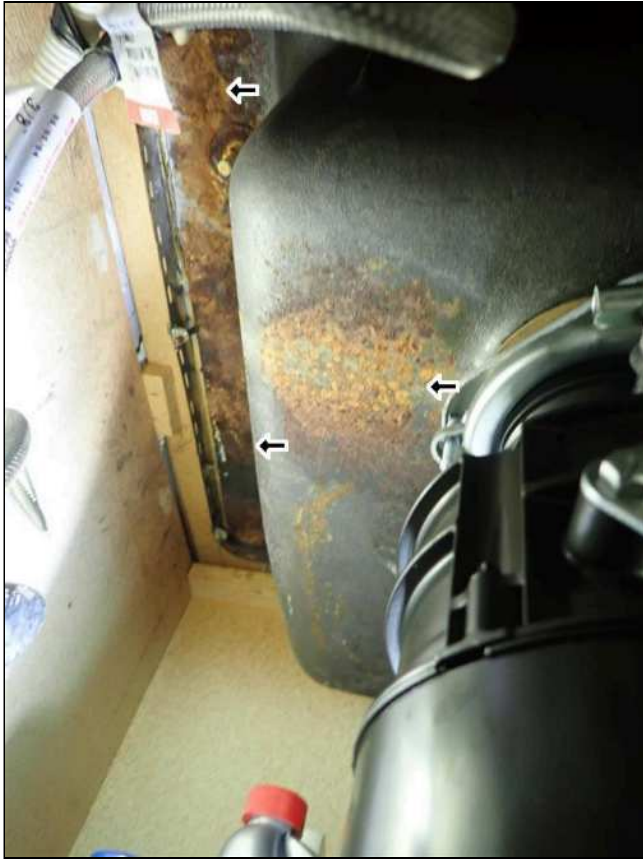
6.0 (1) EXCESSIVE RUST/CORROSION OBSERVED BELOW SINK AT SINK SURFACES. NO LEAKS OBSERVED AT TIME OF INSPECTION.

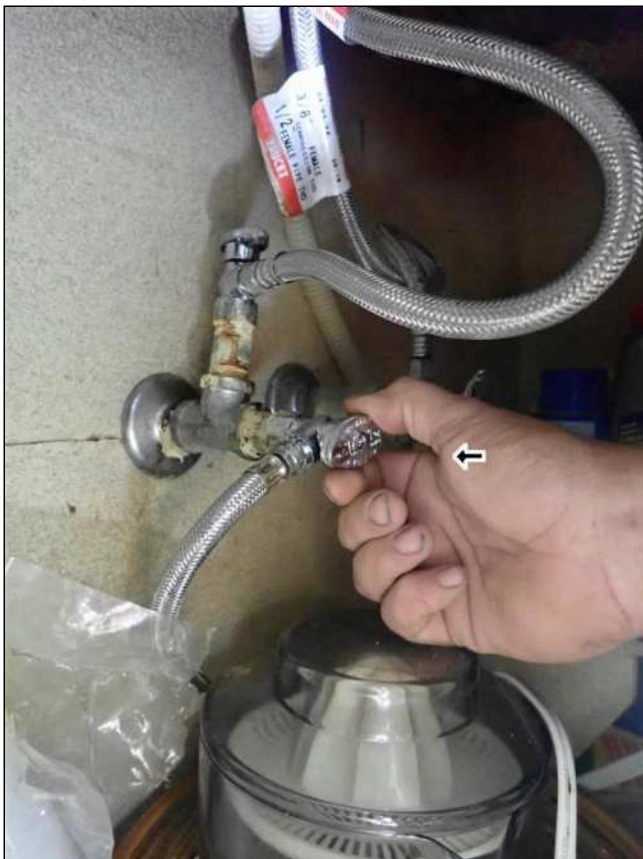
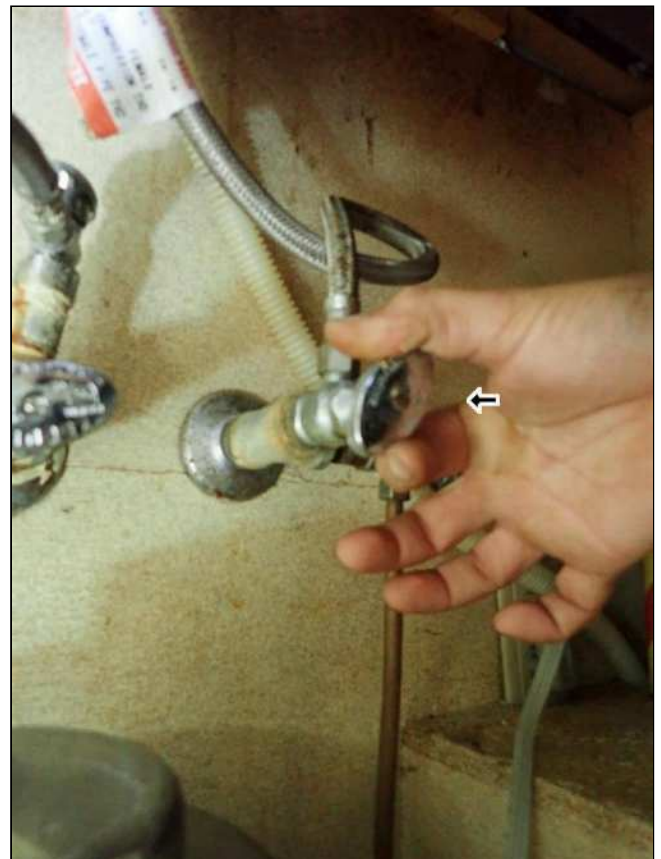
6.0 (2) ALL WATER SHUT-OFF VALVES ARE STUCK / FROZEN IN THE **OPEN** POSITION. *Shut-off valves often freeze in place due to lack of use movement. Shut-off valves should not be forced due to possibility of damage / leak. It may be difficult to shut down individual water supply lines in the case of repair or damage.*

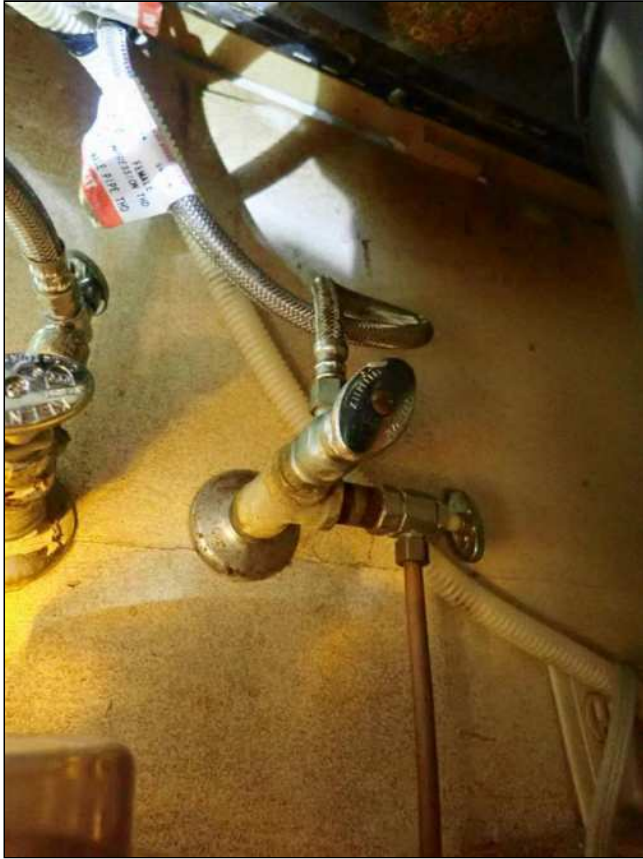
6.0 (3) CORROSION OBSERVED AT THE WATER SUPPLY SHUT OFF VALVES AND/OR RELATED ELEMENTS. *No leaks observed at time of inspection; however, prolonged exposure to corrosion may result in premature wear / failure of affected components. Removal of corrosion may result in exposure of leak. Condition of latent materials was not visible & could not be fully inspected. Hidden damage may exist.*

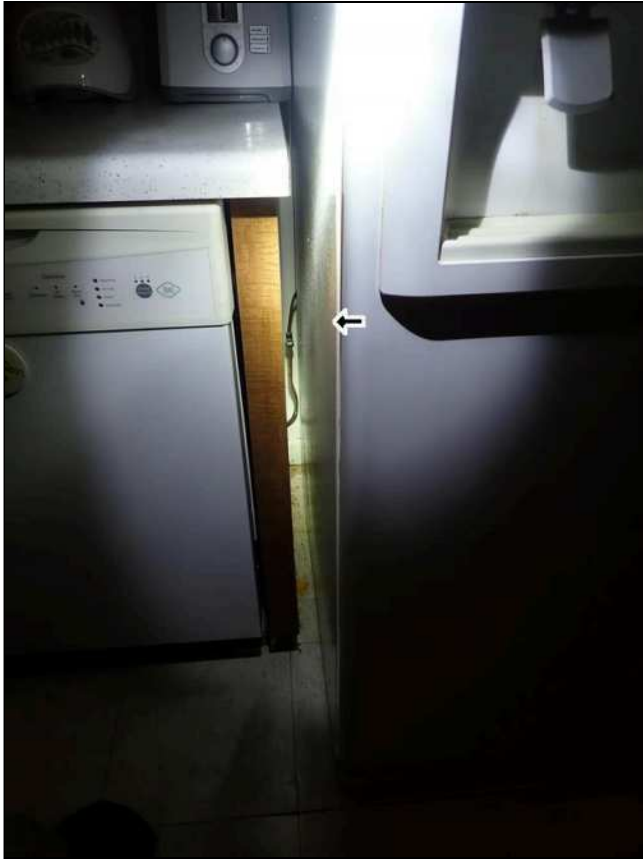
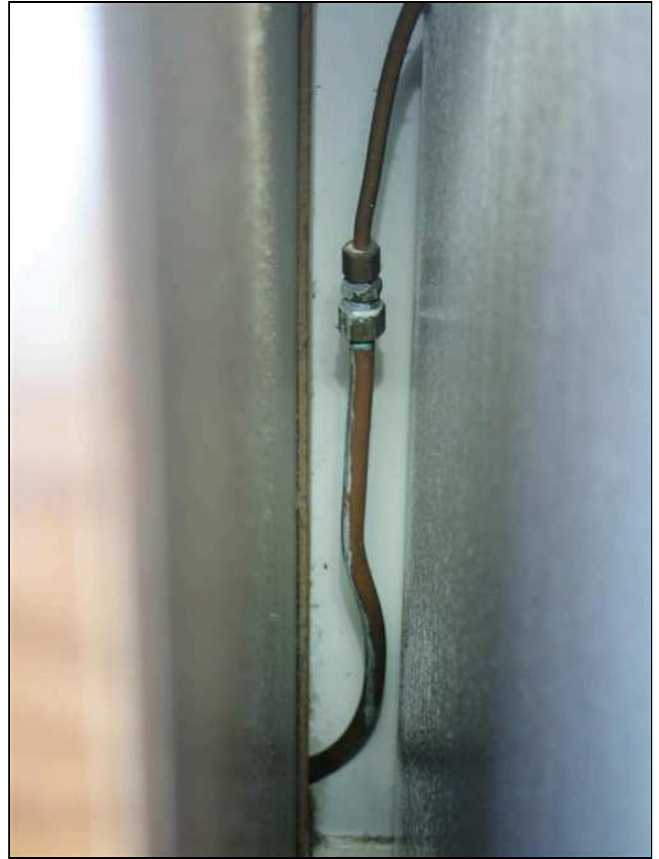
6.0 (4) CORROSION AND WHAT APPEARS TO BE A PREVIOUS LEAK OBSERVED AT WATER LINE BETWEEN REFRIGERATOR AND DISHWASHER POSSIBLY FOR REFRIGERATOR WATER SUPPLY.

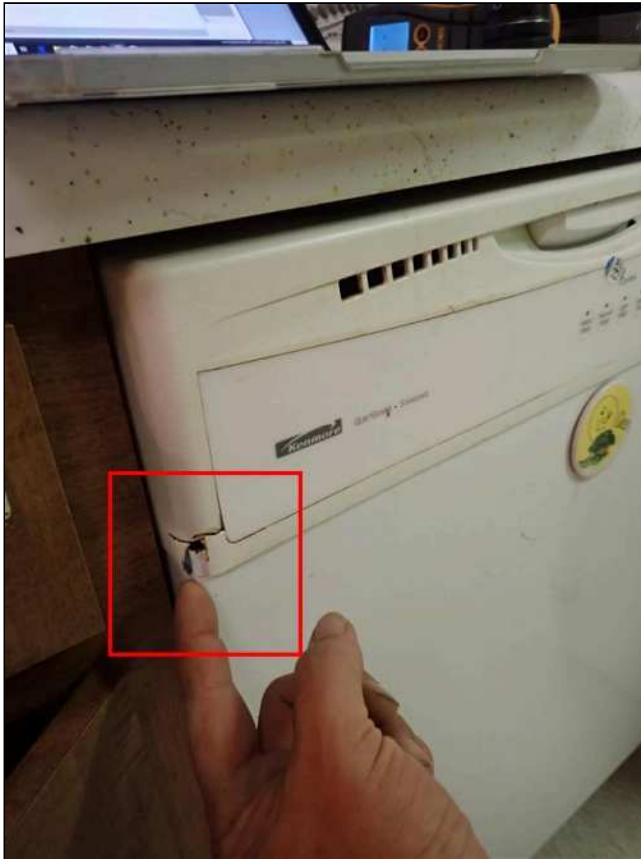
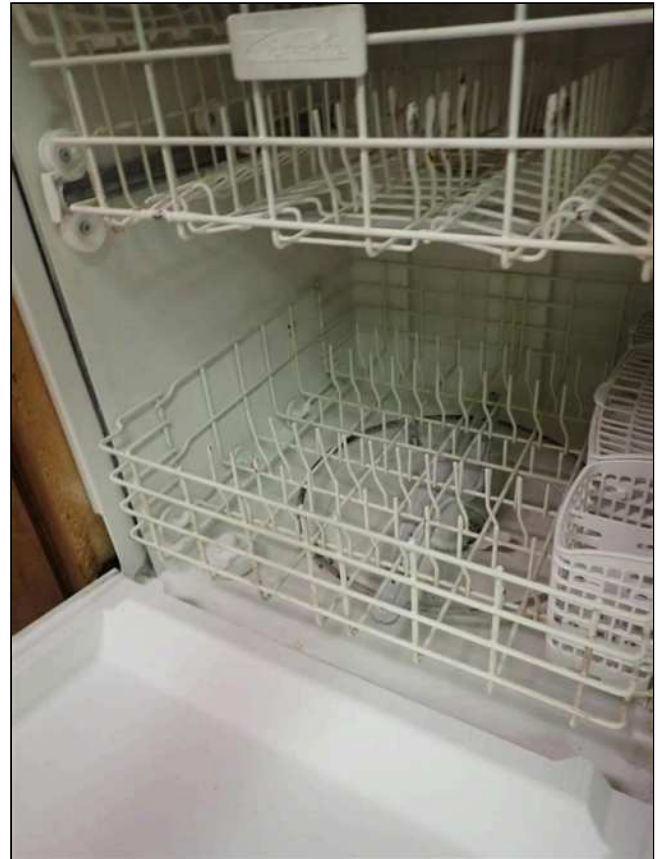
6.6 (1) UNIT OBSERVED TO HAVE MINOR DAMAGE AT TOP LEFT EXTERIOR AND FAIR CONDITIONS OBSERVED AT INTERIOR OF UNIT.

SUGGEST HAVING A LICENSED APPLIANCE SERVICE COMPANY OR CONTRACTOR EVALUATE AND REPAIR OR REPLACE AS NEEDED.

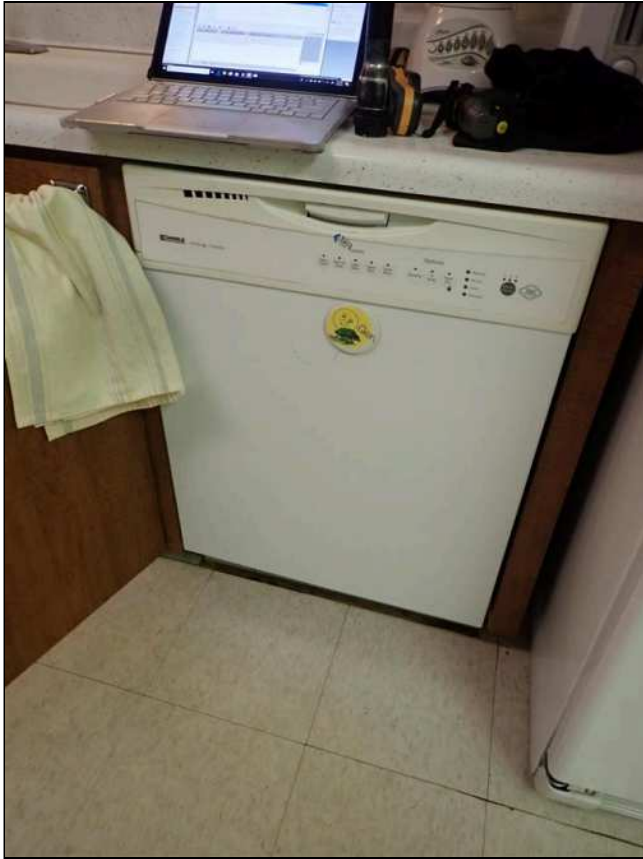
6.6 (2) UNIT MANUFACTURED 2006. ALTHOUGH UNIT WAS FUNCTIONAL AT TIME OF INSPECTION, UNIT HAS SURPASSED THE DESIGNED LIFE RANGE. IT IS RECOMMENDED TO ANTICIPATE REPAIR / REPLACEMENT NEEDS IN THE NEAR FUTURE. *Due to age of the unit, although standard functionality was achieved at time of inspection, unit & related components are at the end of their intended life span & may fail at any time.*

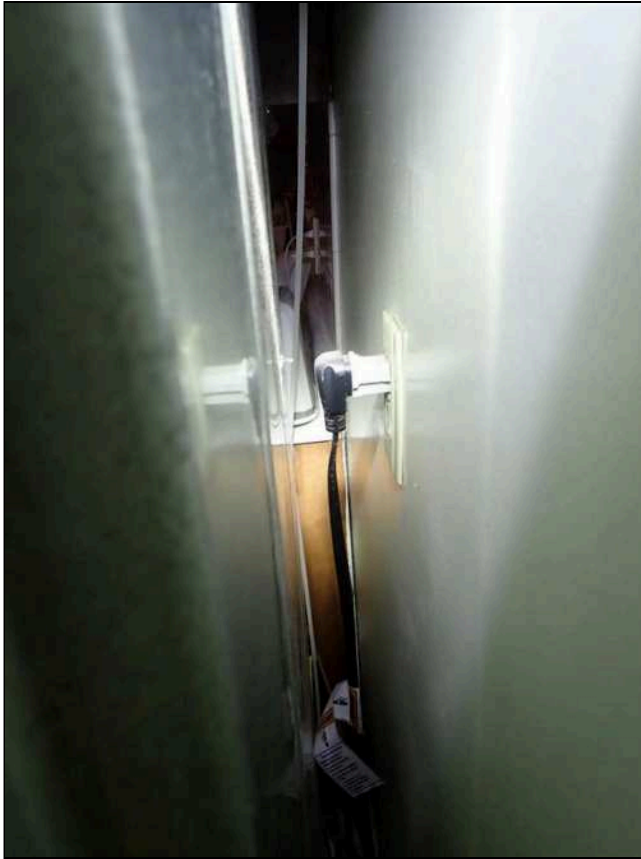
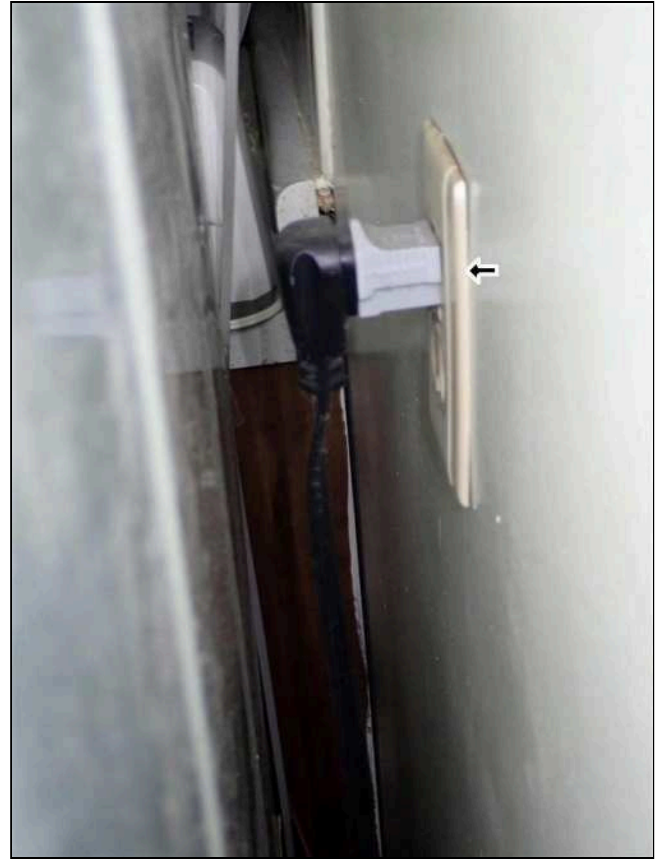
6.11 (1) NOTE: PLUG ADAPTER OBSERVED IN USE FOR REFRIGERATOR WHERE THE OUTLET IS ALREADY GROUNDED. SUCH ADAPTER MAY NOT BE NEEDED.

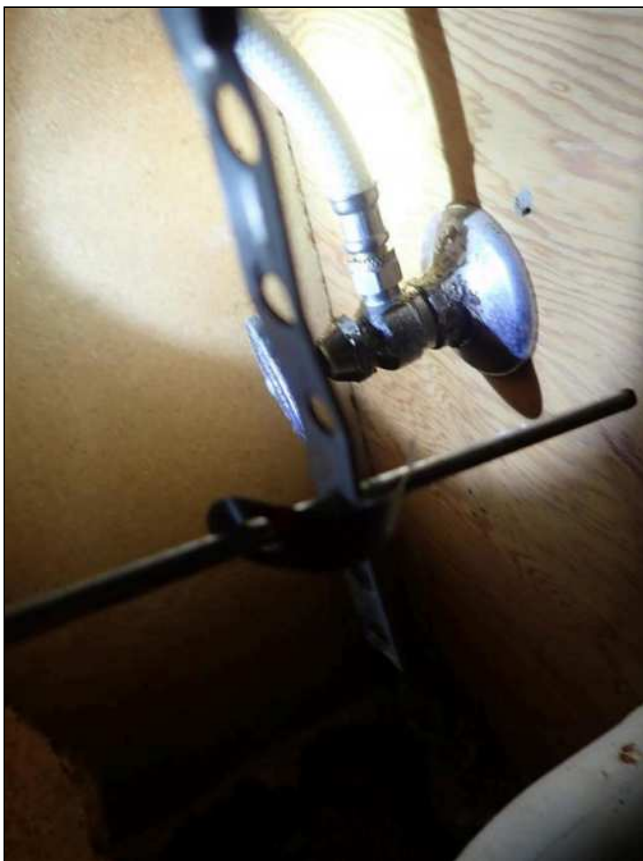
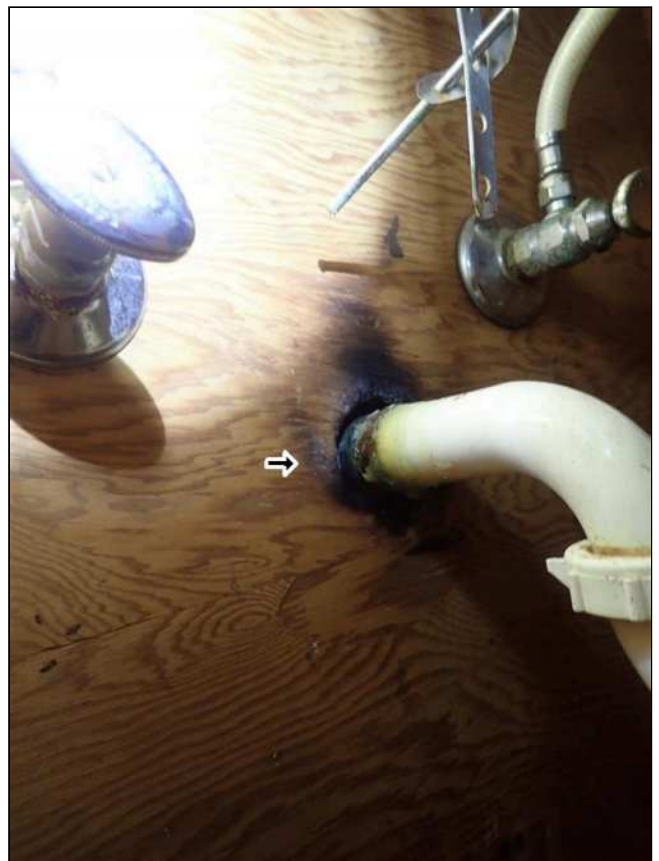
- CORROSION OBSERVED AT THE WATER SUPPLY SHUT-OFF VALVES AND/OR RELATED ELEMENTS. *No leaks observed at time of inspection; however, prolonged exposure to corrosion may result in premature wear / failure of affected components. Removal of corrosion may result in exposure of leak. Condition of latent materials was not visible & could not be fully inspected. Hidden damage may exist.*
- IMPROPER DRAIN LINE CONNECTION OBSERVED.
- EVIDENCE OF PREVIOUS DRAINAGE PROVISIONS LEAKS. *No leaks observed at time of inspection; however, moderate amount of water may be needed to expose leaks.*

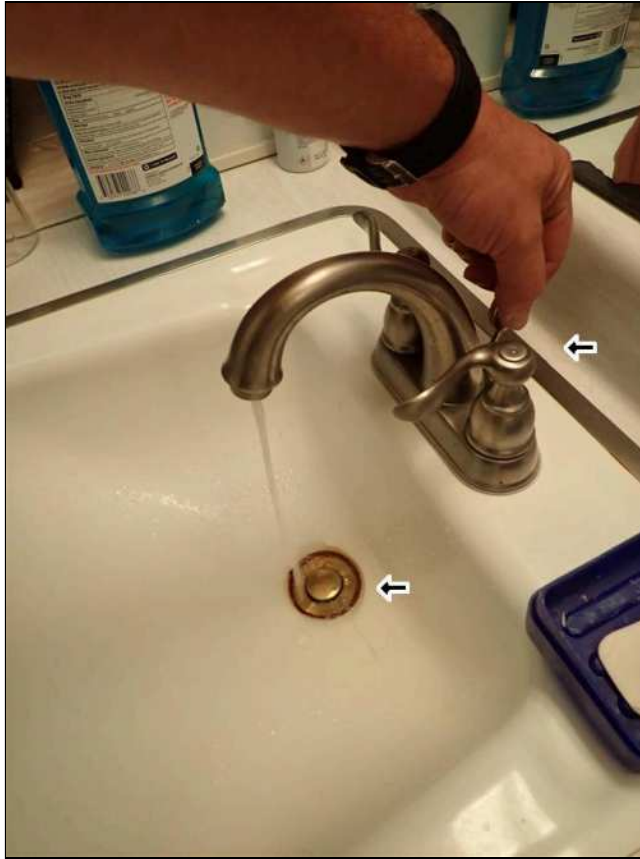
7.1 (2) STOPPER MECHANISM DOES NOT COMPLETELY CLOSE STOPPER TO BE ABLE TO FILL SINK.

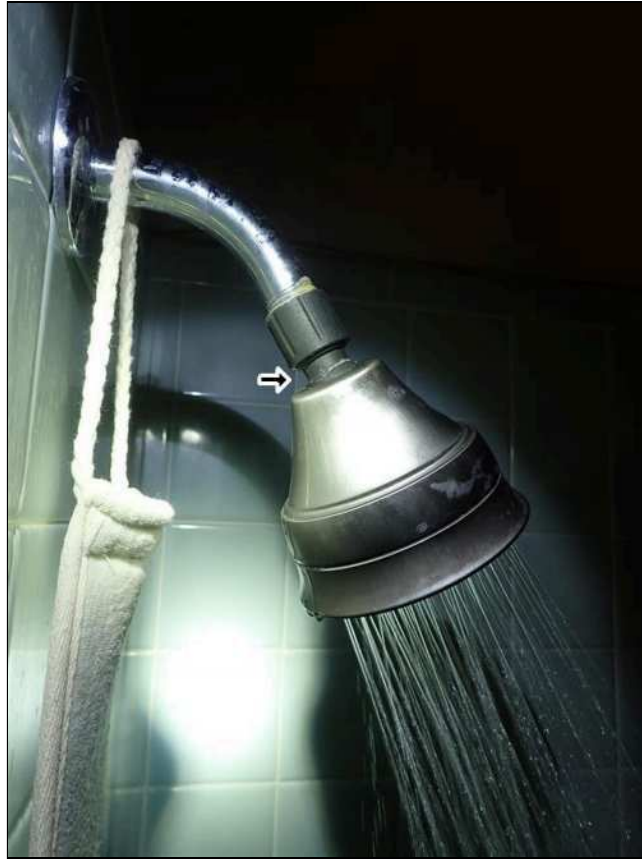
7.3 (2) ACTIVE LEAK AT SHOWER HEAD.

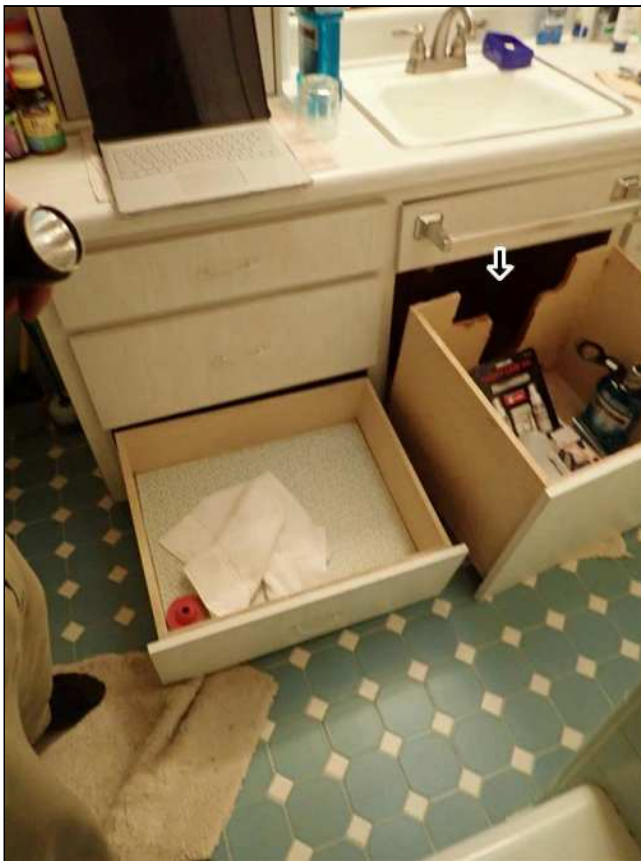
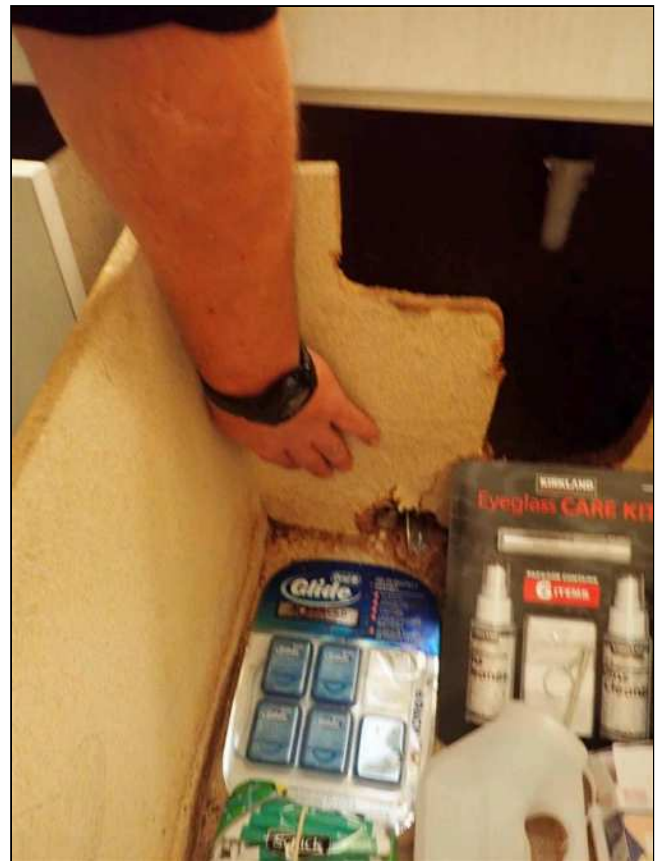
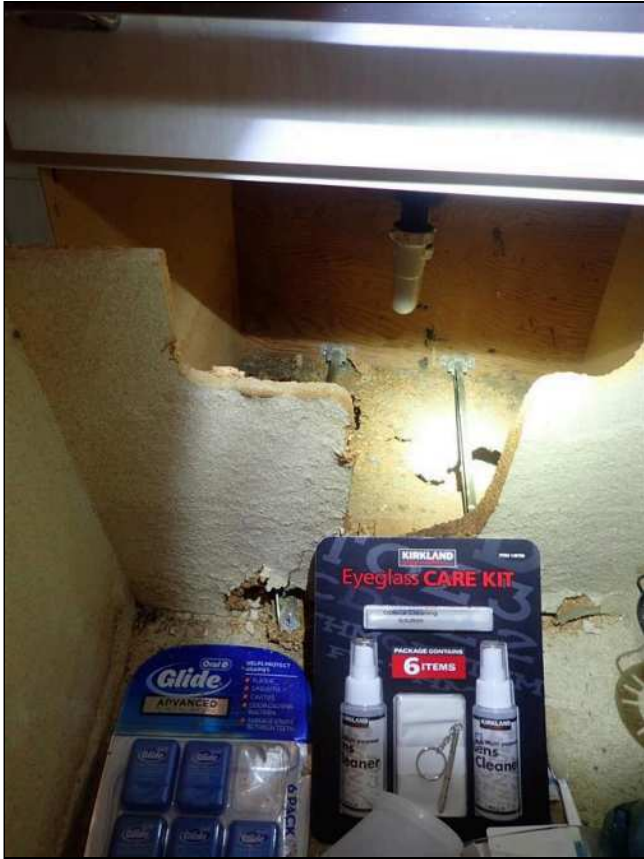
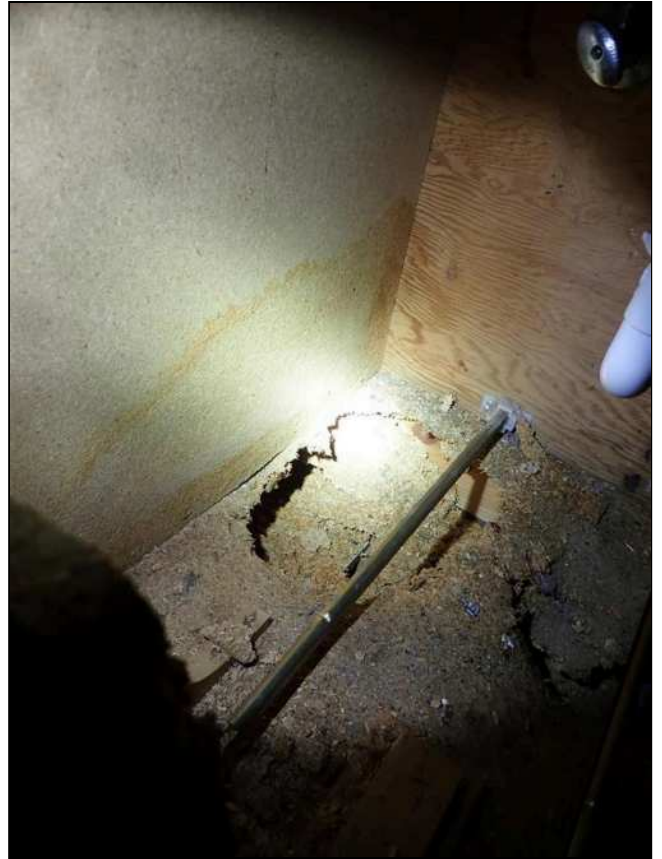
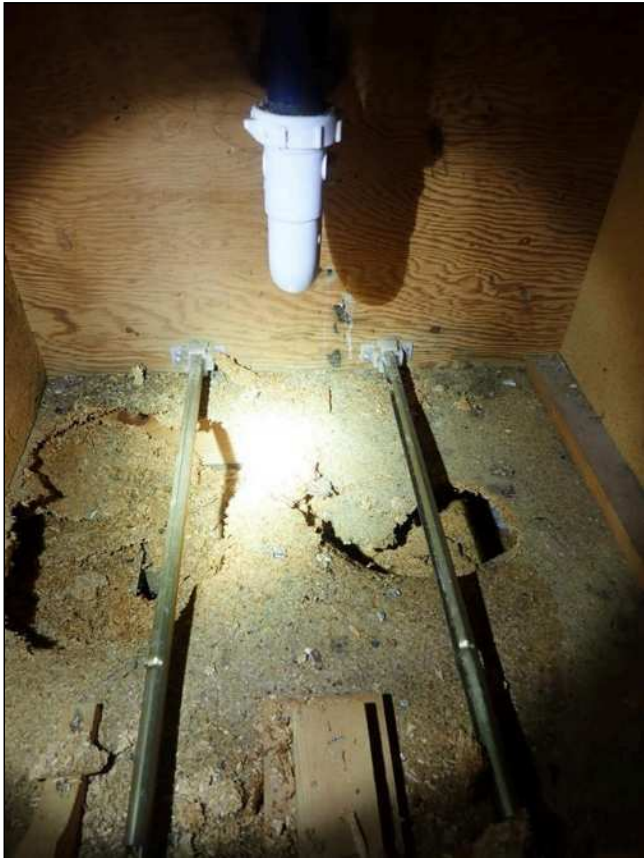
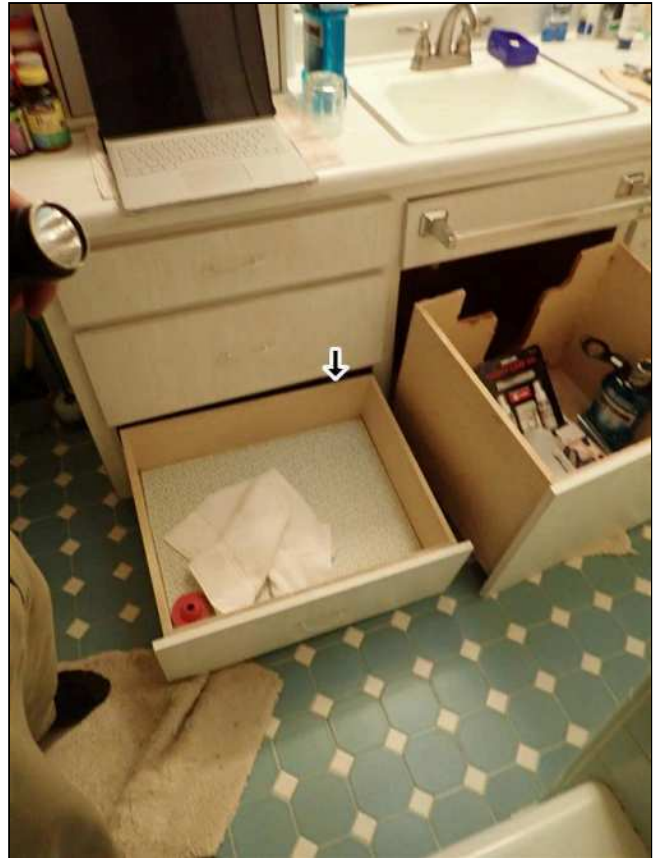
7.5 (2) EXCESSIVE WOOD DECAY AND MICROBIAL GROWTH OBSERVED. FLOORING DAMAGE AND DETERIORATION OBSERVED AT BELOW THE CABINET AND CRAWLSPACE AREA CAN BE SEEN WITH SEVERAL FLOOR JOISTS EXPOSED. *The condition of latent materials can not be seen and addition and/or hidden damage may exist.* AREAS TESTED DRY AT TIME OF INSPECTION USING A DIGITAL MOISTURE METER.

SUGGEST HAVING A LICENSED CONTRACTOR EVALUATE AND REPAIR OR REPLACE AS NEEDED.

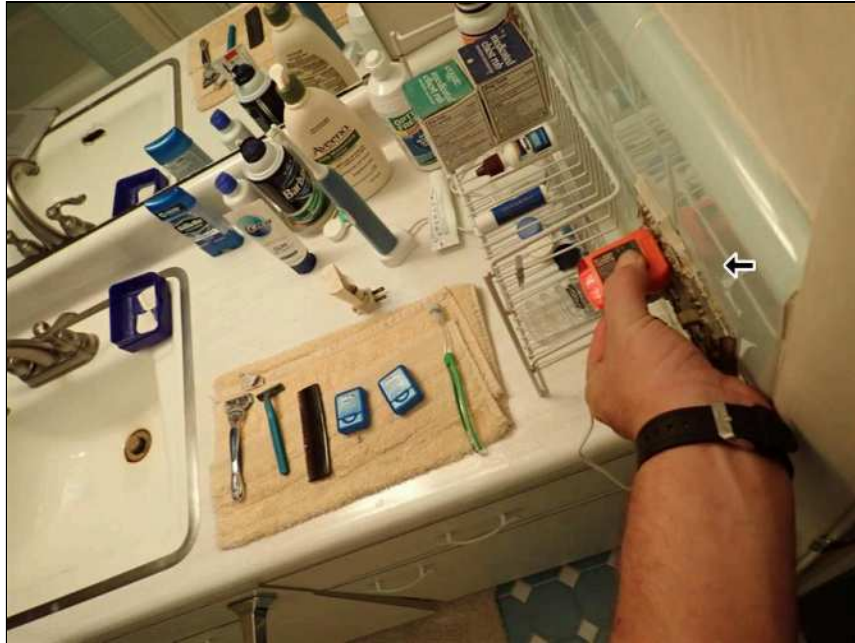
7.9 (1) BATHROOM OUTLETS ARE NOT GFCI PROTECTED / DID NOT TRIP WHEN MANUALLY TESTED. *According to the National Electric Code, All homes built after 1975 should have GFCI protection at all outlets in the bathroom. Due to age of home, no updates are required as the home is **grand-fathered** into previous code. However, for protection of the home occupants, it is recommend to add GFCI protection at all bathroom outlets.*

SUGGEST HAVING A HANDYMAN OR A LICENSED CONTRACTOR EVALUATE AND REMEDY AS NEEDED.

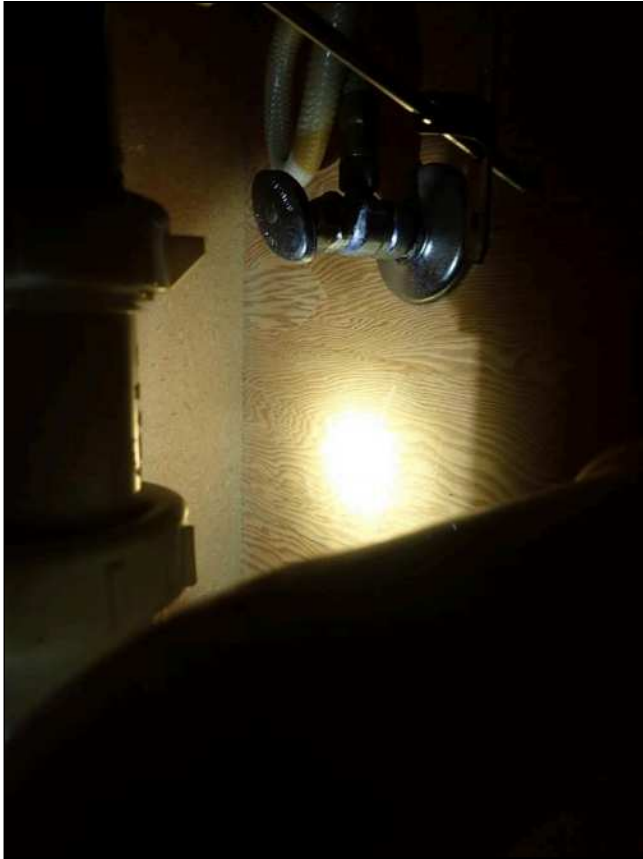
7.12 (3) CORROSION OBSERVED AT THE WATER SUPPLY SHUT-OFF VALVES AND/OR RELATED ELEMENTS. *No leaks observed at time of inspection; however, prolonged exposure to corrosion may result in premature wear / failure of affected components. Removal of corrosion may result in exposure of leak. Condition of latent materials was not visible & could not be fully inspected. Hidden damage may exist.*

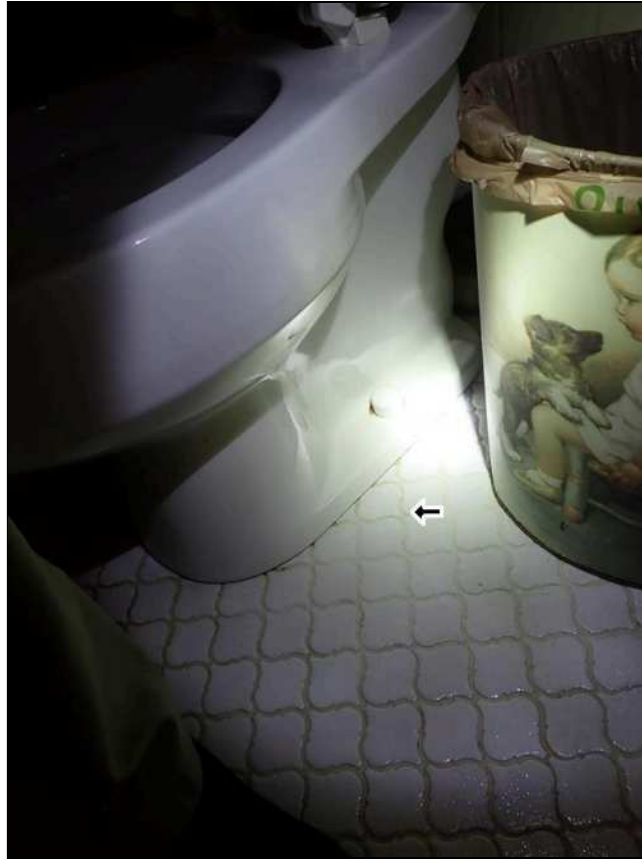
7.13 (5) TOILET IS LOOSE AT FLOOR AND MOVES SLIGHTLY WHEN STRADDLED.

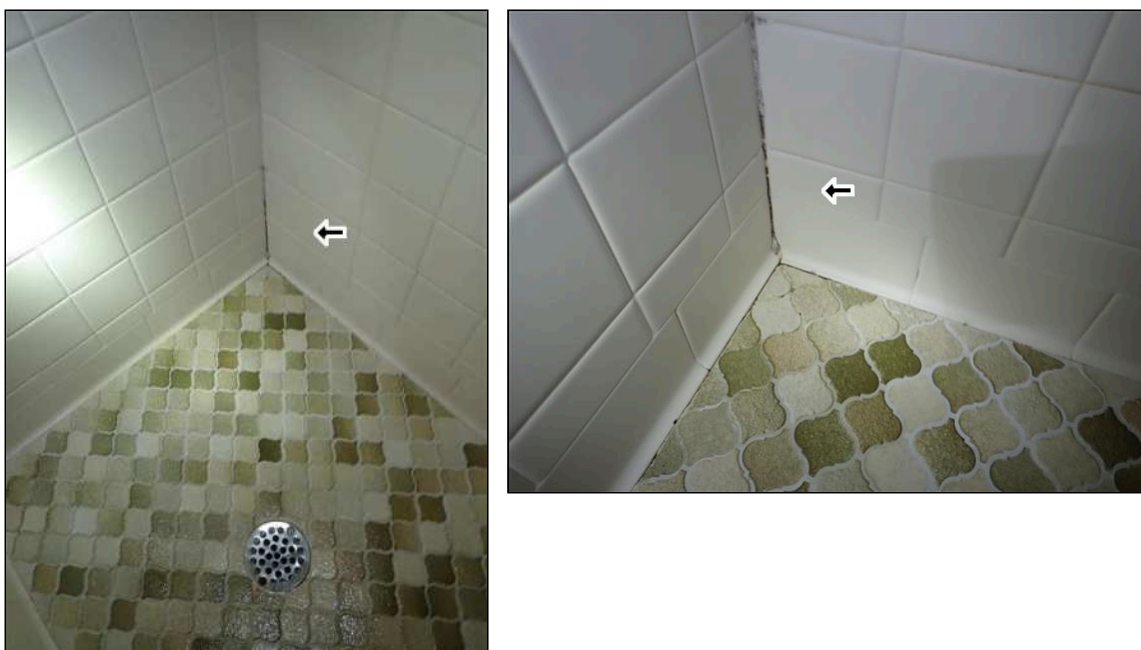
7.24 (1) SEPARATION AND/OR DETERIORATED SEALANT MATERIALS OBSERVED AT WALL TILES. *Separation / cracking in tile sealant may allow moisture intrusion. Damage behind tile may not be readily visible / detectable at the time of inspection.*

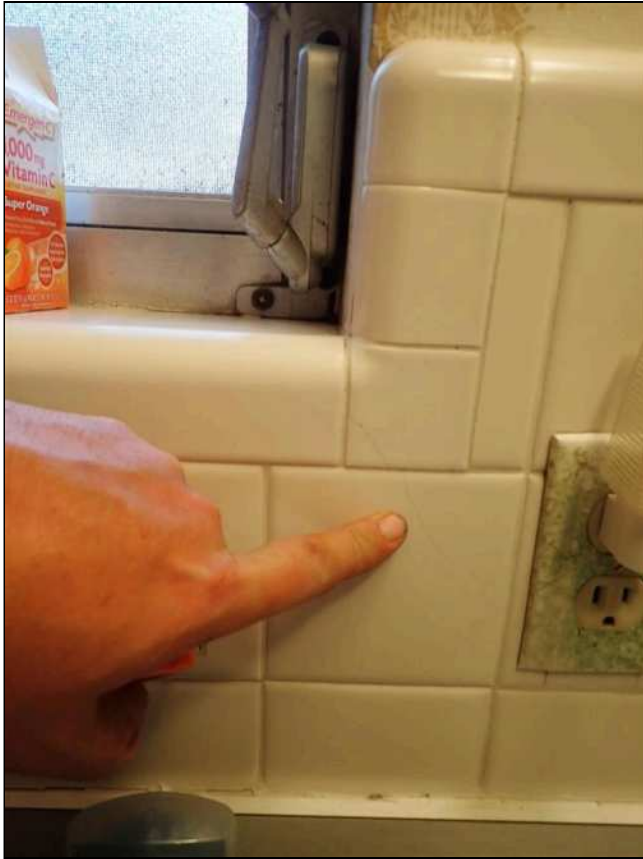
7.25 (Picture 1)

SEVERAL CRACKED WALL TILES OBSERVED.

SUGGEST HAVING A HANDYMAN OR A LICENSED CONTRACTOR EVALUATE AND REPAIR OR REPLACE AS NEEDED.

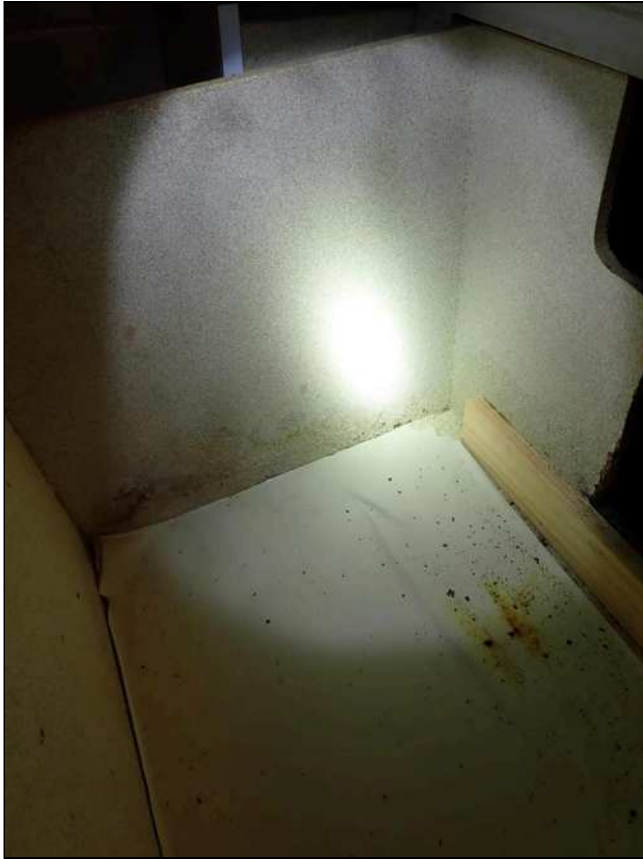
7.26 (1) PREVIOUS WATER DAMAGE, WOOD DECAY, AND MICROBIAL GROWTH OBSERVED AT BASE OF SINK CABINET AND DRAWER.

SUGGEST HAVING A HANDYMAN OR A LICENSED CONTRACTOR EVALUATE AND REPAIR OR REPLACE AS NEEDED.
