INSPECTION INFORMATION

Standard Home Inspection

Single Family Dwelling

51 Years

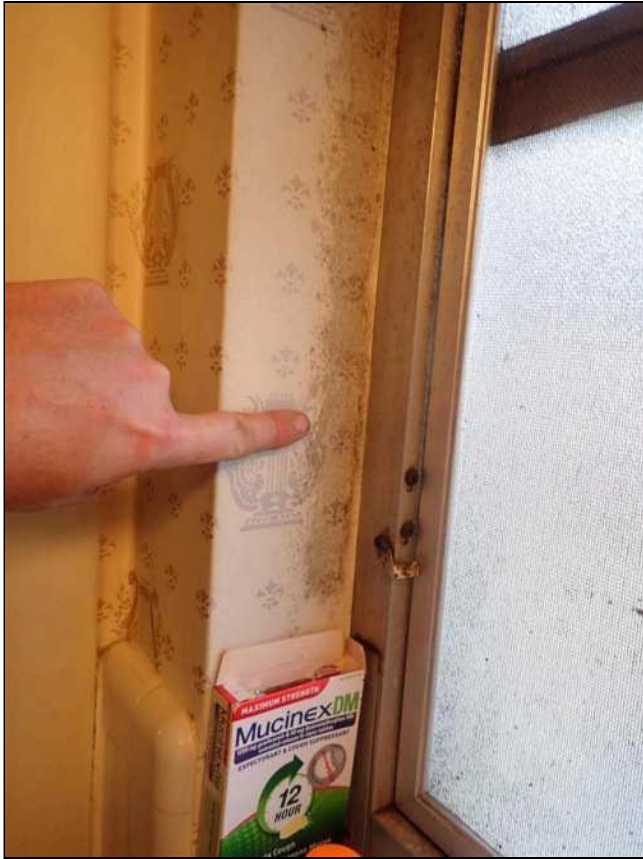
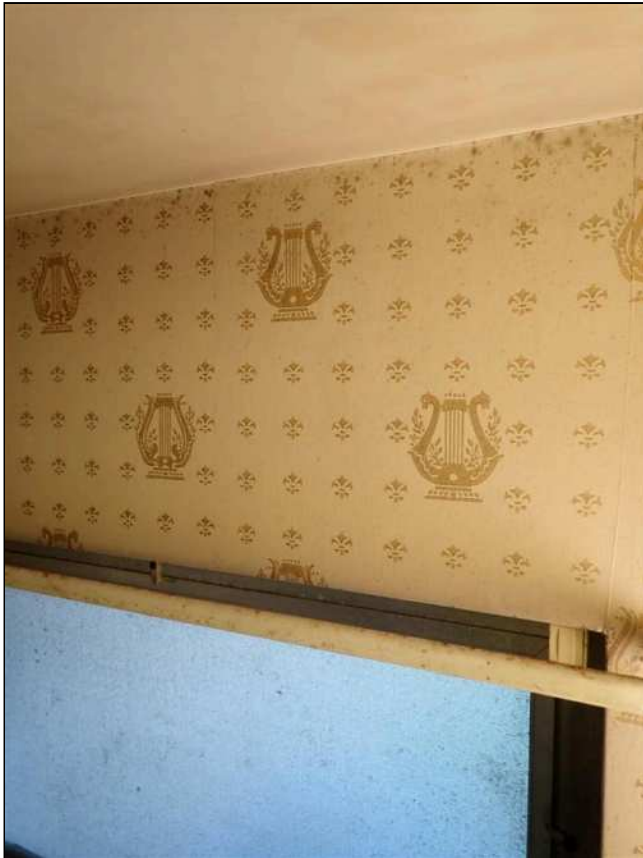
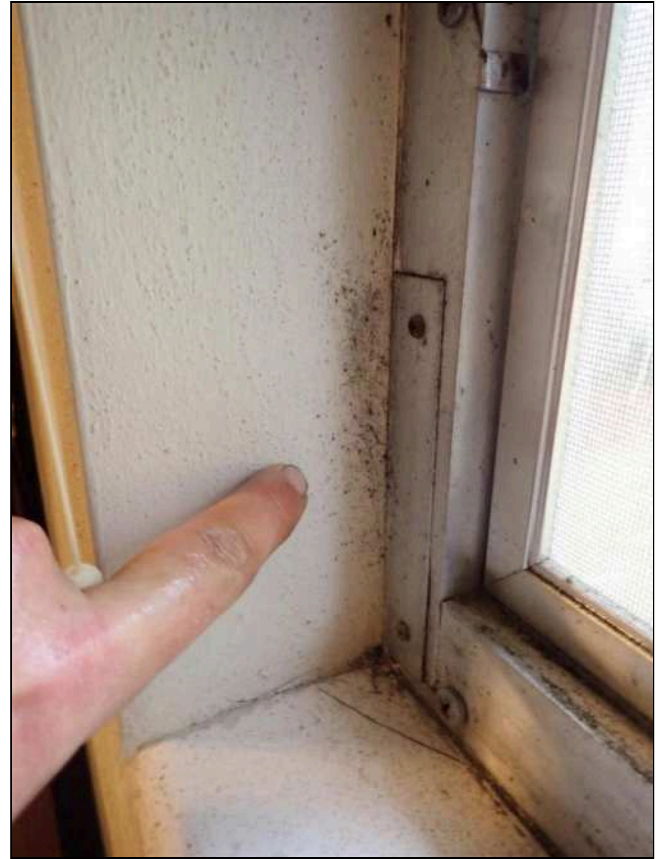
7.27 (1) MICROBIAL GROWTH OBSERVED AT THE BATHROOM WALLS / CEILING. *Current condition is indicative of poor / improper ventilation of high moisture / humidity areas. Microbial growth may also hold excessive moisture against attached building materials potentially promoting premature wear / failure of affected components. The condition of latent materials can not be seen and hidden damage may exist.*

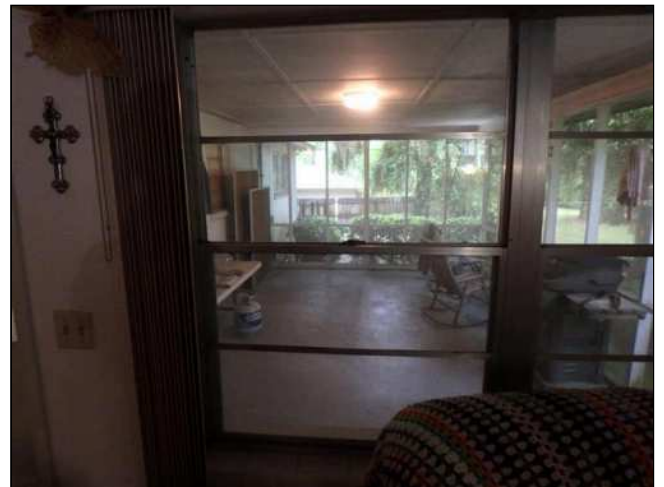
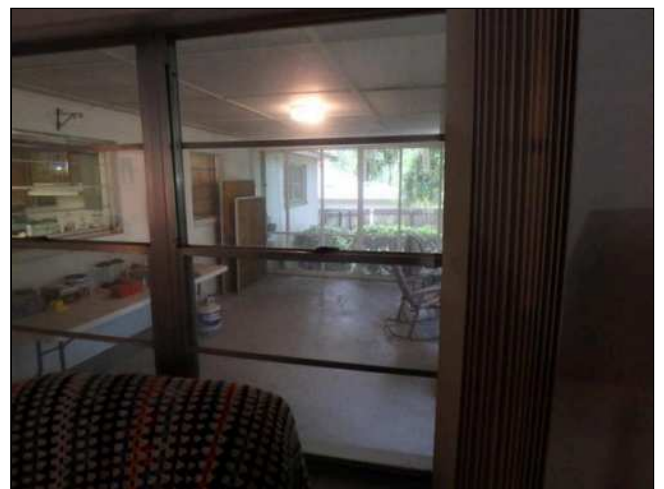
8.3 (5) LEFT SIDE FAMILY ROOM WINDOWS DO NOT REMAIN IN THE "UP" POSITION. Condition may be due to damaged / detached balancer springs.

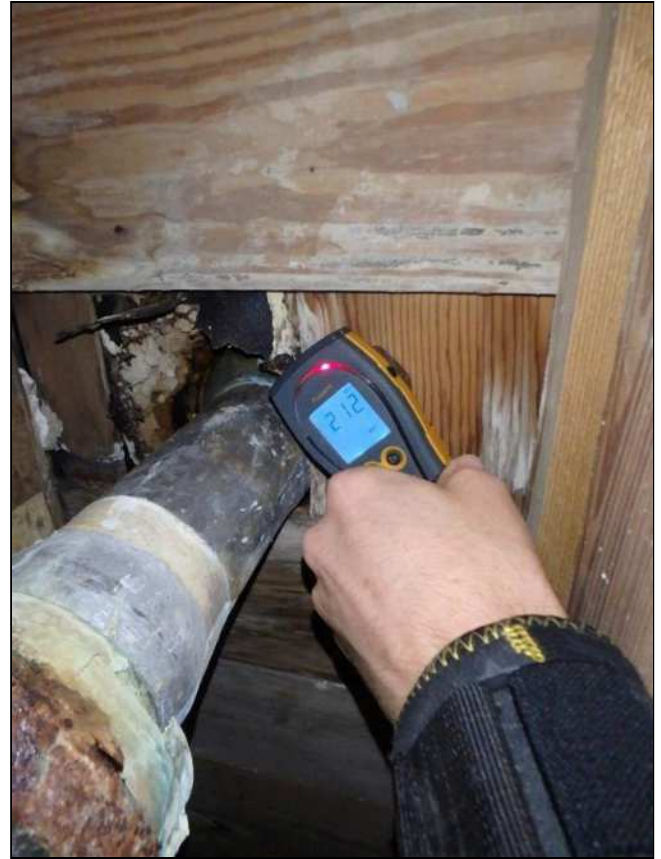
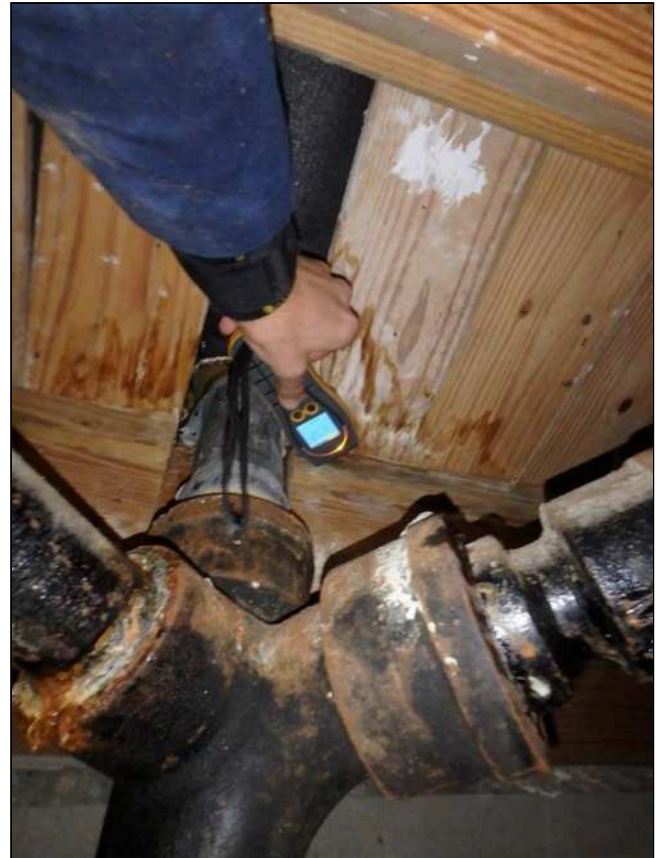
9.2 (2) STAINING OBSERVED AT THE SUB-FLOORING, MAINLY ADJACENT TO PLUMBING PROVISIONS. AREAS TESTED POSITIVE FOR MOISTURE CONTENT USING A DIGITAL MOISTURE METER AT TIME OF INSPECTION. *Extent of moisture penetration / condition of latent materials was not visible and could not be fully inspected. Hidden damage may exist.*

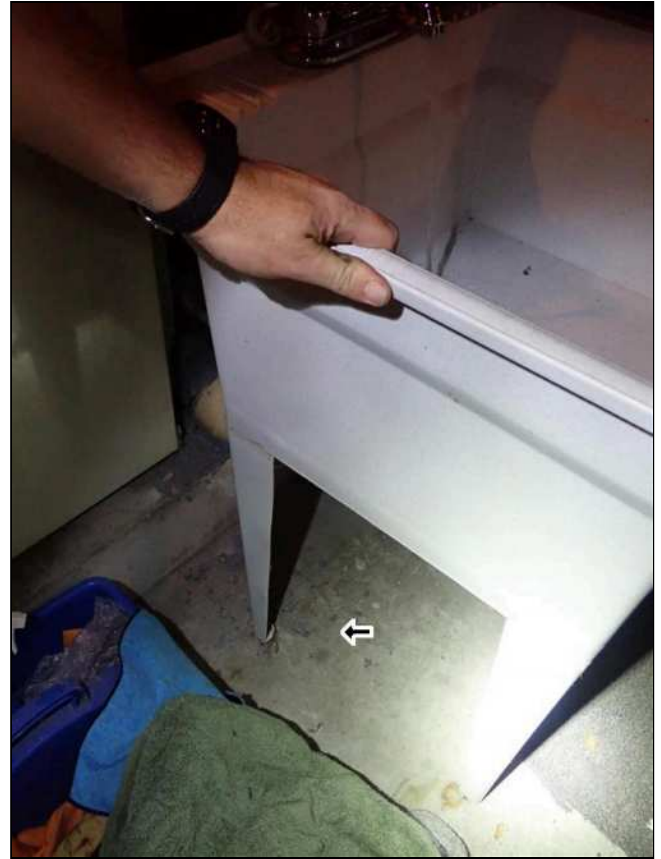
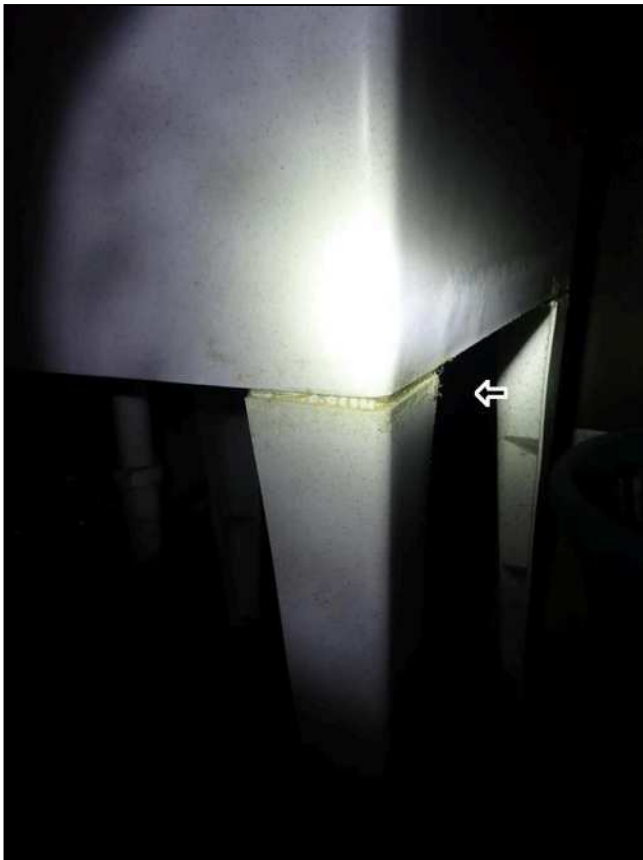
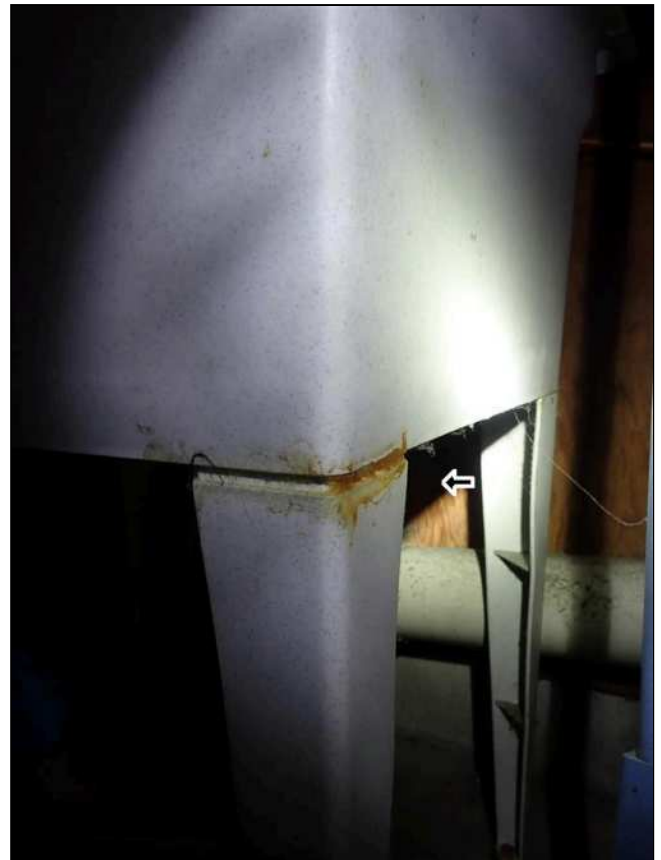
14.5 (2) LAUNDRY SINK IS NOT SECURE TO WALL NOR FLOOR AND HAS WHAT APPEARS TO BE PREVIOUS REPAIRS AT LEG(S.)

SUGGEST HAVING A LICENSED PLUMBER OR CONTRACTOR EVALUATE AND REMEDY AS NEEDED.

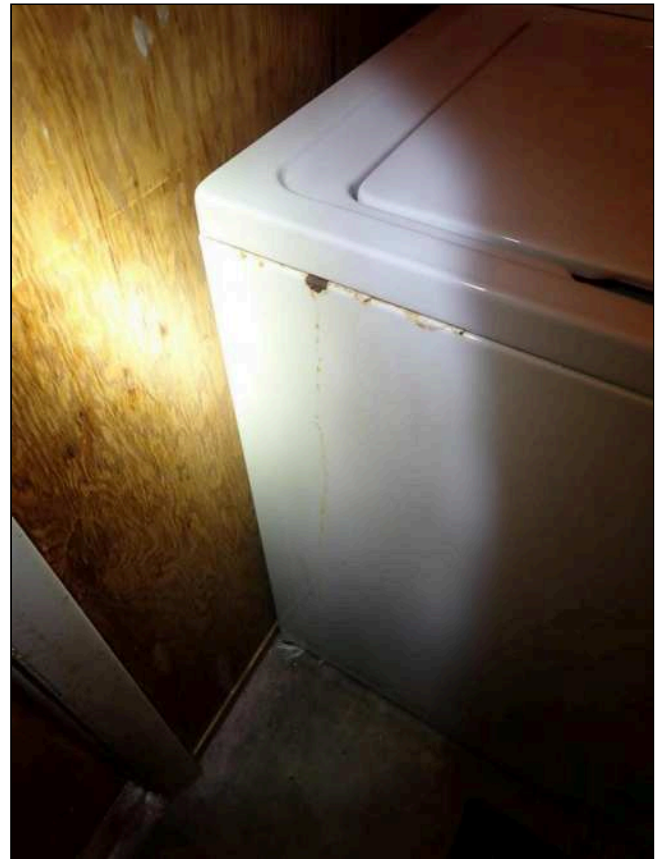
14.8 (4) FAIR RATING ALSO DUE TO AGE & CONDITION AS WELL AS RUST/CORROSION OF UNITS. SUGGEST HAVING A LICENSED APPLIANCE SERVICE COMPANY OR CONTRACTOR EVALUATE AND REMEDY AS NEEDED.

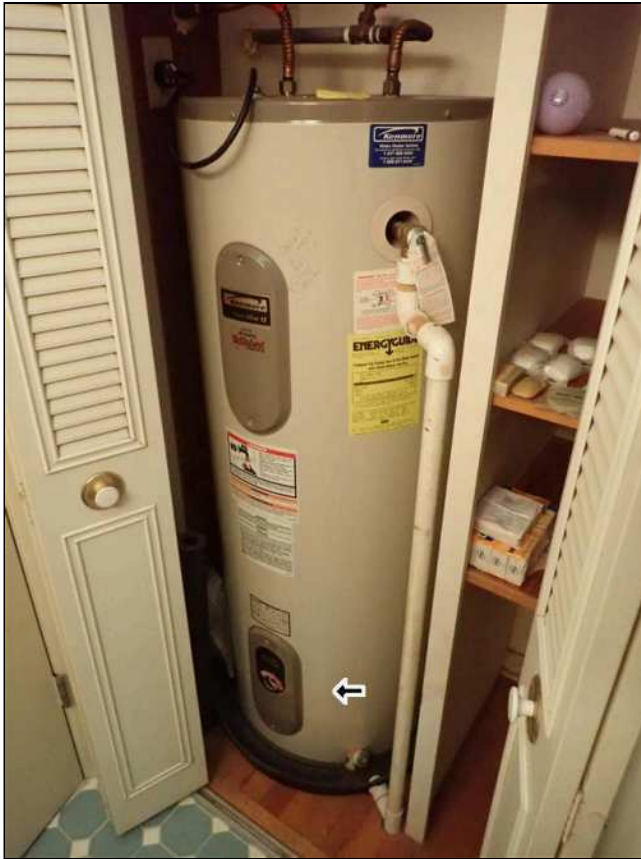
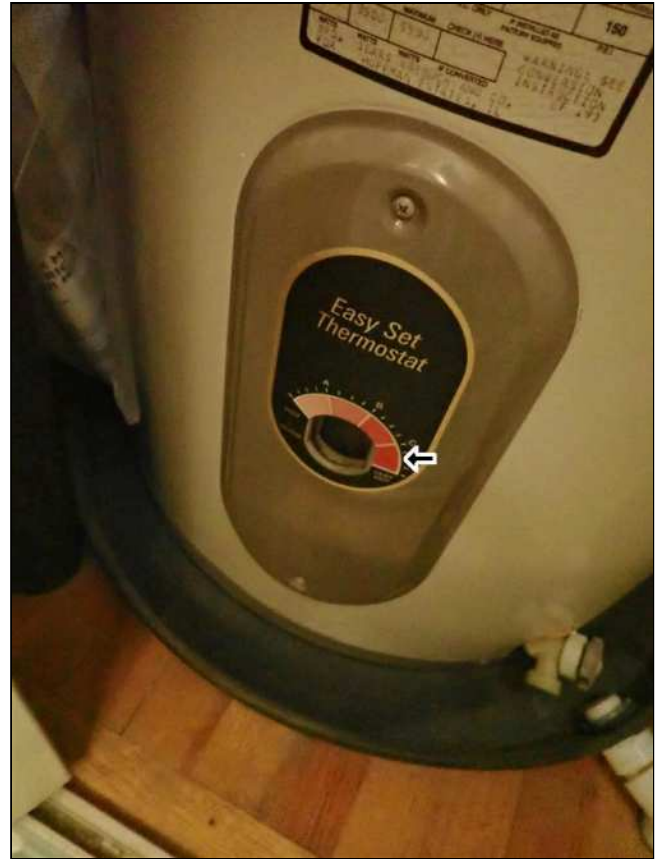
15.1 (2) IT APPEARS AS THOUGH THE THERMOSTAT OR CONTROL IS MISSING OR HAS BROKEN.
