INSPECTION INFORMATION

Standard Home Inspection

Single Family Dwelling

51 Years

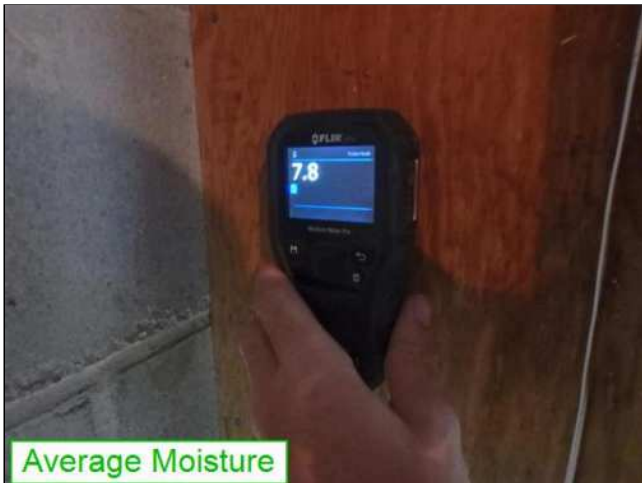
4.4(2) WALLS / CEILINGS (Picture 3)

Average Moisture

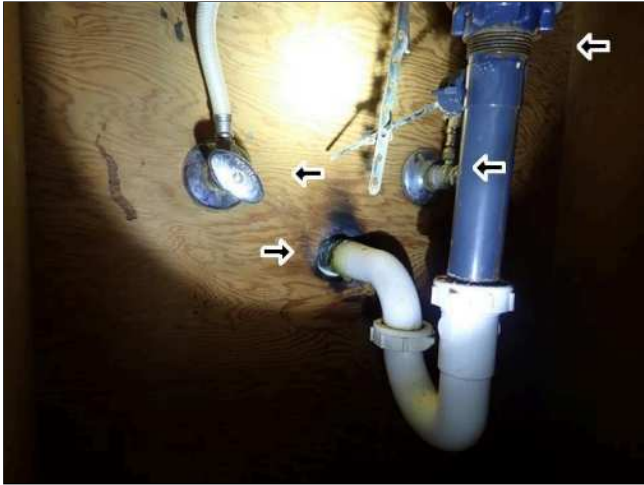
7.1(1) SINK(S) (Picture 1)

●	●	●	●	●	<p>7.0 ----- BATHROOM 1 ----- LEFT REAR GUEST BATHROOM</p>
●	●	●	●	●	<p>7.1 SINK(S) (1)</p> <ul style="list-style-type: none"> • CORROSION OBSERVED AT THE WATER SUPPLY SHUT-OFF VALVES AND/OR RELATED ELEMENTS. <i>No leaks observed at time of inspection; however, prolonged exposure to corrosion may result in premature wear / failure of affected components. Removal of corrosion may result in exposure of leak. Condition of latent materials was not visible & could not be fully inspected. Hidden damage may exist.</i> • IMPROPER DRAIN LINE CONNECTION OBSERVED. • EVIDENCE OF PREVIOUS DRAINAGE PROVISIONS LEAKS. <i>No leaks observed at time of inspection; however, moderate amount of water may be needed to expose leaks.</i> <p>(2) STOPPER MECHANISM DOES NOT COMPLETELY CLOSE STOPPER TO BE ABLE TO FILL SINK. (3) RUST/CORROSION OBSERVED AT DRAIN OPENING AND DRAIN HARDWARE. (4) HOT WATER PRESSURE IS POOR WHILE COLD WATER PRESSURE IS FAIR TO POOR. GALVANIZED WATER PIPING OBSERVED AT BATHROOMS AND KITCHEN. ALSO SEE PLUMBING COMMENTS. SUGGEST HAVING A LICENSED PLUMBER OR CONTRACTOR EVALUATE AND REPAIR OR REPLACE AS NEEDED.</p>

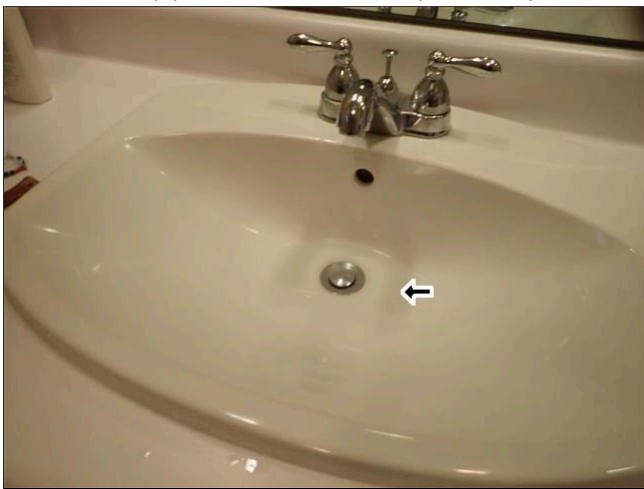
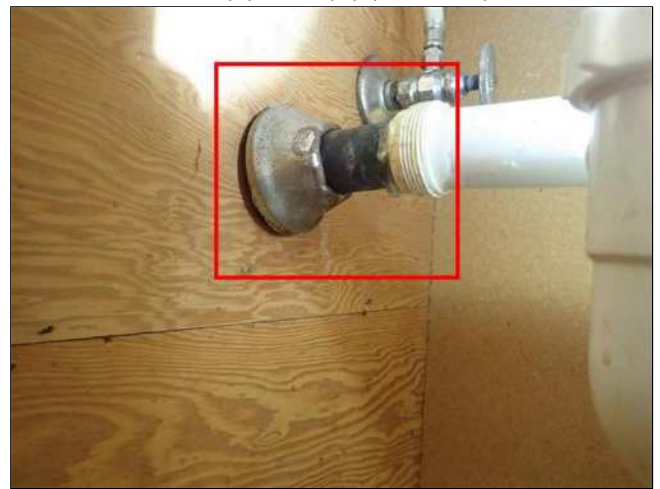
7.12(1) SINK(S) (Picture 1)

<p>7.11 ----- BATHROOM 2 -----</p> <p>LEFT FRONT BATHROOM</p>
				<p>7.12 SINK(S)</p> <p>(1) SINK IS SLOW TO DRAIN. <i>A slow or blocked drain may indicate a localized concern or may be related to the condition or flow of branch or main waste lines. A licensed plumbing contractor should be consulted in order to determine whether cleaning or other corrective measures are required.</i></p> <p>(2) EVIDENCE OF PREVIOUS DRAINAGE PROVISIONS LEAK(S). <i>No leak(s) observed at time of inspection; however, moderate amount of water may be needed to expose leak(s).</i></p> <p>(3) CORROSION OBSERVED AT THE WATER SUPPLY SHUT-OFF VALVES AND/OR RELATED ELEMENTS. <i>No leaks observed at time of inspection; however, prolonged exposure to corrosion may result in premature wear / failure of affected components. Removal of corrosion may result in exposure of leak. Condition of latent materials was not visible & could not be fully inspected. Hidden damage may exist.</i></p> <p>(4) HOT AND COLD WATER PRESSURE IS FAIR THEN POOR WITH 2 OR MORE FIXTURES RUNNING. ALSO SEE PLUMBING COMMENTS.</p> <p>SUGGEST HAVING A LICENSED PLUMBER OR CONTRACTOR EVALUATE AND REPAIR OR REPLACE AS NEEDED.</p>

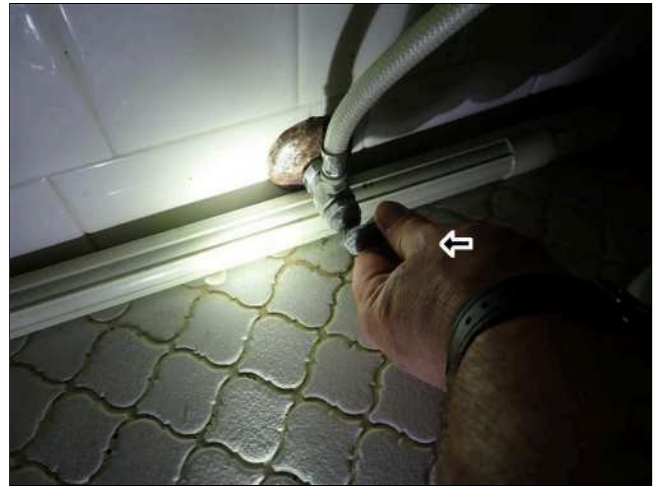
7.13(1) TOILET (Picture 1)

<p>7.13 TOILET</p> <p>(1) BROKEN CONTROL KNOB AND CORROSION OBSERVED AT THE TOILET MAIN WATER SHUT-OFF VALVE AND/OR RELATED ELEMENTS. <i>Prolonged exposure to corrosion may result in premature wear / failure of components. Active leak observed at time of inspection; however, removal of corrossions may result result in exposure of the leak.</i></p> <p>(2) MAIN WATER SHUT-OFF VALVE IS STUCK / FROZEN IN THE OPEN POSITION. <i>Shut-off valves often freeze in place due to lack of use movement. Shut-off valves should not be forced due to possibility of</i></p>

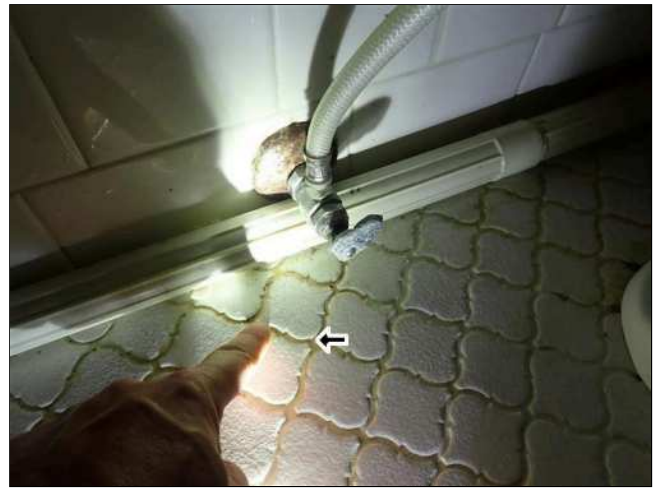
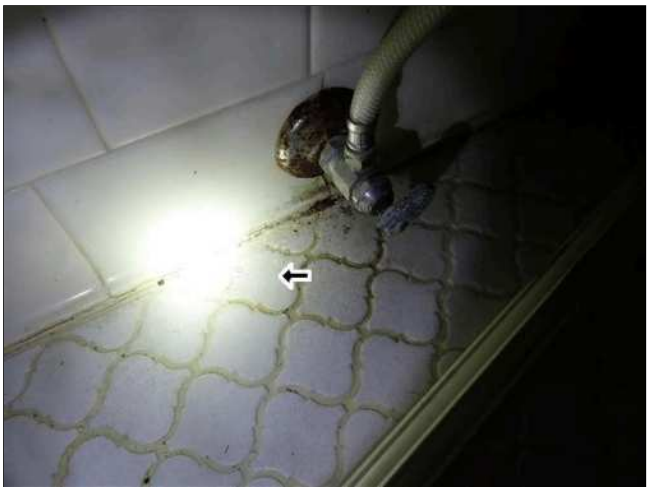
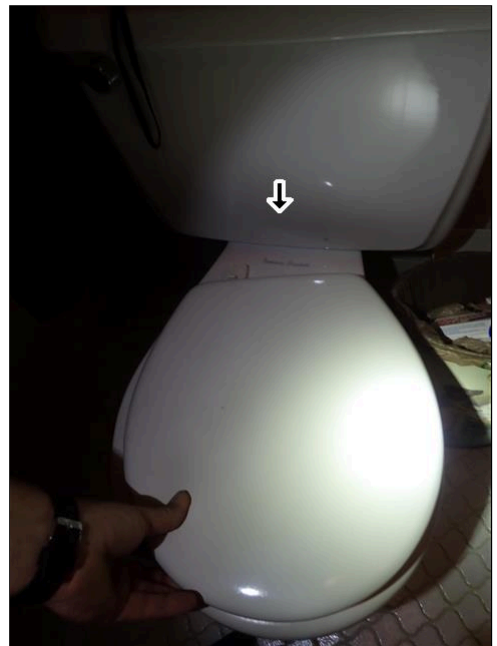
7.13(3) TOILET (Picture 1)

<p>damage / leak. It may be difficult to shut down individual water supply lines in the case of repair or damage.</p> <p>(3) ACTIVE LEAK OBSERVED AT THE TOILET WATER SHUT OFF VALVE. WATER WAS OBSERVED SITTING ON THE FLOOR BELOW VALVE.</p> <p>SUGGEST HAVING A LICENSED CONTRACTOR EVALUATE AND REPAIR OR REPLACE AS NEEDED.</p> <p>(4) TOILET SEAT WAS FOUND BROKEN AT TIME OF INSPECTION.</p> <p>(5) TOILET IS LOOSE AT FLOOR AND MOVES SLIGHTLY WHEN STRADDLED.</p> <p>(6) CORROSION OBSERVED AT THE TOILET MAIN WATER SHUT-OFF VALVE AND/OR RELATED ELEMENTS. <i>Prolonged exposure to corrosion may result in premature wear / failure of components. No leaks observed at time of inspection; however, removal of corrossions may result result in exposure of leak.</i></p> <p>SUGGEST HAVING A LICENSED PLUMBER OR CONTRACTOR EVALUATE AND REPAIR OR REPLACE AS NEEDED.</p>
●				<p>7.14 BATHTUB</p> <p>(1) BATHTUB IS VERY SLOW TO DRAIN. <i>A slow or blocked drain may indicate a localized concern or may be related to the condition or flow of branch or main waste lines. A licensed plumbing contractor should be consulted in order to determine whether cleaning or other corrective measures are required.</i></p> <p>SUGGEST HAVING A HANDYMAN OR A LICENSED CONTRACTOR EVALUATE AND REPAIR AS NEEDED.</p> <p>(2) SEE FOUNDATION / SUBSTRUCTURE COMMENTS.</p>

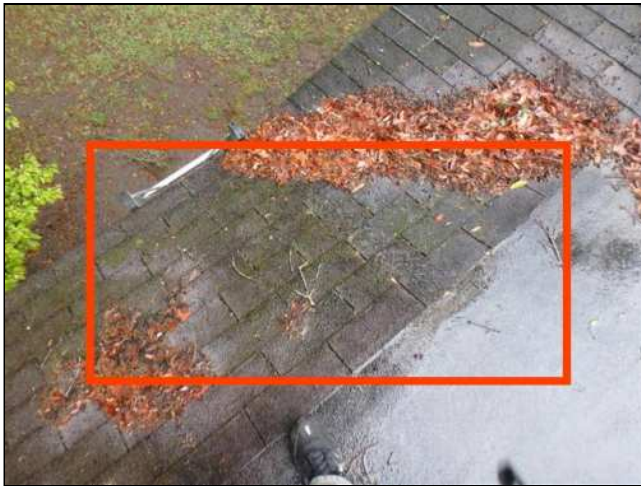
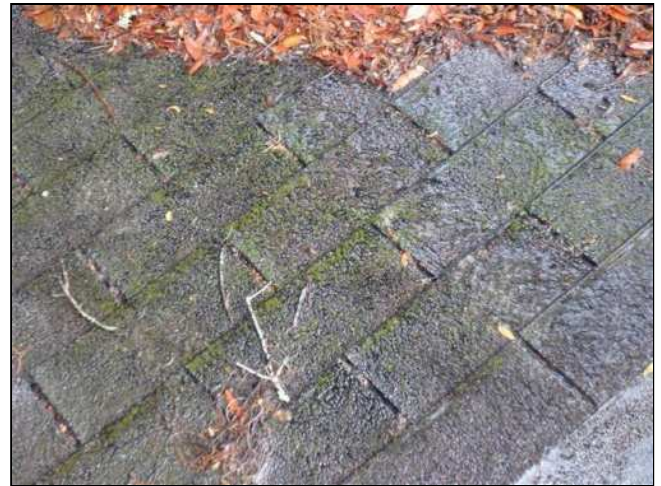
1.0 (1) ALGAE GROWTH OBSERVED AT ROOF COVERING MATERIALS. *This condition is often most prevalent in shaded areas where moisture stays on the roof surface for an extended period. Minor conditions generally affect the roof's appearance only; however, heavy build-up can result in roof wear or damage. Professional cleaning may temporarily reduce or eliminate conditions; however regular monitoring is advised.*

RECOMMEND REMOVAL OF ALGAE GROWTH / DEBRIS & CHECK UNDERLYING AREAS FOR HIDDEN DAMAGE.

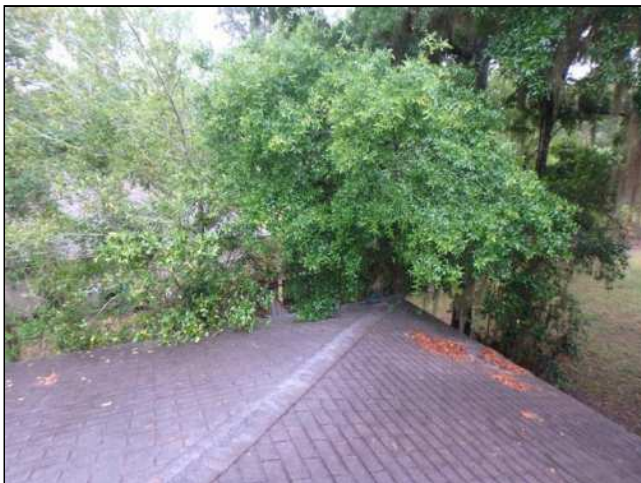
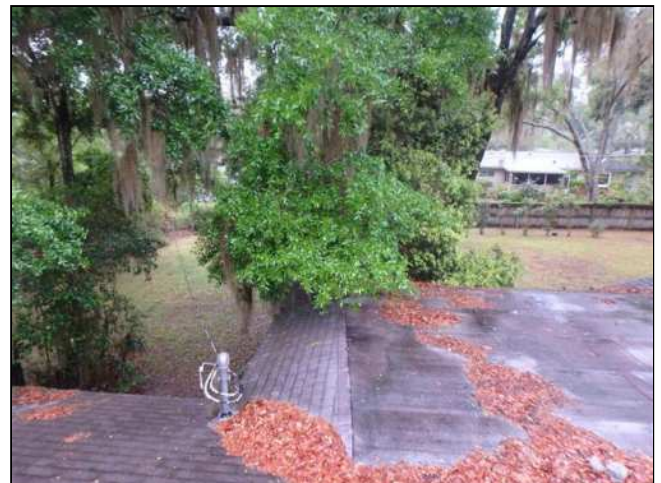
1.0 (2) TREE BRANCHES / VEGETATION OBSERVED IN CLOSE PROXIMITY OR IN CONTACT WITH ROOF COVERING. *Tree Branches in contact and/or in close proximity to roof material can cause damage to shingles. Wind can cause tree branches to scrape against roof material causing granule loss or damage and greatly decreasing life of shingles. Recommend keeping tree branches trimmed away from roofing material, which may require annual maintenance.*

RECOMMEND HAVING A LICENSED TREE COMPANY EVALUATE / REMEDY AS NEEDED.

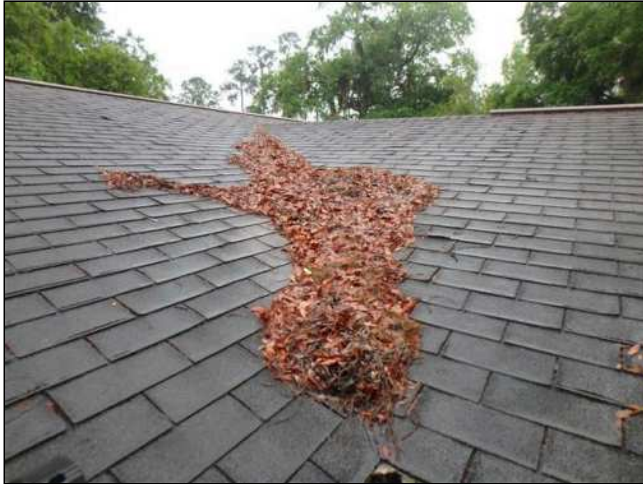
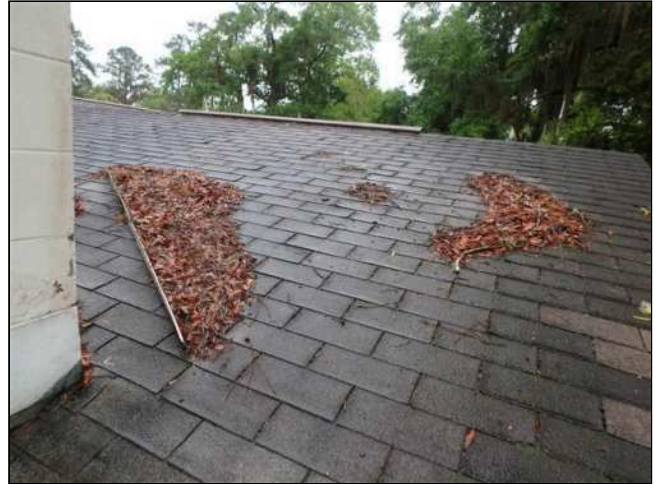
1.0 (3) LEAVES / DEBRIS ACCUMULATION OBSERVED AT THE ROOF COVERING. *Leaves and debris can hold excessive moisture to shingles, which can lead to premature wear / damage. Leaves may also block / slow proper roof drainage which may*

allow water to back up onto roof / shingles, which can lead to roof leaks and/or damage at other exterior elements. Pictures shown are a representative number of affected areas.

RECOMMEND REMOVAL OF LEAVES / DEBRIS & CHECK UNDERLYING AREAS FOR HIDDEN DAMAGE.

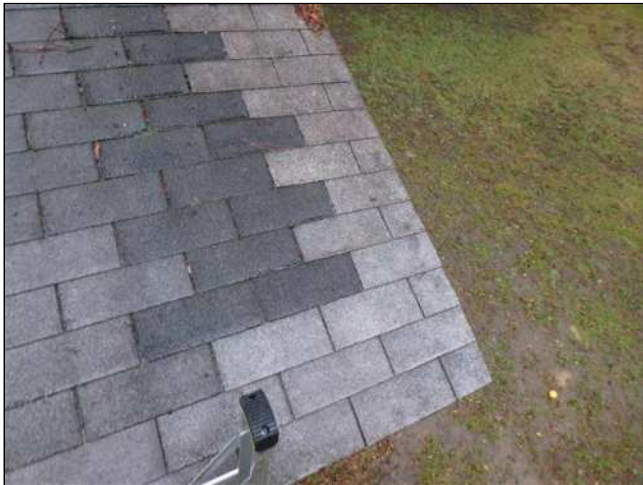
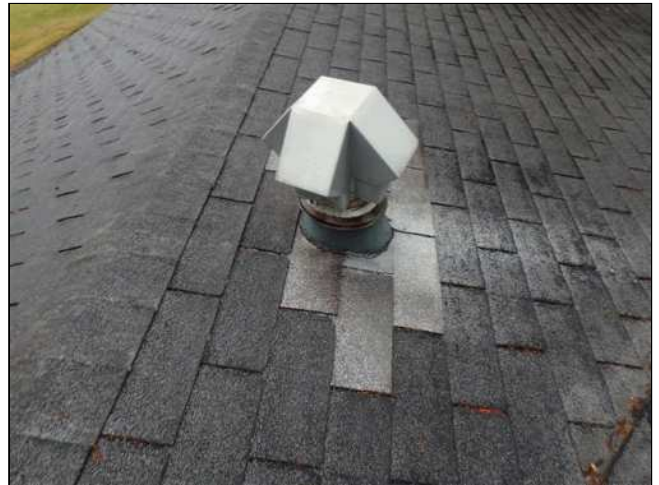
1.0 (4) AREA(S) OF PREVIOUS REPAIR / PATCHED SHINGLES OBSERVED AT THE ROOF COVERING. *No permitting information was found on the Alachua County / City of Gainesville permit tracking websites. Adequacy of installation / repair was not determined & condition of latent materials was not visible & could not be fully inspected. Hidden damage may exist.*

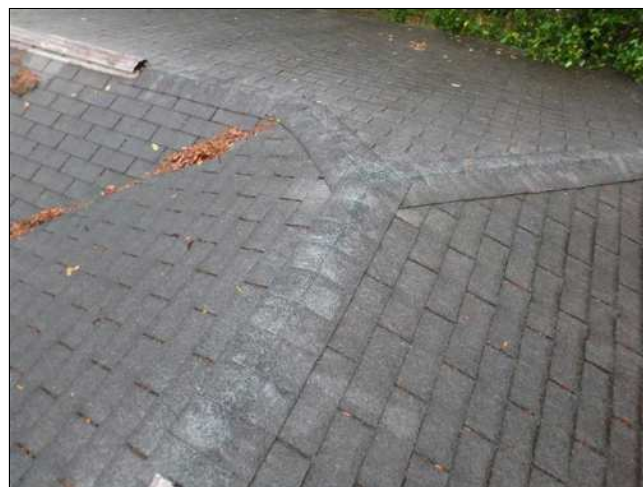
1.0 (5) MINOR DAMAGE AND/OR GRANULE LOSS OBSERVED AT THE ROOF COVERING MATERIALS. *Granules protect the roof / shingles from damage due to UV light and weather conditions. Loss of granules may leave the shingles / roof susceptible to damage from weather elements. Granule loss is a normal condition that occurs with age. Other common reasons for granule loss include manufacturers defects, inadequate maintenance and/or a severe storm weather. Pictures shown are a representative number of affected areas.*

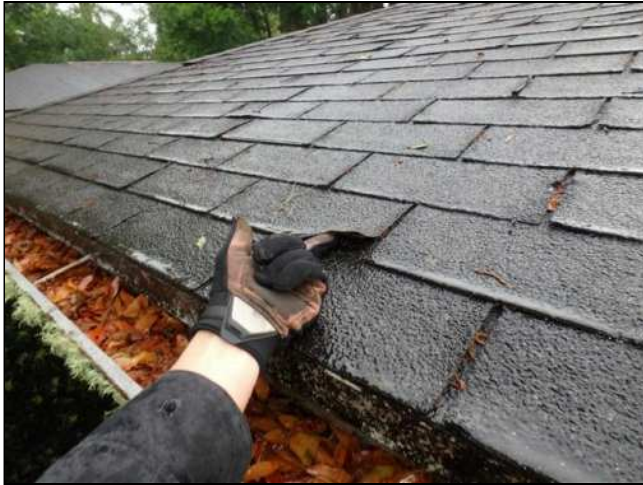
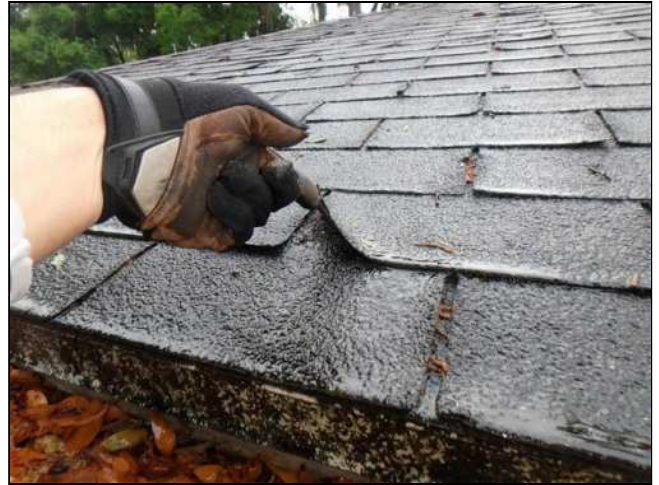
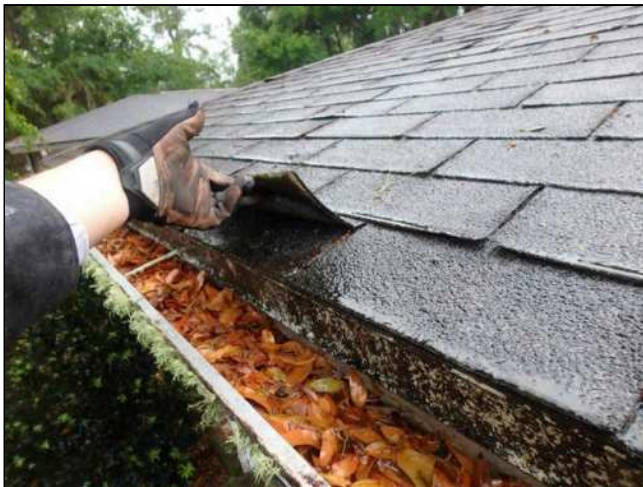
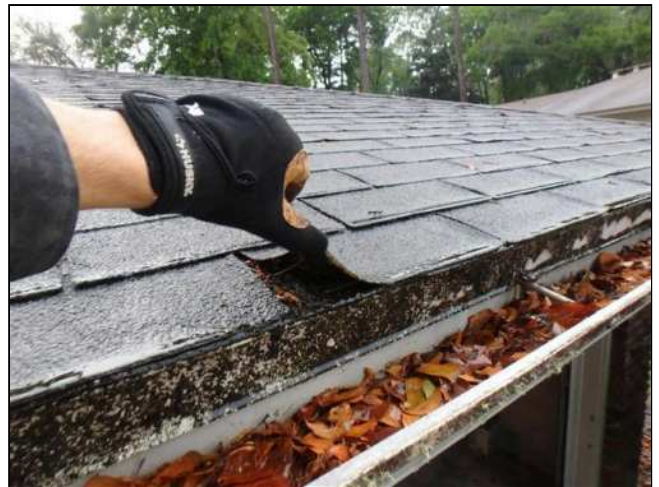
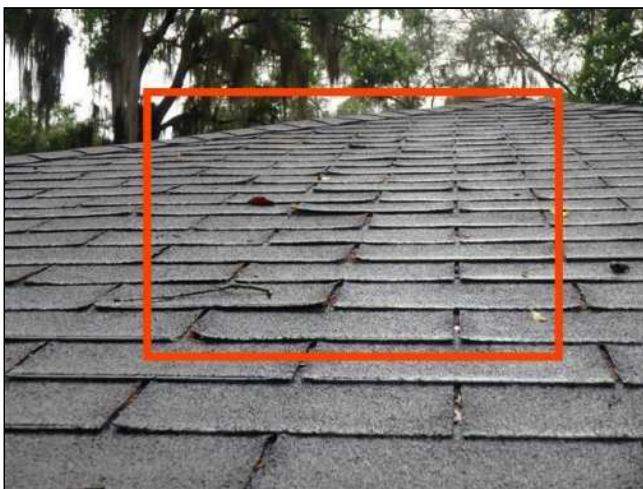
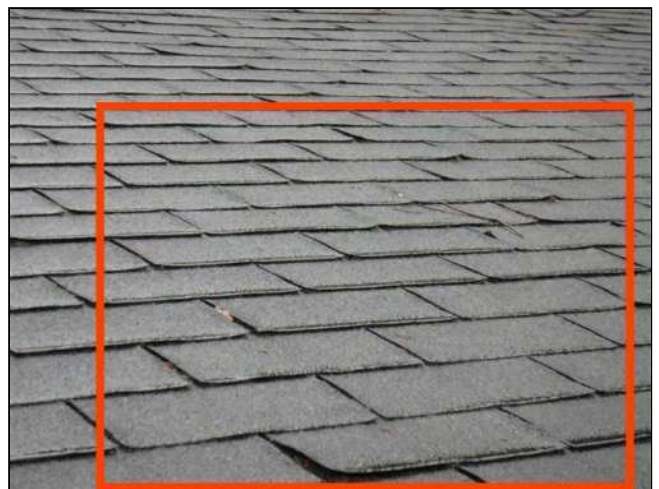
1.0 (6) UNSECURED SHINGLE(S) OBSERVED AT THE ROOF COVERING MATERIALS. *Unsecured roof covering components may promote moisture intrusion / future damage. Condition of latent materials was not visible & could not be fully inspected. Hidden damage may exist. Pictures shown are a representative number of affected areas. All similar areas should be addressed accordingly.*

RECOMMEND HAVING A LICENSED ROOFING CONTRACTOR EVALUATE / REMEDY AS NEEDED.

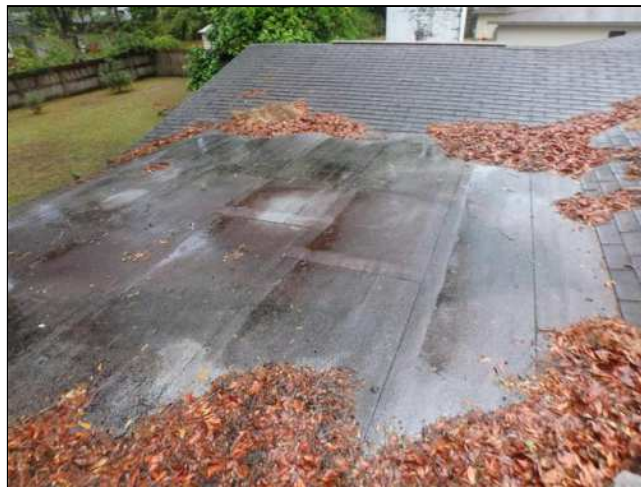
1.1 (2) STAINING AND/OR EVIDENCE OF PONDING WATER OBSERVED AT THE ROOF COVERING MATERIALS. *Ponding water coupled with deteriorated sealant may promote moisture intrusion / concealed damage. Condition of latent materials was not visible & could not be fully inspected. Hidden damage may exist.*

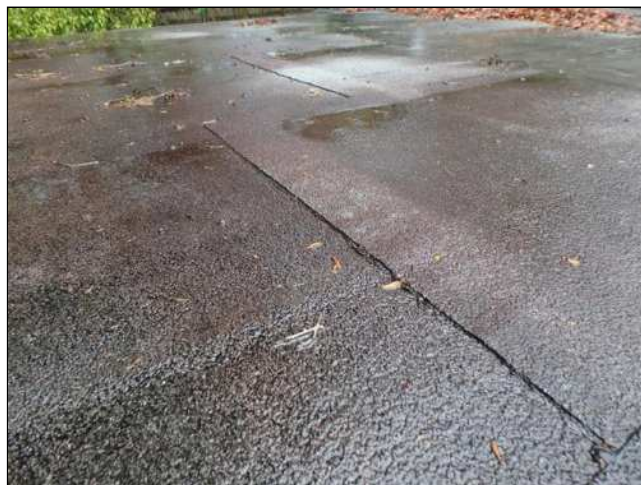
1.1 (3) DRIED / DETERIORATED SEALANT MATERIALS OBSERVED AT THE ROLLED ROOF COVERING MATERIALS. *Over time, deteriorated sealant / separation may promote moisture / pest intrusion. Condition of latent materials was not visible & could not be fully inspected. Hidden damage may exist.*

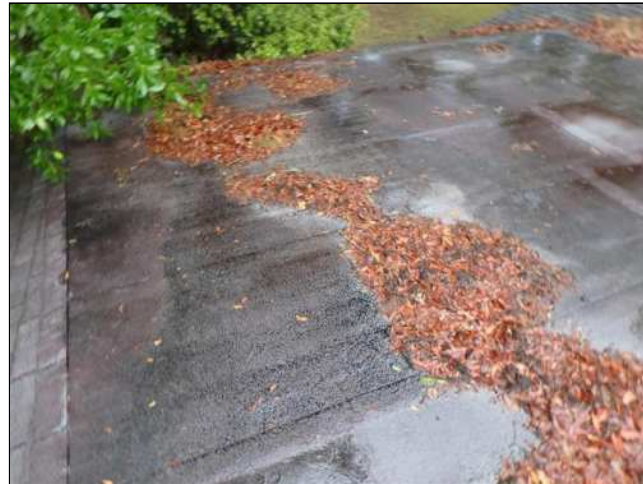
1.1 (4) MINOR DAMAGE AND/OR GRANULE LOSS OBSERVED AT THE ROOF COVERING MATERIALS. *Granules protect the roof from damage due to UV light and weather conditions. Loss of granules may leave the roof susceptible to damage from weather elements. Granule loss is a normal condition that occurs with age. Other common reasons for granule loss include manufacturers*

defects, inadequate maintenance and/or a severe storm weather. Pictures shown are a representative number of affected areas. All similar areas should be addressed accordingly.

RECOMMEND HAVING A LICENSED ROOFING CONTRACTOR EVALUATE / REMEDY AS NEEDED.

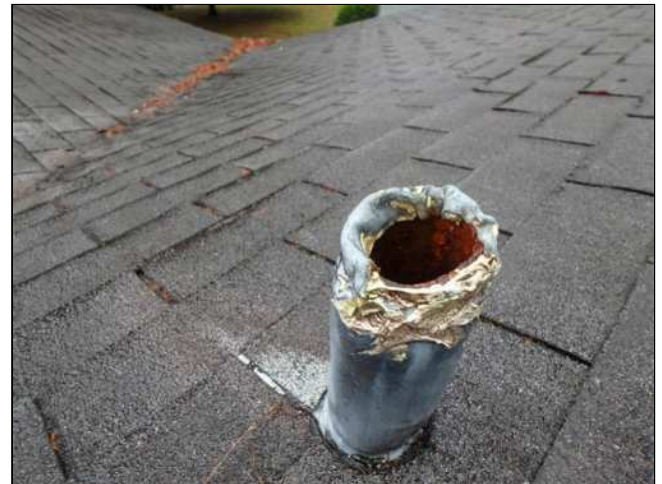
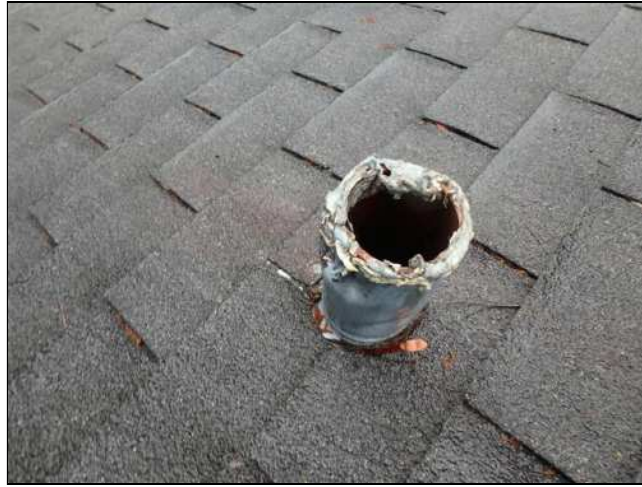
1.2 (1) DAMAGE / DETERIORATED COMPONENTS OBSERVED AT PLUMBING STACKS. *Damage / deterioration may promote moisture intrusion / concealed damage. Condition of latent materials was not visible & could not be fully inspected. Hidden damage may exist.*

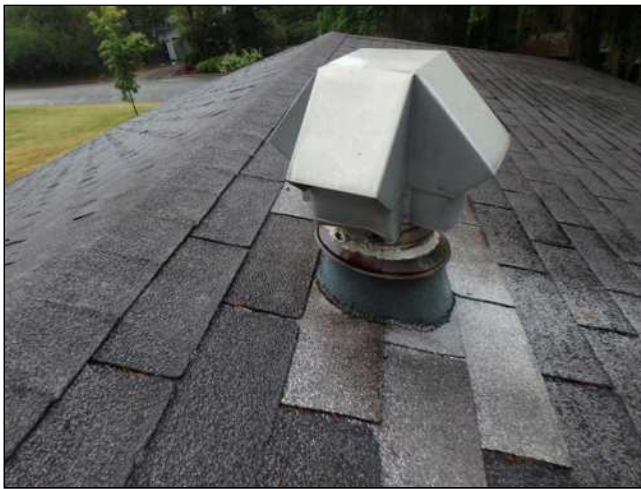
1.2 (2) CORROSION OBSERVED AT VENTILATOR COVER(S). *Prolonged exposure to corrosion may result in premature wear / failure of affected components. Also note location of materials.*

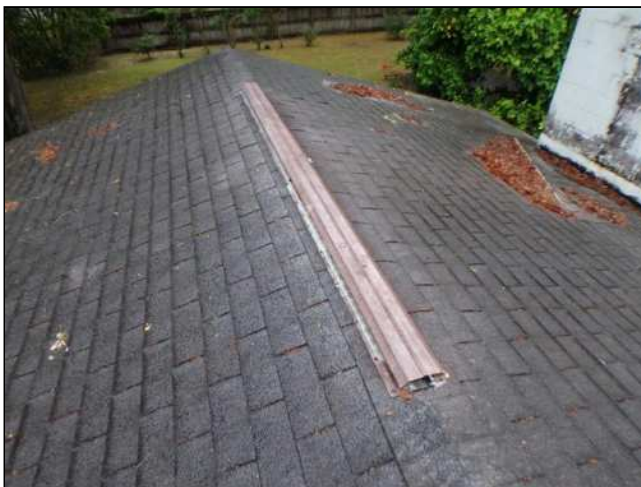
1.2 (3) EXPOSED AND/OR CORRODED HARDWARE OBSERVED AT ROOF FLASHING MATERIALS. *Exposed hardware can result in corrosion due to weather conditions which can lead to water intrusion, possibly causing hidden damage. Hardware needs to be sealed in order to maintain roofing / flashing integrity.*

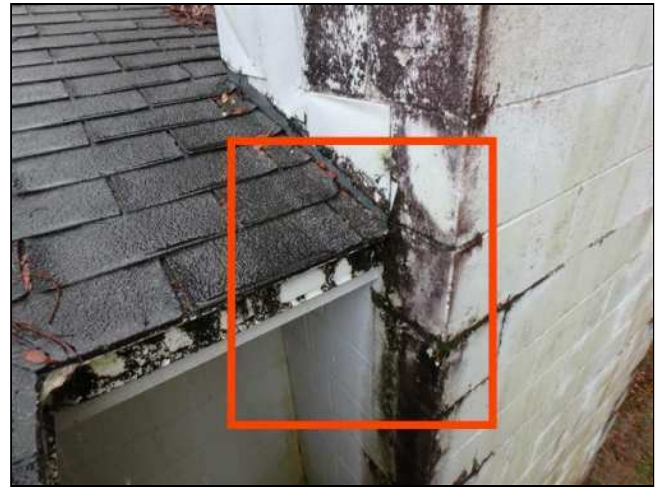
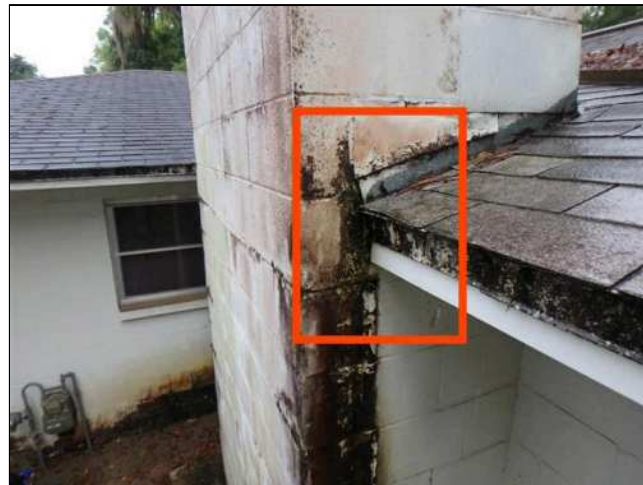
1.2 (4) LACK OF KICK-OUT FLASHING OBSERVED AT THE EXTERIOR SIDING (CHIMNEY) / ROOF LINE INTERFACE. *Condition may allow roof drainage / rainwater to drain onto underlying materials, which may lead to moisture related damage. Condition of latent materials was not visible & could not be fully inspected. Hidden damage may exist.*

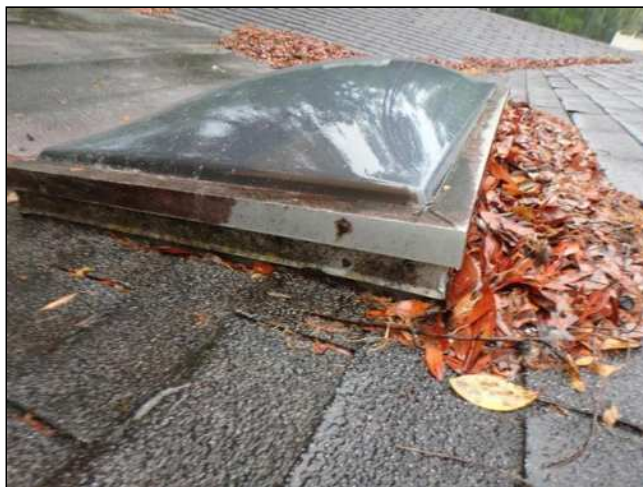
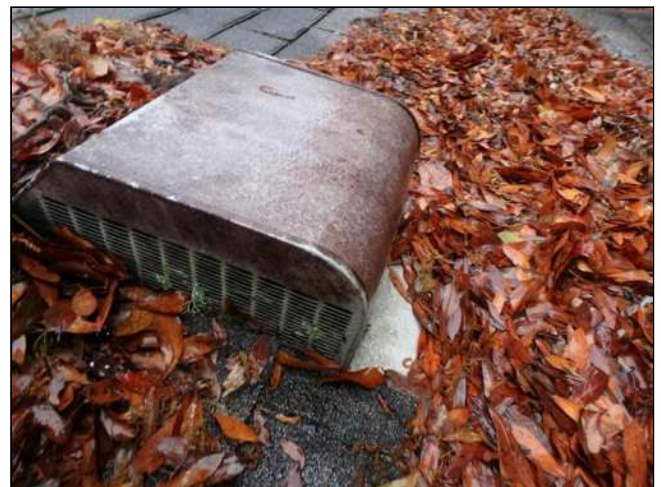
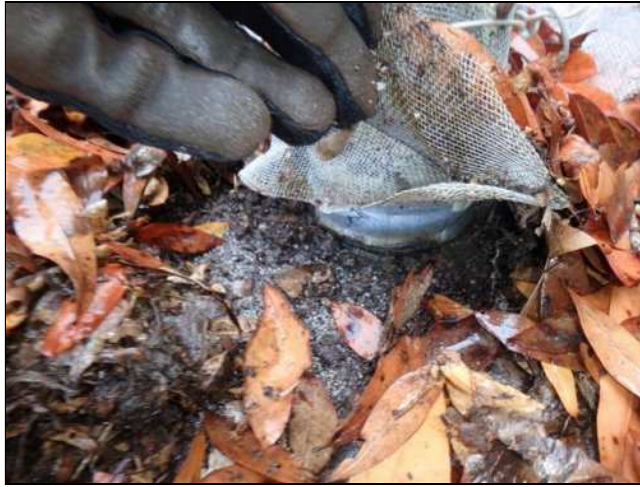
1.2 (5) DRIED / DETERIORATED SEALANT OBSERVED AT VENTILATION COVER(S), PLUMBING STACK(S) & SKYLIGHT(S). Sealant naturally dries out due to Heat, UV, or Weather conditions. Annual / Bi-Annual maintenance may be required in order to maintain flashing / roofing integrity.

RECOMMEND HAVING A LICENSED ROOFING CONTRACTOR EVALUATE / REMEDY AS NEEDED.

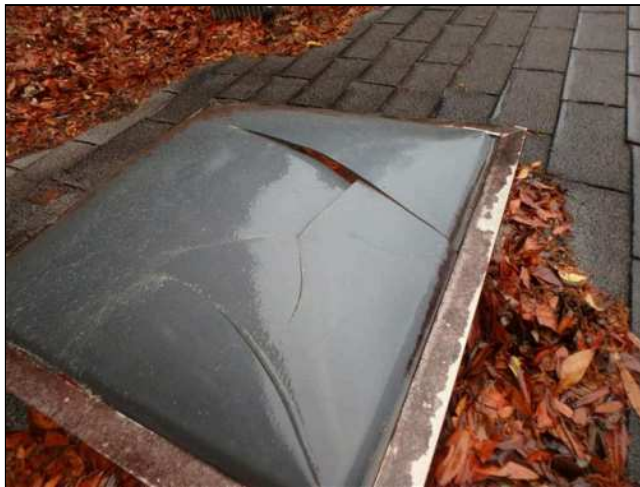
1.5 (1) LEFT SIDE SKYLIGHT IS BROKEN / DAMAGED. *Current state may promote moisture intrusion into the attic / home. Condition of latent materials was not visible & could not be fully inspected. Hidden damage may exist.*

RECOMMEND HAVING A LICENSED HANDYMAN OR CONTRACTOR EVALUATE / REMEDY AS NEEDED.

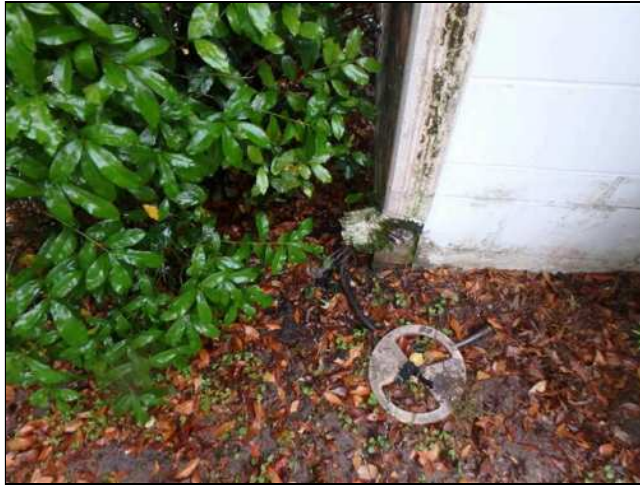
1.6 (1) EROSION / LACK OF PROPER SPLASH-BLOCK(S) OBSERVED AT THE TERMINATION POINT OF DOWNSPOUT(S). *Discharge should be extended a minimum of 2' away from adjacent foundation edge. Over time, condition may begin to erode adjacent grading & potentially undermining the exterior foundation edge.*

RECOMMEND THE ADDITION OF A SPLASH BLOCK / WATER MITIGATION SYSTEM IN ORDER MINIMIZE EROSION.

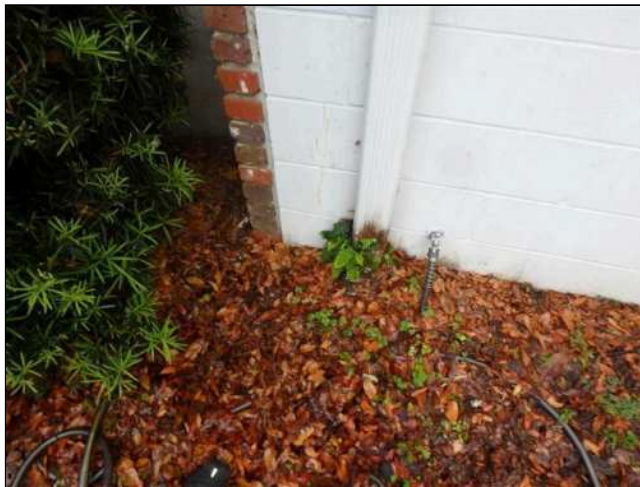
1.6 (2) DOWNSPOUTS OBSERVED TERMINATING INTO UNDERGROUND DRAINAGE PIPING. *Sub-grade drainage piping is prone to blockage / back-up. Condition of latent materials / flow of water water not visible & could not be fully inspected. Hidden damage may exist.*

RECOMMEND HAVING A LICENSED HANDYMAN OR CONTRACTOR EVALUATE / REMEDY AS NEEDED.

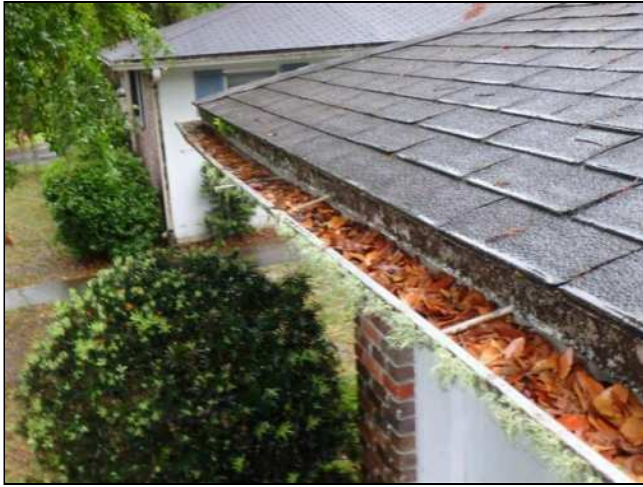
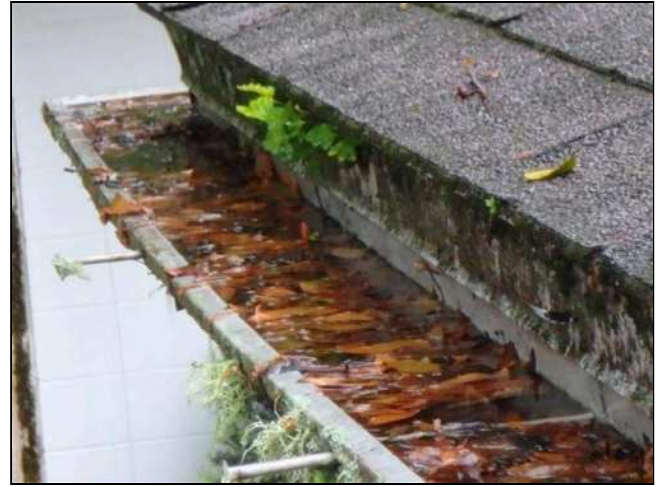
1.7 (1) RAIN GUTTER AND/OR GUARD SYSTEM OBSERVED FULL OF LEAVES / DEBRIS & WATER. *Full gutters can allow water to wash over gutter or may cause leaking at seams and/or end-caps of gutters and downspouts. Water leaking from gutters / downspouts can effect other exterior elements of the home. Gutter(s) should remain clean in order to allow easy full of water and maintain overall integrity.*

RECOMMEND PERIODICALLY MONITORING / CLEANING GUTTER SYSTEM & RELATED ELEMENTS TO ENSURE PROPER FLOW OF WATER.

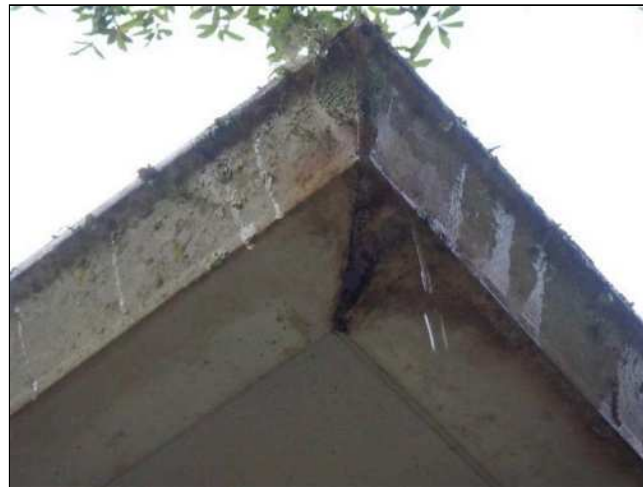
1.7 (2) STAINING OBSERVED AT DOWNSPOUT AND/OR GUTTER SYSTEM SEAMS. THIS IS USUALLY AN INDICATION OF SEAM LEAKS. *Full gutters and/or downspout blockage is the primary cause of leaks at the seams of gutters / downspouts. Annual / Bi-annual maintenance may be required in order to ensure gutter / downspout integrity. Pictures shown are a representative number of affected areas.*

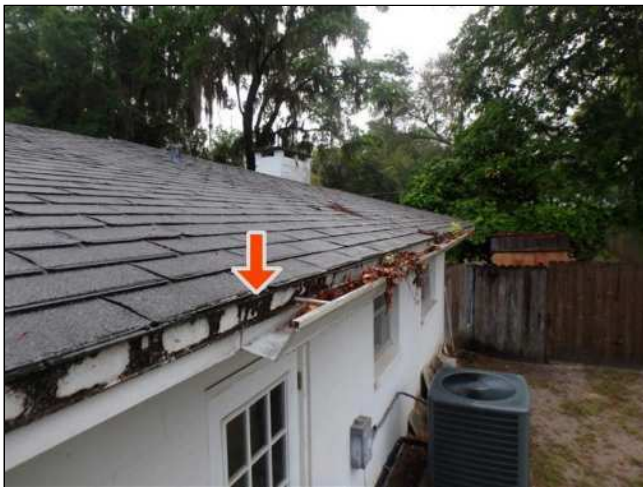
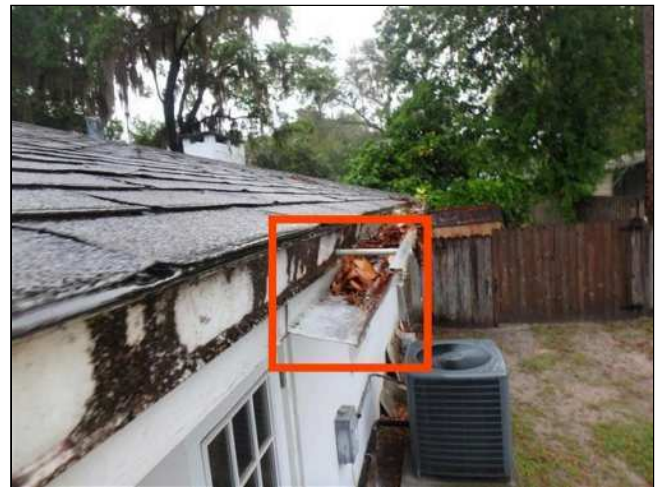
1.7 (3) MISSING END CAP(S) OBSERVED AT THE GUTTER SYSTEM. *Missing end caps at gutters can cause erosion at the ground below the termination points. Many time the gutter has been installed to divert water away from an entryway. Erosion can often time be fixed with the addition of downspouts or other remedial methods such as gravel or swales.*

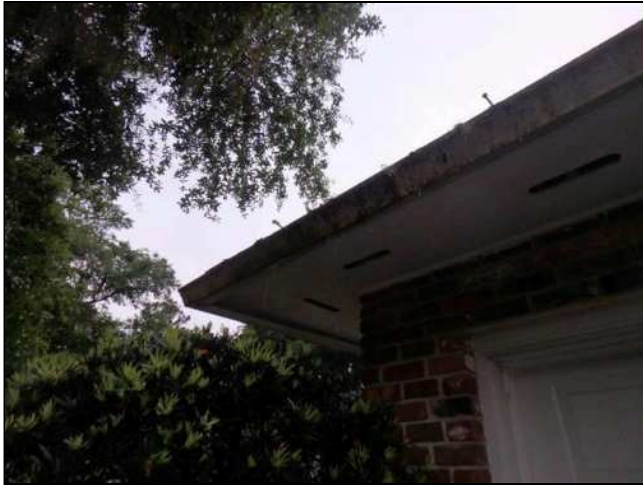
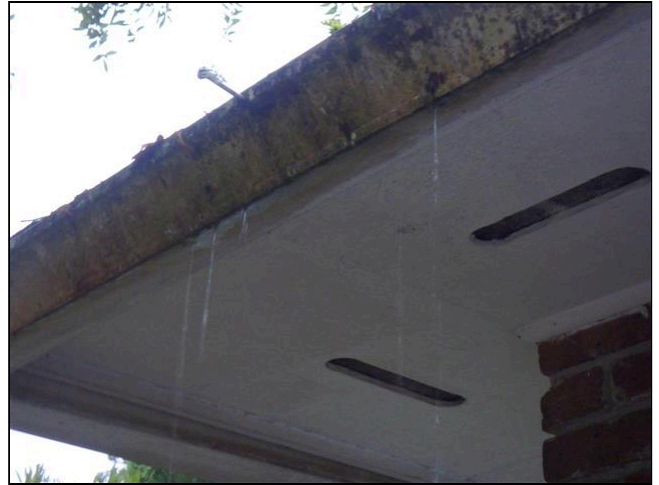
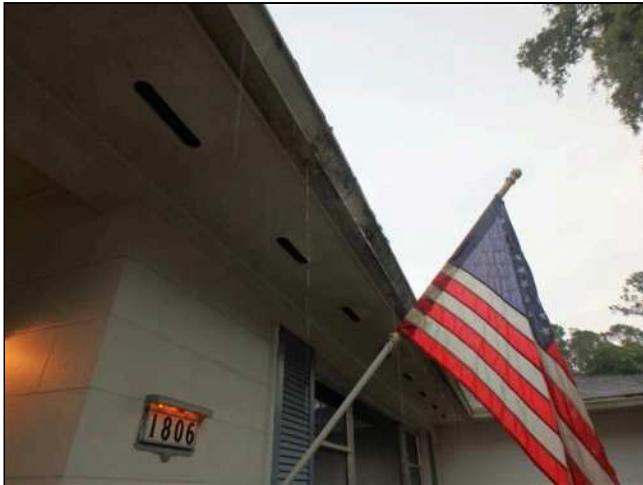
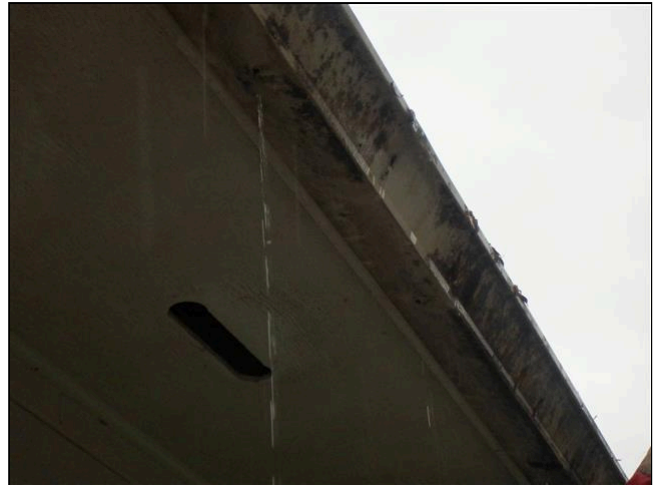
1.7 (4) FRONT GUTTER SYSTEM IS LEAKING / HAS FAILED & HAS HOLES DRILLED INTO THE BOTTOM OF THE GUTTER SYSTEM. *Current condition may be due to leaves / debris accumulation in the gutter system & related downspouts. RECOMMEND HAVING A LICENSED HANDYMAN OR CONTRACTOR EVALUATE / REMEDY AS NEEDED.*

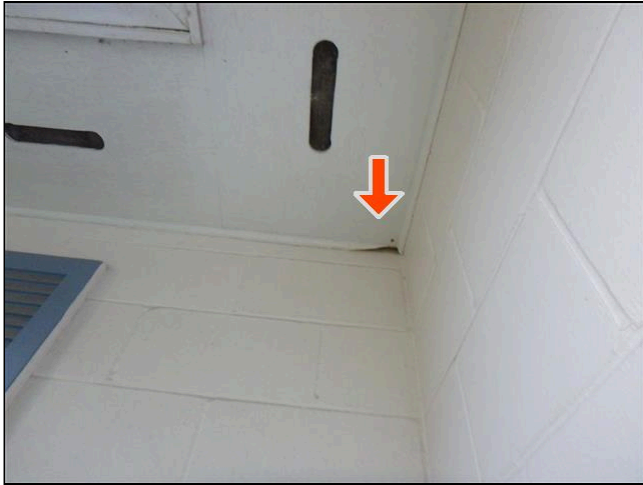
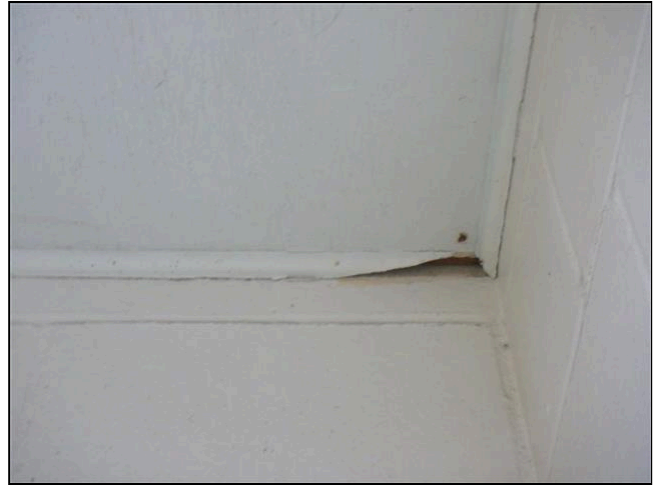
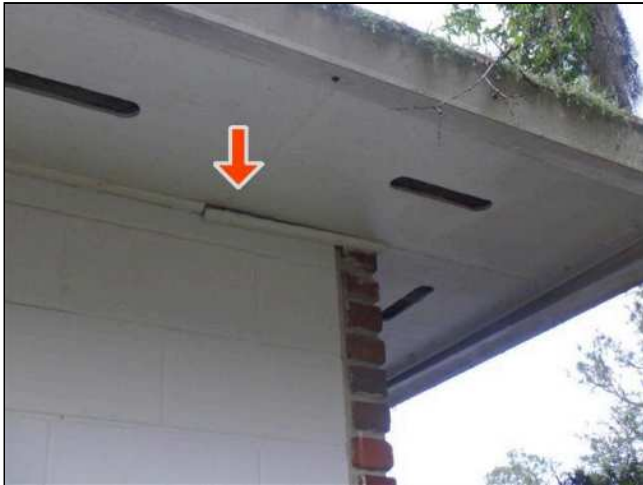
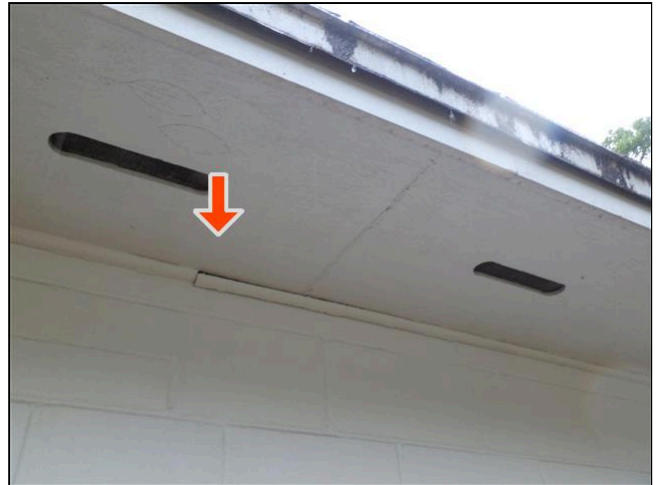
1.8 (2) DAMAGED / SEPARATED TRIM OBSERVED. *Damaged / unsecured components may promote moisture intrusion and/or concealed damage.*

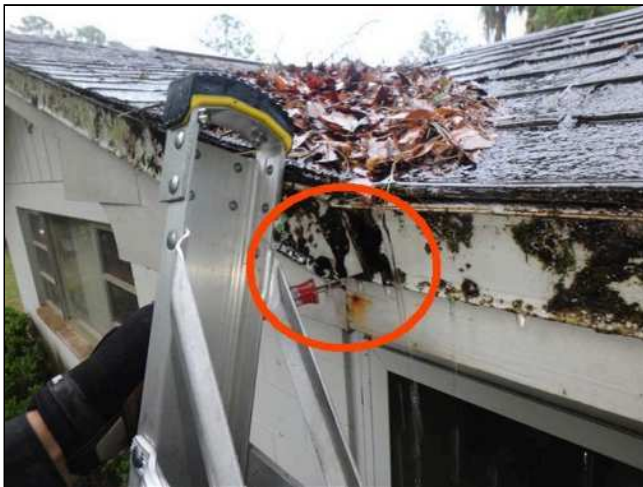
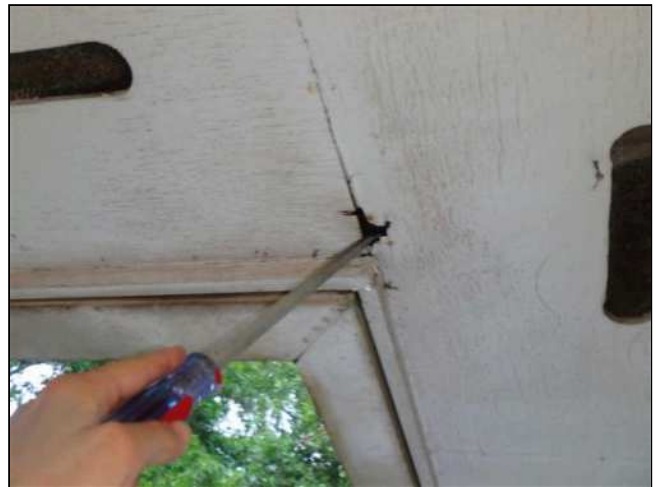
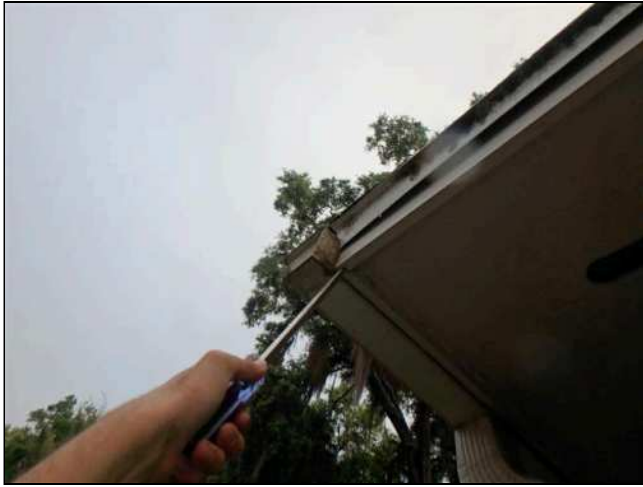
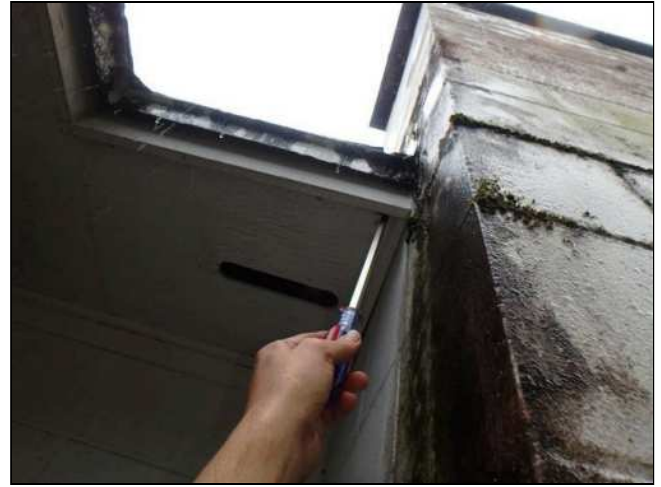
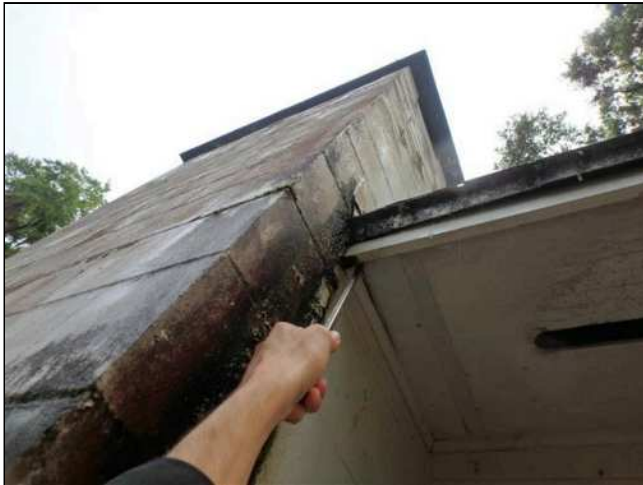
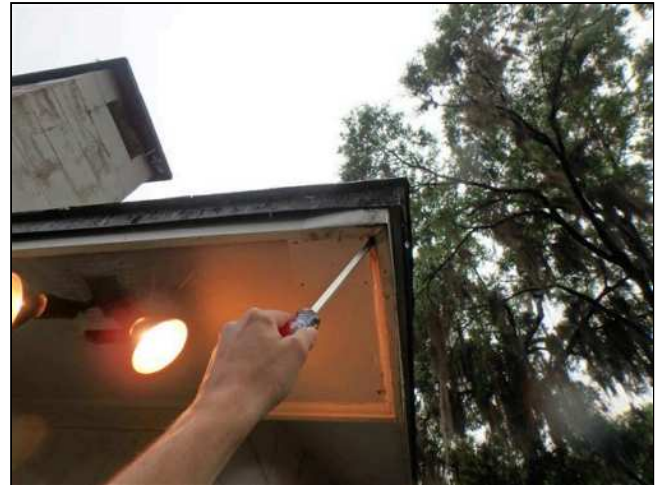
1.8 (3) WOOD DECAY AND/OR DAMAGE OBSERVED AT THE FASCIA BOARDS & RELATED SOFFIT ELEMENTS. *Wood decay / damage at fascia components is usually due to improper sealing / maintenance and/or full gutters. Wood is susceptible to decay / damage due to the high moisture content found in Florida's environment and weather. Routine maintenance may be required in order to maintain fascia integrity. All areas of fascia could not be reached due to height / design, un-exposed damage may exist.* RECOMMEND HAVING A LICENSED HANDYMAN OR CONTRACTOR EVALUATE / REMEDY AS NEEDED.

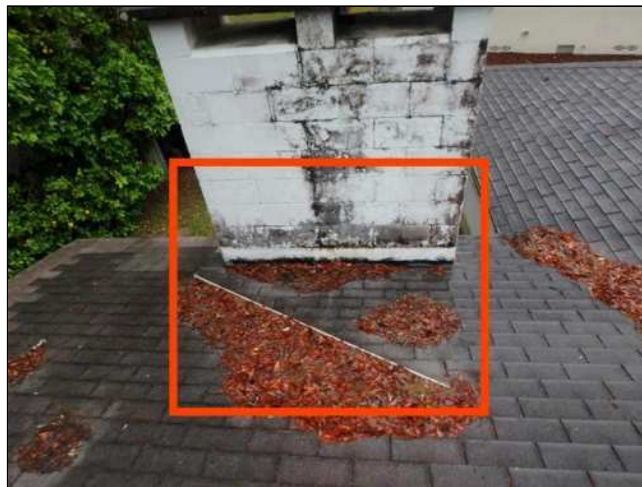
1.9 (1) CRICKET / SADDLE WAS NOT INSTALLED AT CHIMNEY. *All Chimneys 30" or wider need to have a cricket installed to properly shed water. When cricket / saddle is not installed condition may hold excess moisture to the chimney and roofing surface, which can result in roof leaks.*

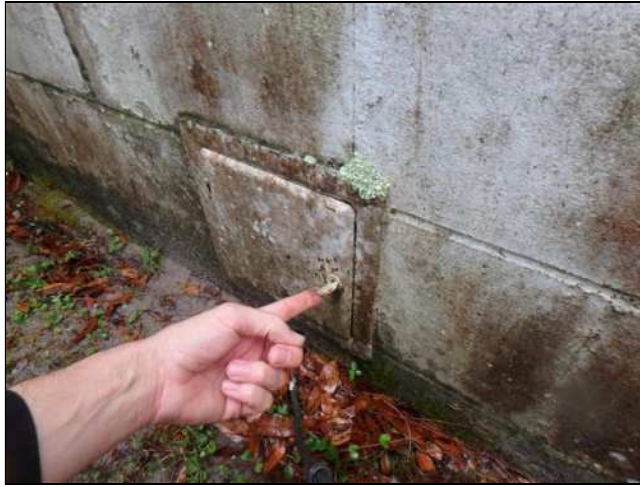
1.9 (2) ASH TRAP DOOR IS STUCK / FROZEN IN THE CLOSED POSITION. *Condition of latent materials was not visible & could not be fully inspected. Hidden damage may exist.*
