INSPECTION INFORMATION

Standard Home Inspection

Single Family Dwelling

51 Years

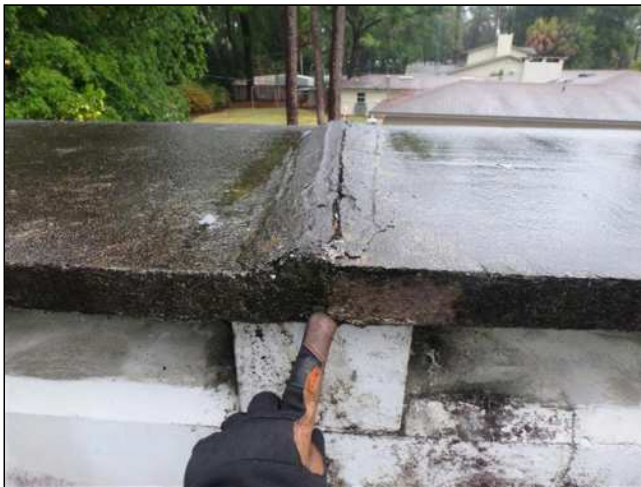
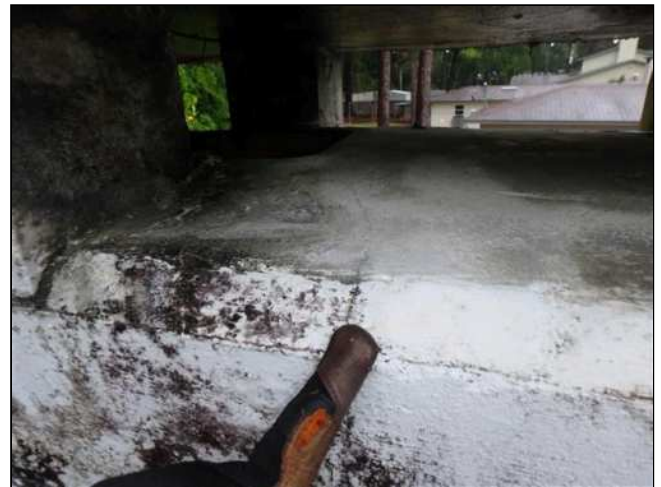
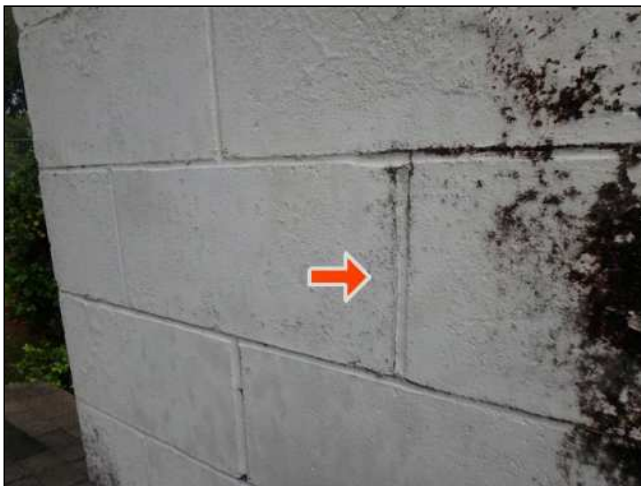
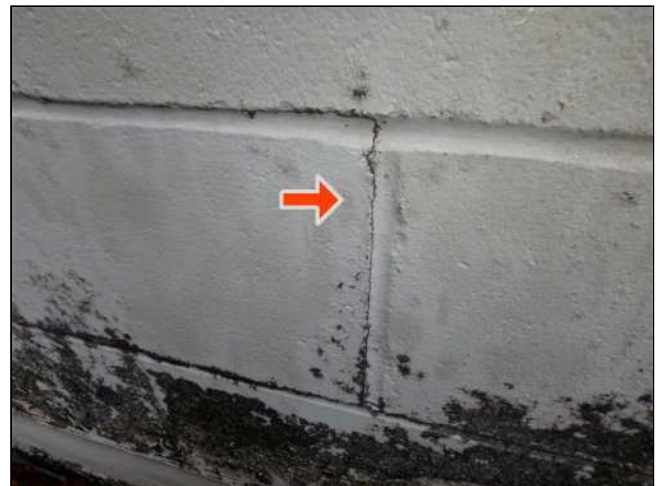
1.9 (3) CRACKING / DETERIORATED MORTAR OBSERVED AT THE CHIMNEY & RELATED ELEMENTS. *Damage / deteriorated sealant materials may promote integrity failure of affected components. Extent of deteriorated components was not determined / condition of latent materials was not visible & could not be fully inspected. Hidden damage may exist.*

RECOMMEND HAVING A LICENSED HANDYMAN OR CONTRACTOR EVALUATE / REMEDY AS NEEDED.

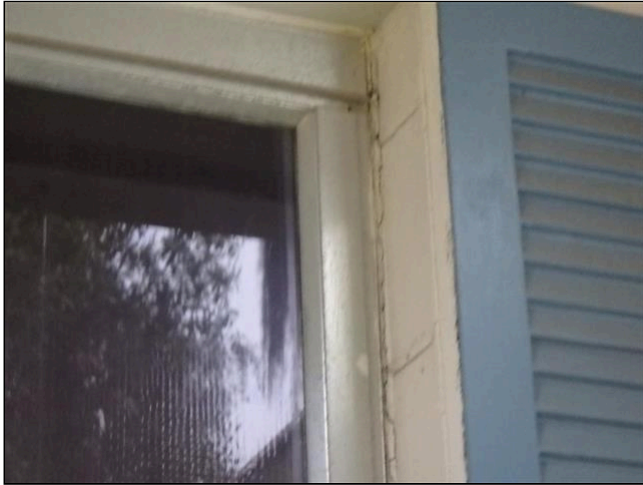
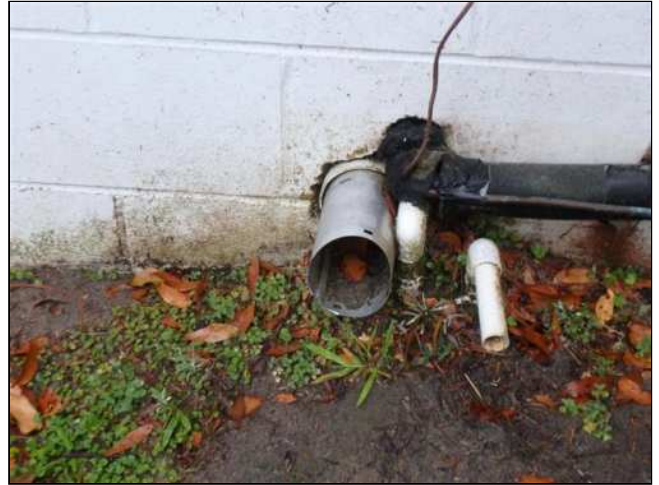
2.0 (1) SEPARATION AND/OR DETERIORATED SEALANT MATERIALS OBSERVED AT EXTERIOR SIDING. *Gaps in concrete block / brick sealant may allow moisture intrusion, which could lead to further damage. Sealant is susceptible to damage due to the UV light and varying weather conditions found in Florida's environment. Regular / Routine maintenance may be required in order to maintain a weather proof barrier and prevent moisture related damage. Surrounding / Underlying elements could not be seen and could not be inspected. Hidden damage may exist. Pictures are a representative number of affected areas. All similar areas should be addressed accordingly.*

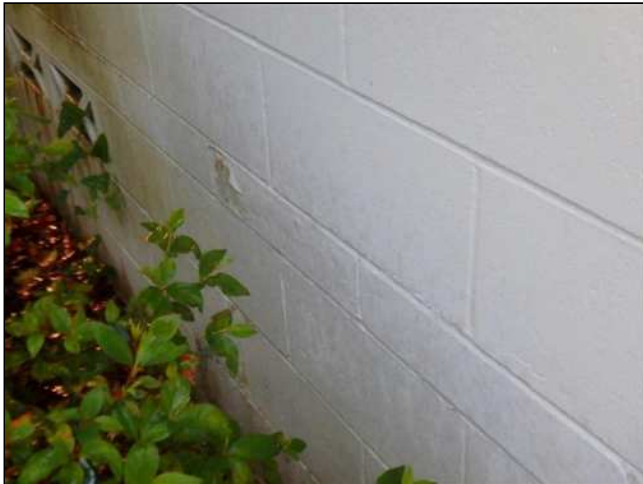
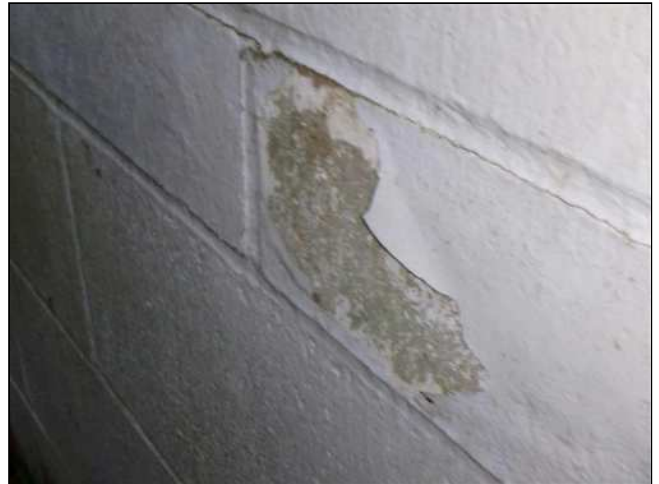
2.0 (2) THIN OR DETERIORATED SIDING COATING / PAINT OBSERVED AT THE EXTERIOR. *Thin or deteriorated sealant / coating is mainly a cosmetic issue, but can result in moisture intrusion. Periodic maintenance may be required. Pictures shown are a representative number of affected areas.*

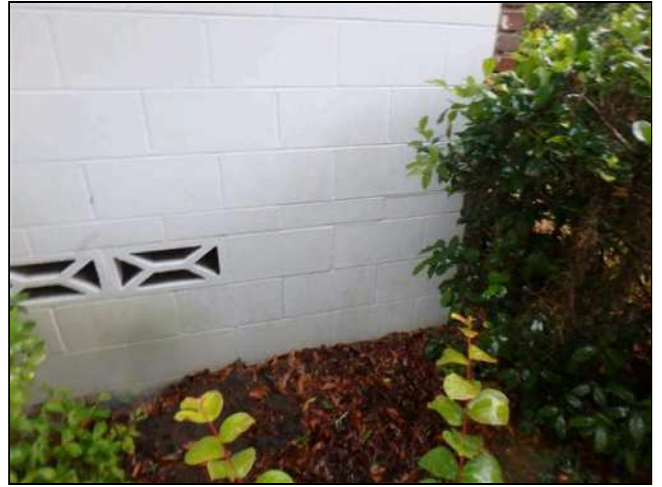
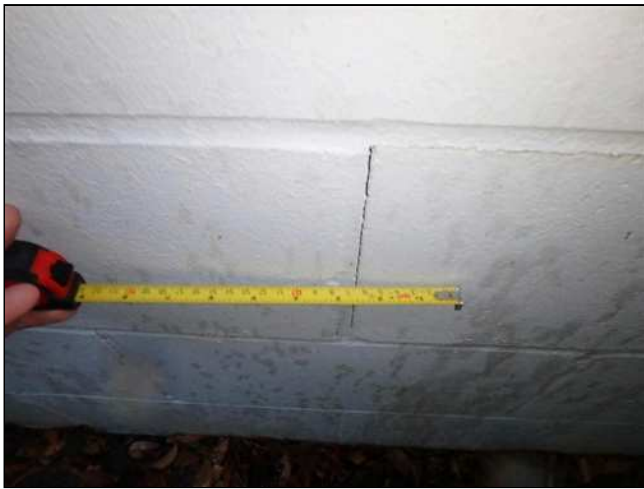
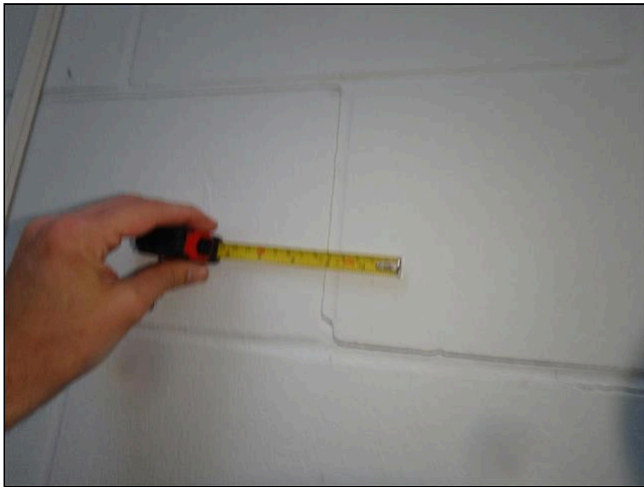
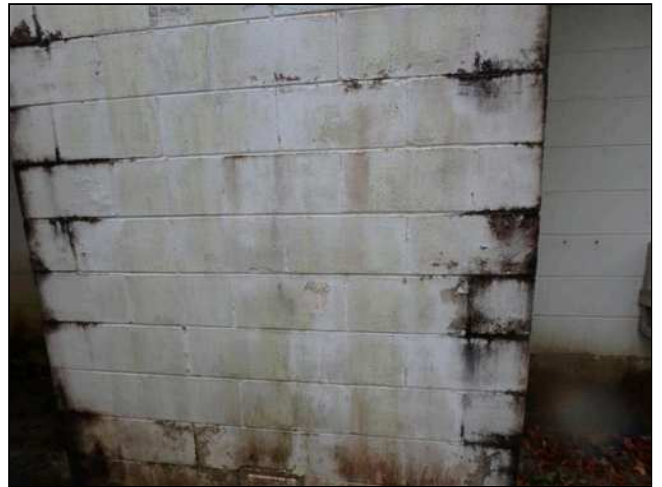
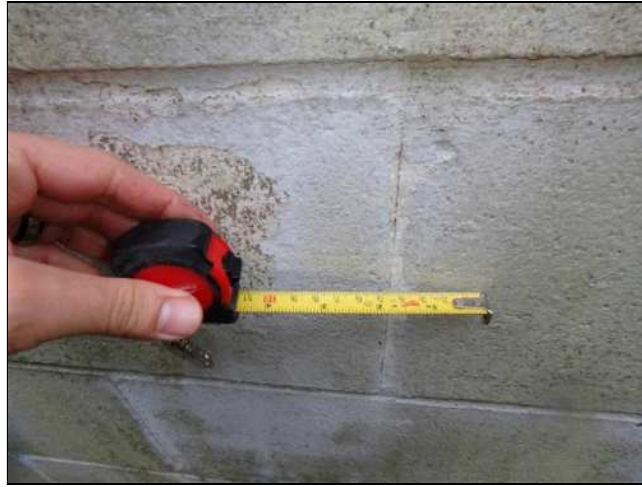
2.0 (3) STAIR-STEP CRACKING OBSERVED AT THE EXTERIOR SIDING MATERIALS. CRACKING IS MAINLY FOLLOWING MORTAR LINES & MEASURES LESS THAN 1/8" IN WIDTH. *Cracking of this size / type is not usually structurally significant; however, condition of latent materials was not visible & could not be fully inspected. Hidden damage may exist. Pictures are a representative number of affected areas. All similar areas should be addressed accordingly.*

RECOMMEND HAVING A LICENSED HANDYMAN OR CONTRACTOR EVALUATE / REMEDY AS NEEDED.

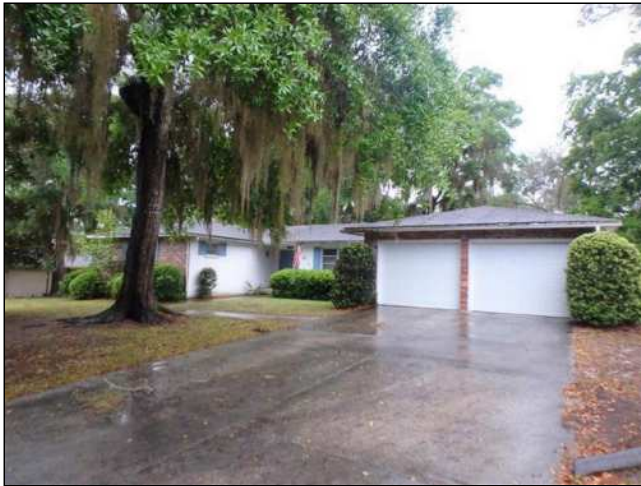
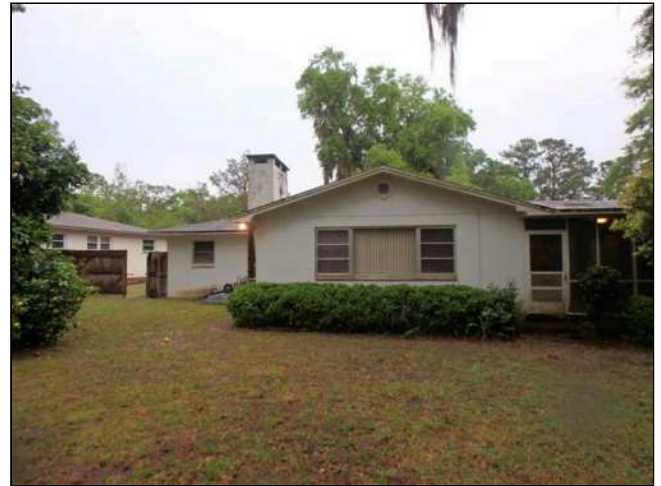
2.0 (4) DUE TO HEIGHT / DESIGN LIMITATIONS, ENTIRE EXTERIOR SIDING MATERIALS / TRIM & FASCIA / SOFFITS WERE NOT ACCESSIBLE & COULD NOT BE PHYSICALLY REACHED / FULLY INSPECTED. *Pictures shown are a representative number of affected areas.*

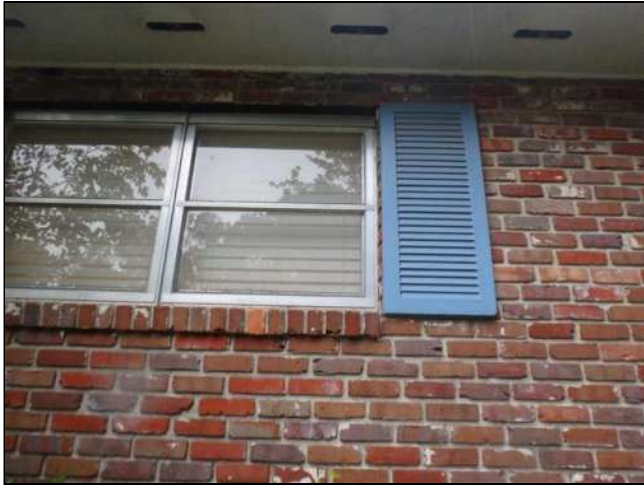
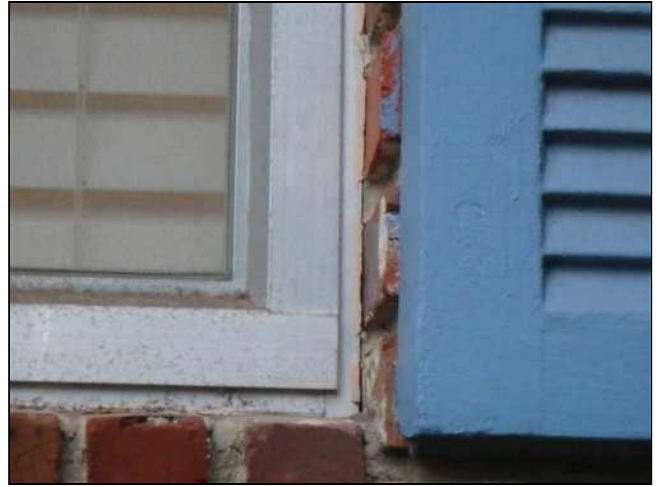
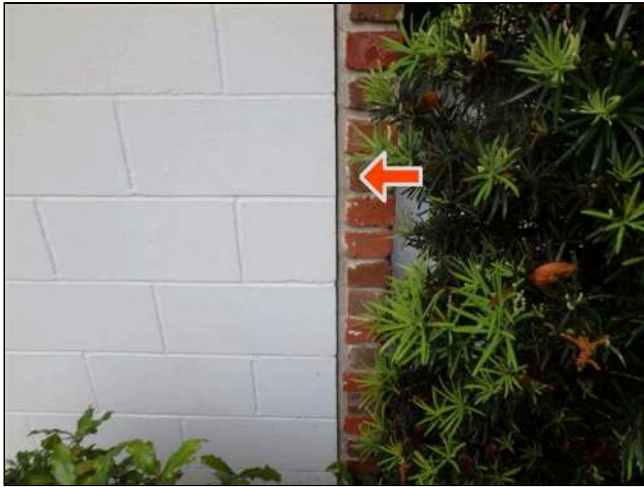
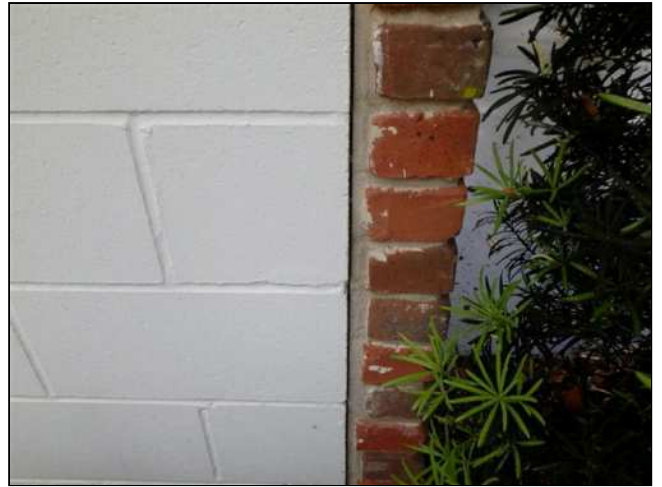
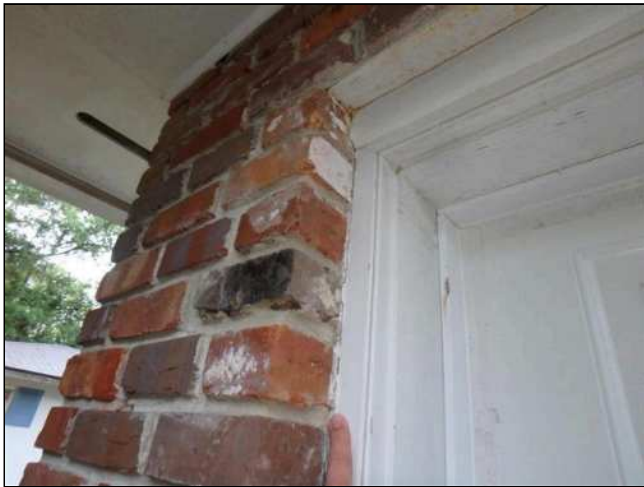
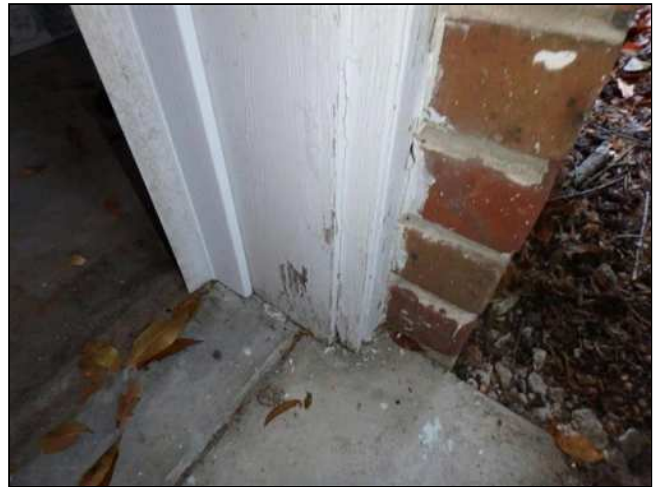
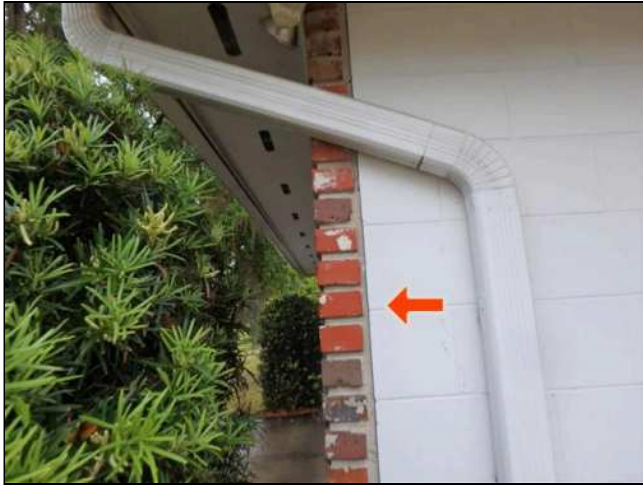
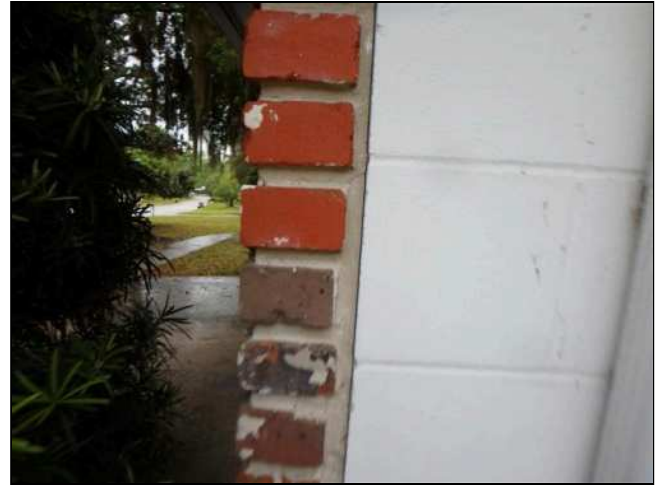
2.1 (1) SEPARATION AND/OR DETERIORATED SEALANT MATERIALS OBSERVED AT EXTERIOR SIDING. *Gaps in concrete block / brick sealant may allow moisture intrusion, which could lead to further damage. Sealant is susceptible to damage due to the UV light and varying weather conditions found in Florida's environment. Regular / Routine maintenance may be required in order to maintain a weather proof barrier and prevent moisture related damage. Surrounding / Underlying elements could not be seen and could not be inspected. Hidden damage may exist. Pictures are a representative number of affected areas. All similar areas should be addressed accordingly.*

RECOMMEND HAVING A LICENSED HANDYMAN OR CONTRACTOR EVALUATE / REMEDY AS NEEDED.

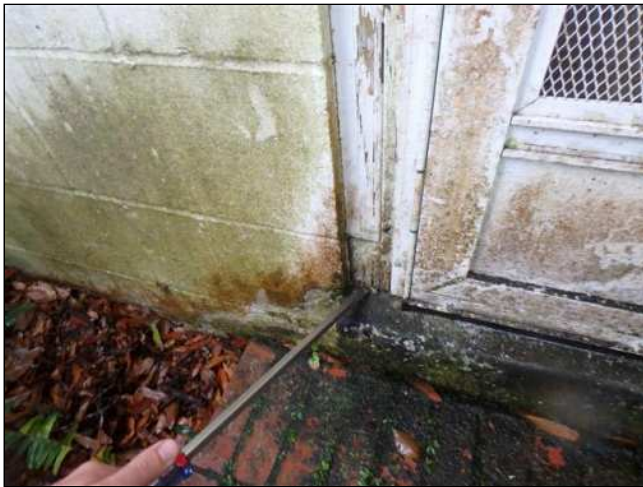
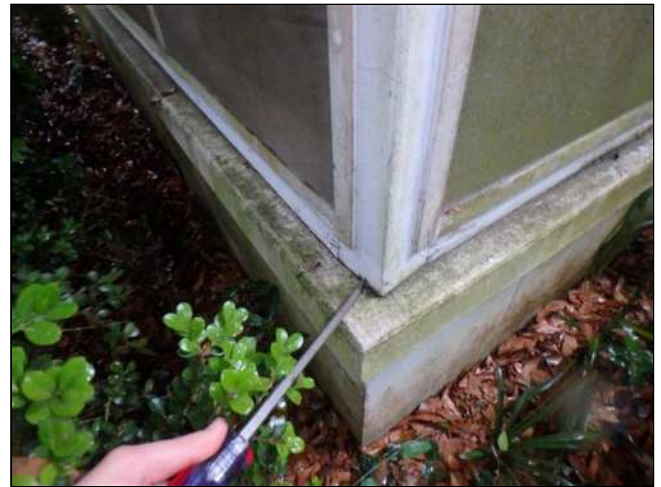
2.2 (1) WOOD DECAY AND/OR DAMAGE OBSERVED AT THE EXTERIOR SIDING / TRIM. *Wood decay at the base of siding / trim is usually due to roof drainage / rain water splash back and/or improper sealing / maintenance. Wood is highly susceptible to decay / fungi due to the high moisture content found in Florida's environment and weather conditions. Annual / Bi-annual maintenance may be required in order to maintain siding / wall cladding integrity. Conditions of underlying elements could not be seen due to finished materials. Hidden damage may exist. Pictures are a representative number of affected areas. All similar areas should be addressed accordingly.*

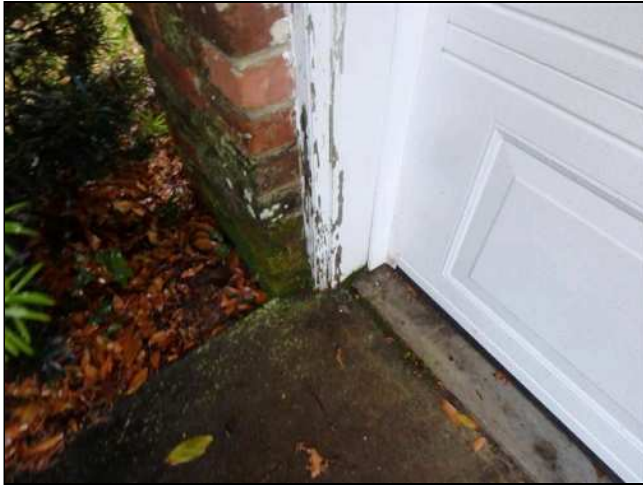
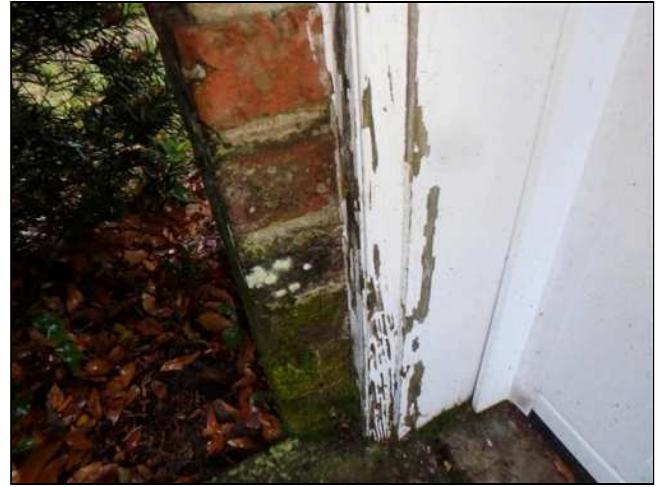
2.2 (2) SEPARATION AND/OR DETERIORATED SEALANT OBSERVED AT TRIM BOARDS. *Gaps between trim boards may allow moisture to enter between trim, which could promote the growth of wood decaying fungi. Sealant is susceptible to damage due to the UV light and varying weather conditions found in Florida's Environment and weather. Regular / Routine maintenance may be needed in order to maintain a weather proof barrier and ensure trim integrity. Underlying elements were not visible and could not be inspected. Hidden damage may exist. Pictures included are representation of issue describe. All similar areas should be addressed accordingly.*

RECOMMEND HAVING A LICENSED HANDYMAN OR CONTRACTOR EVALUATE / REMEDY AS NEEDED.

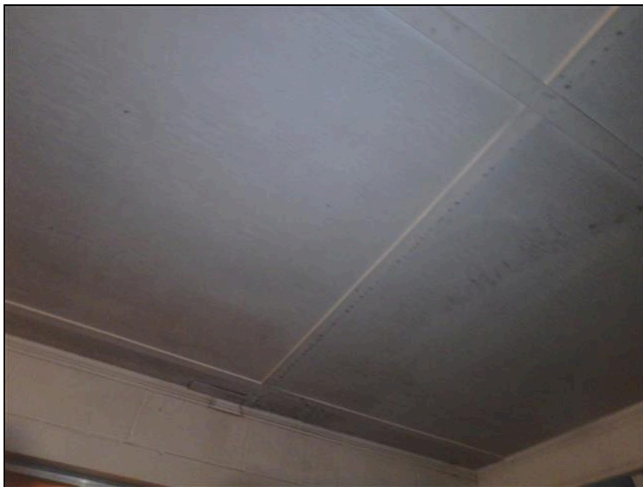
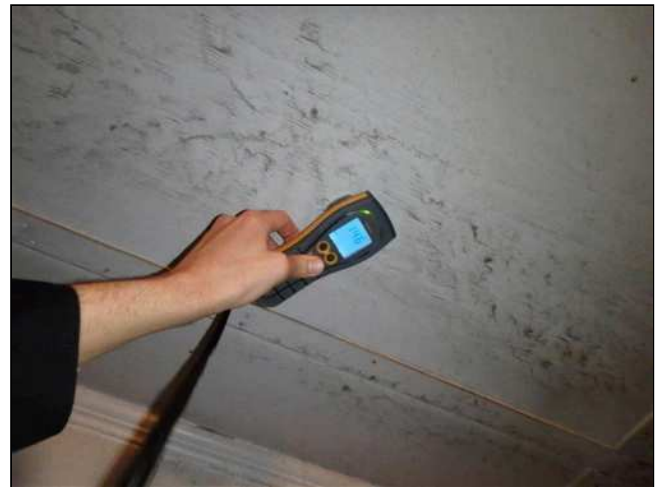
2.3 (1) STAINING / DISCOLORATION OBSERVED AT THE REAR PORCH CEILING. AREA(S) TESTED DRY USING A DIGITAL MOISTURE METER AT TIME OF INSPECTION. *Condition of latent materials was not visible and could not be fully inspected. Hidden damage may exist.*

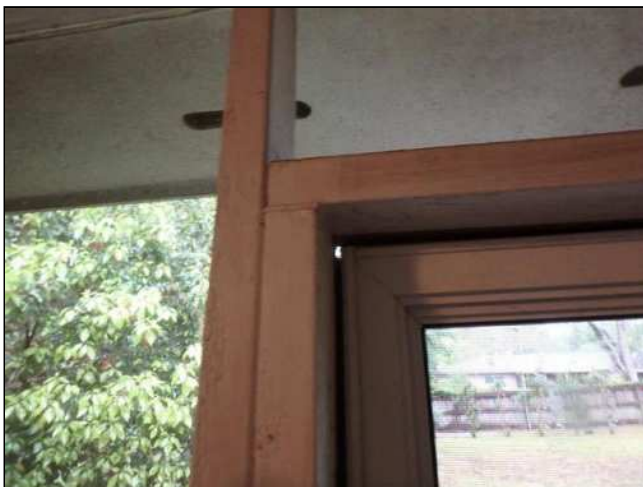
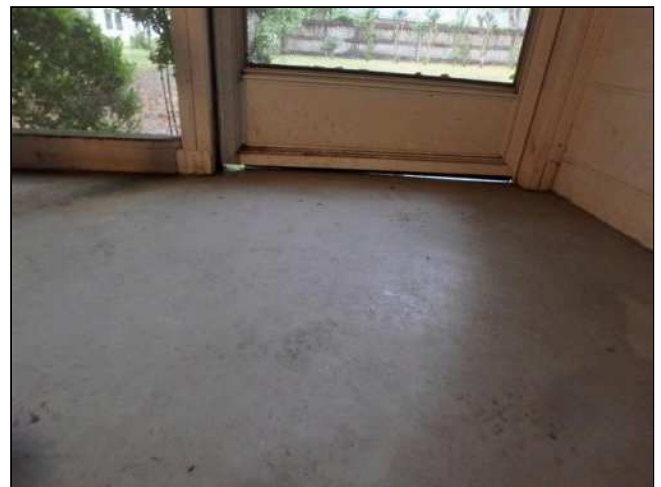
2.3 (2) AIR GAPS OBSERVED AT THE PORCH SCREEN DOOR(S). *Gaps may allow pest / insect intrusion.*

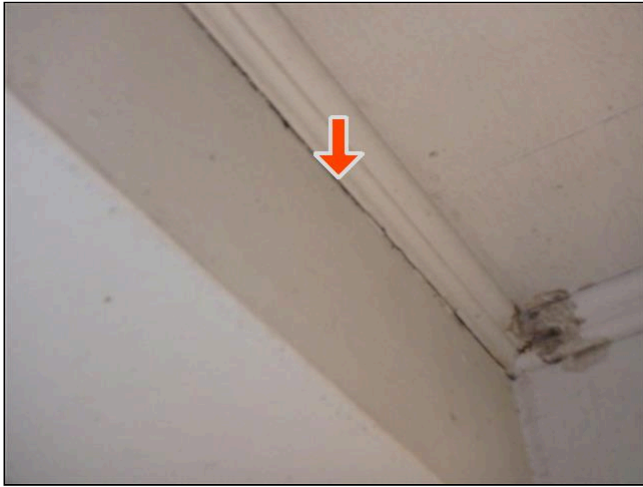
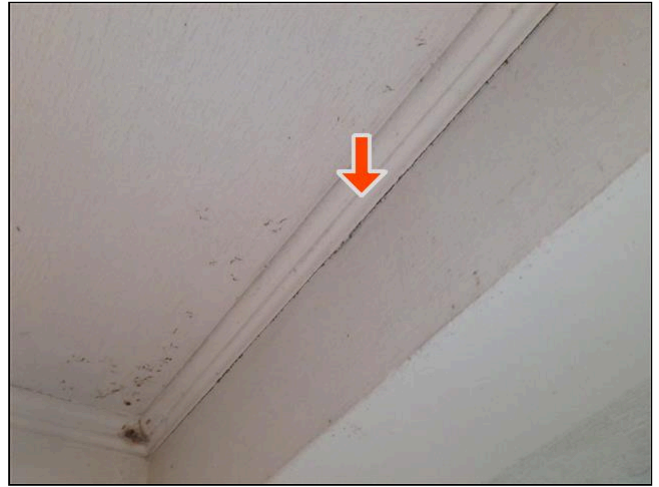
2.3 (3) SEPARATION / DETERIORATED SEALANT OBSERVED AT THE PORCH CEILING / WALL(S) UNION. *Separation may promote pest / moisture intrusion into the attic. Condition of latent materials was not visible & could not be fully inspected. Hidden damage may exist.*

RECOMMEND HAVING A LICENSED HANDYMAN OR CONTRACTOR EVALUATE / REMEDY AS NEEDED.

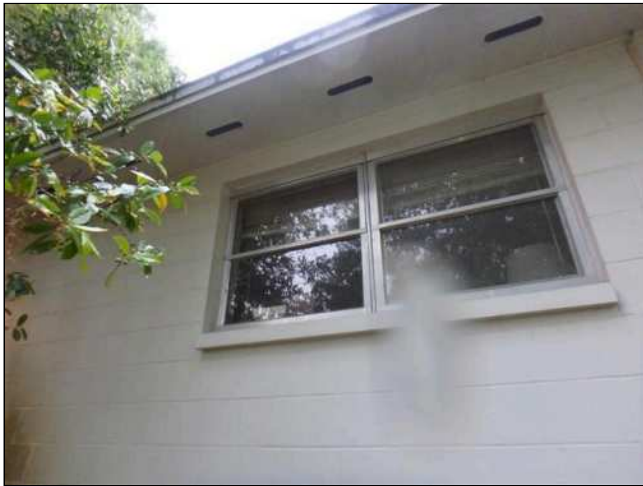
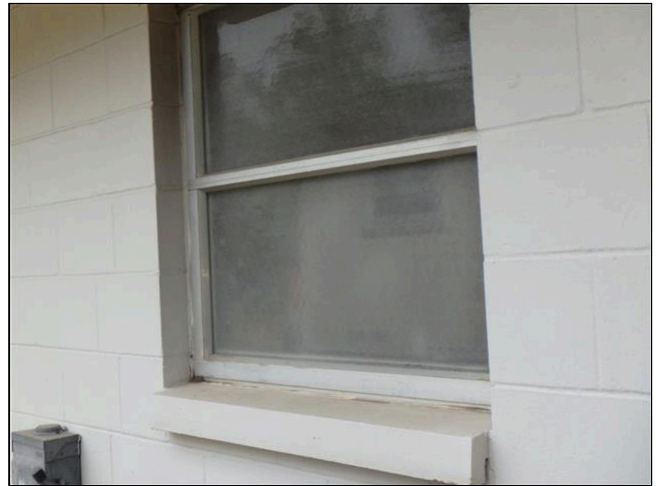
2.4 (1) MISSING / UN-INSTALLED SCREENING MATERIALS OBSERVED AT THE EXTERIOR WINDOW(S). *Missing screening / framing may allow insect / pest intrusion, when window is in use / while window is in the up position. Pictures shown are a representative number of affected windows.*

RECOMMEND INSTALLATION / ADDITION OF SCREENING COMPONENTS.

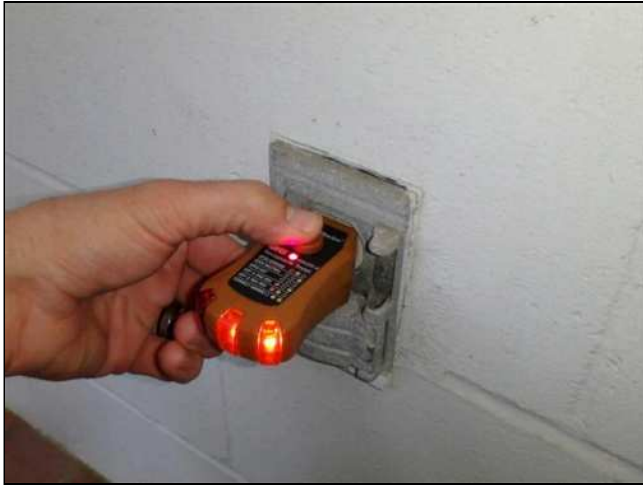
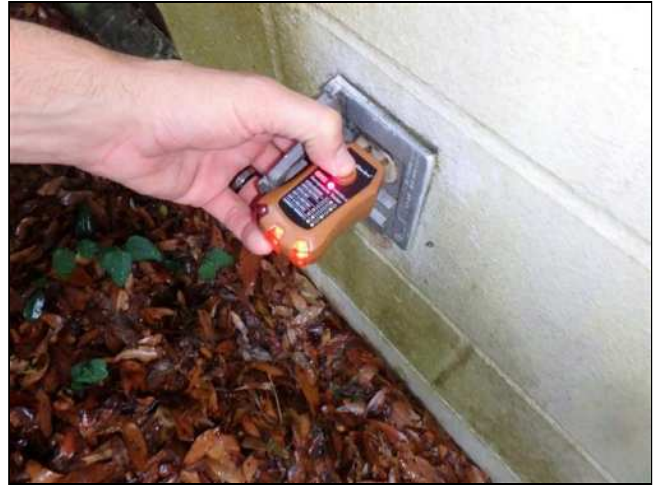
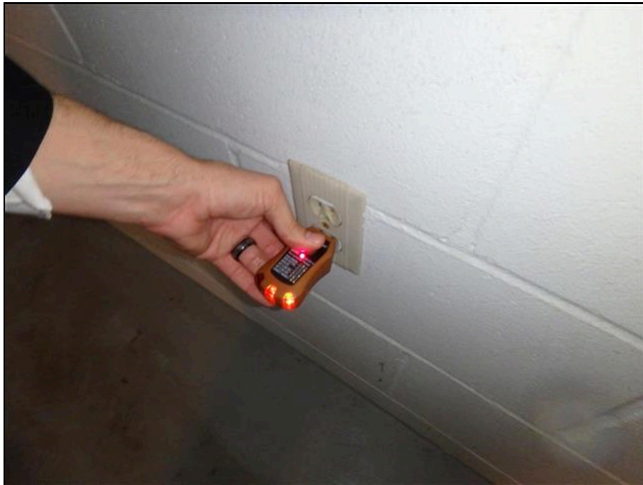
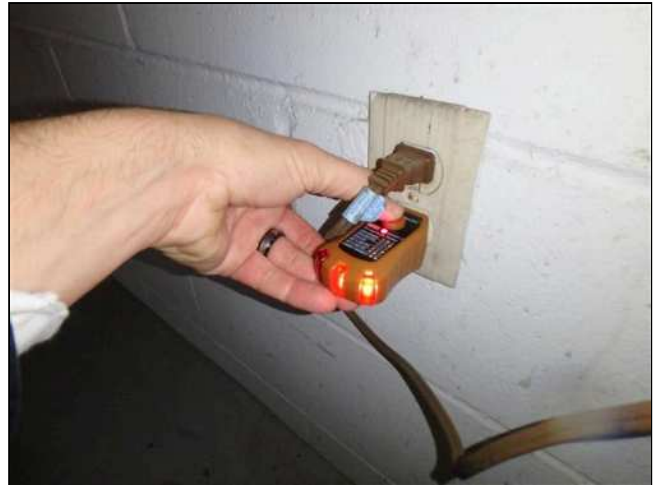
2.6 (1) EXTERIOR ELECTRICAL OUTLET(S) ARE NOT GFCI PROTECTED / DID NOT TRIP WHEN MANUALLY TESTED. *According to the National Electric Code, all exterior outlets should be GFCI protected in homes built after 1975. Home is built pre-code & may be grand-fathered into current code; however, GFCI protection should be added to all exterior electrical outlets for safety of the home occupants.*

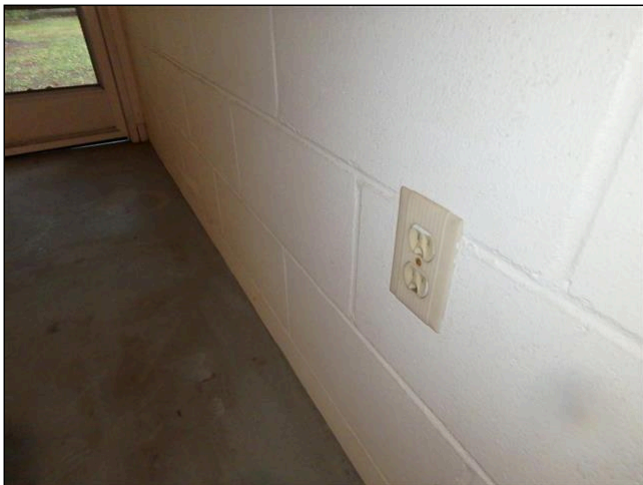
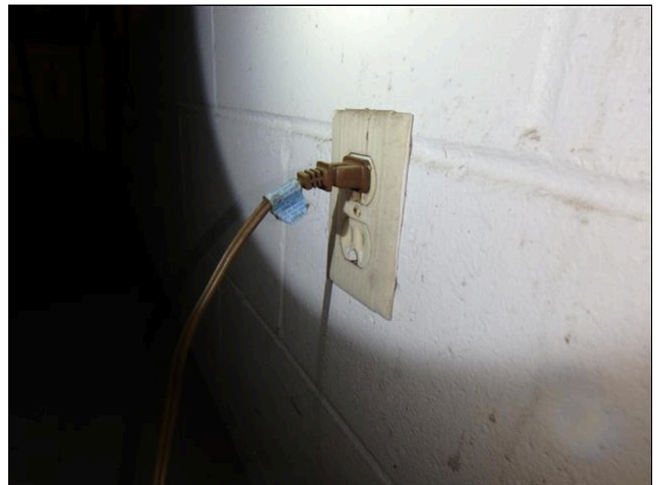
2.6 (2) EXTERIOR ELECTRICAL OUTLET(S) ARE LACKING EXTERIOR-TYPE OUTLET COVER(S). *All exterior outlets should be covered in order to protect them from moisture penetration and/or other exterior elements. Current condition may promote accidental damage to occur.*

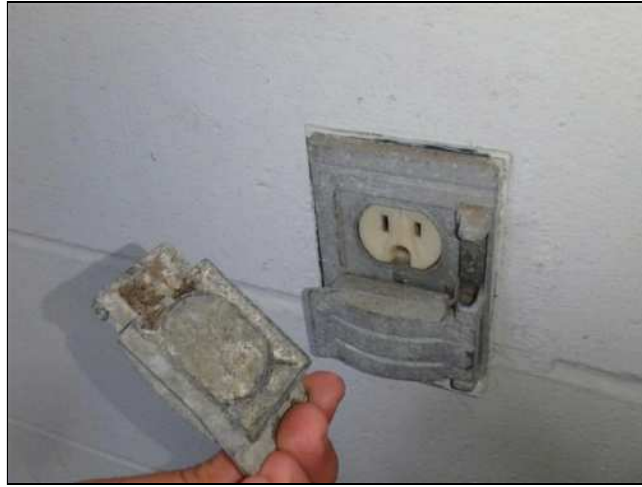
2.6 (3) DAMAGED COVER PLATE COMPONENTS OBSERVED AT THE FRONT ELECTRICAL OUTLET. *Damage may promote moisture intrusion / accidental damage.*

RECOMMEND HAVING A LICENSED HANDYMAN OR CONTRACTOR EVALUATE / REMEDY AS NEEDED.

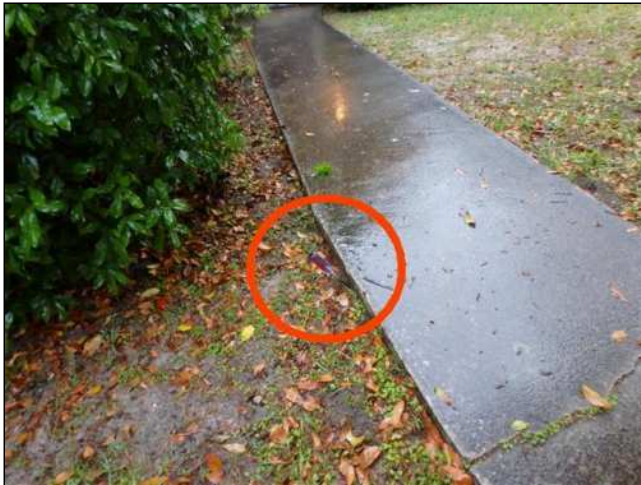
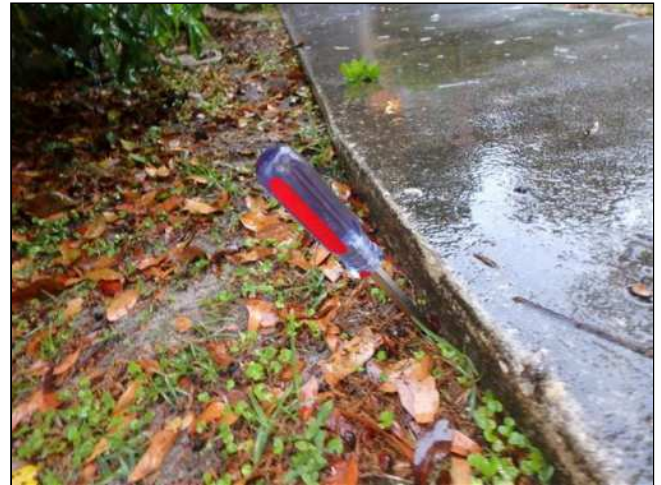
3.0 (1) UNDERMINING AND/OR GRADING EROSION OBSERVED AT THE FRONT WALKWAY. *Undermining of walkway materials may result in failure of affected materials. Condition of latent materials was not visible & could not be fully inspected. Hidden damage may exist.*

RECOMMEND HAVING A LICENSED HANDYMAN OR CONTRACTOR EVALUATE / REMEDY AS NEEDED.

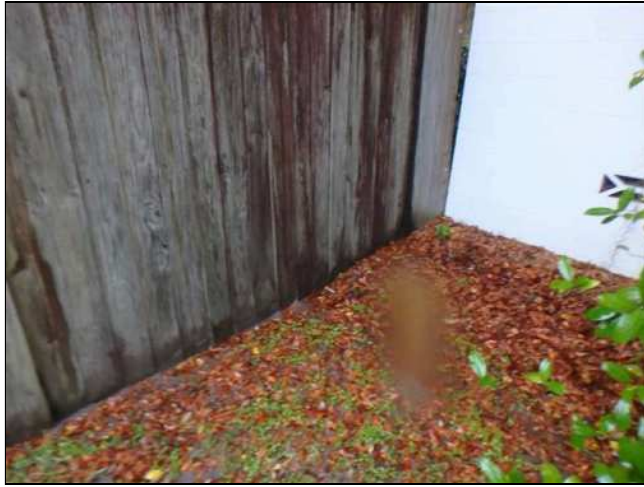
3.2 (1) SOIL TO WOOD CONTACT OBSERVED AT REAR FENCING ENCLOSURE. *Soil to wood contact can expedite the formation of wood decay. Where possible, it is recommended that soil be at least 2-4 inches away from wood. Formation of wood decay at the base of fencing is a common occurrence and repair/replacement may be discretionary.*

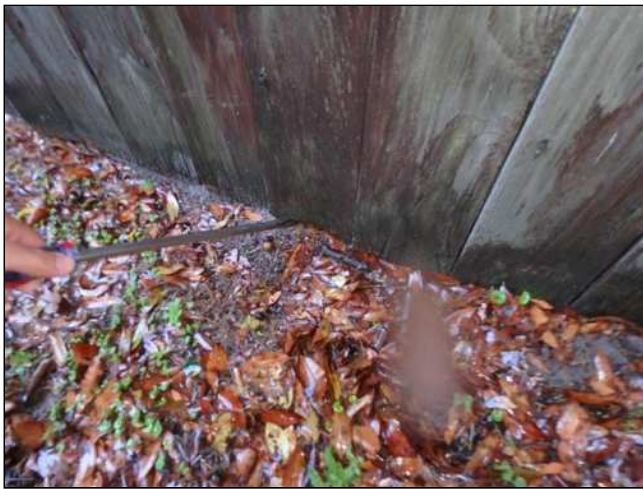
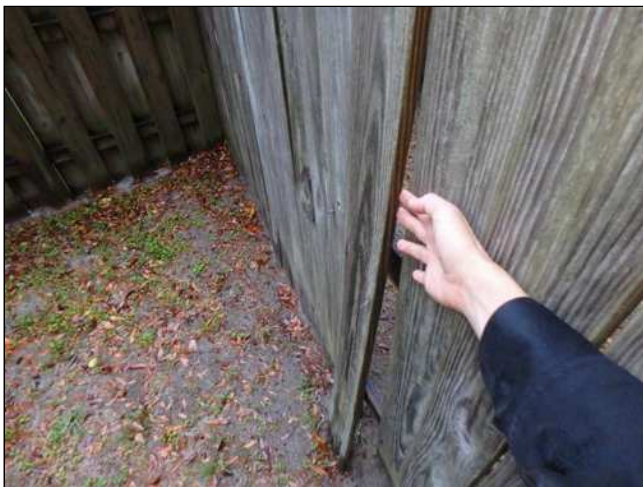
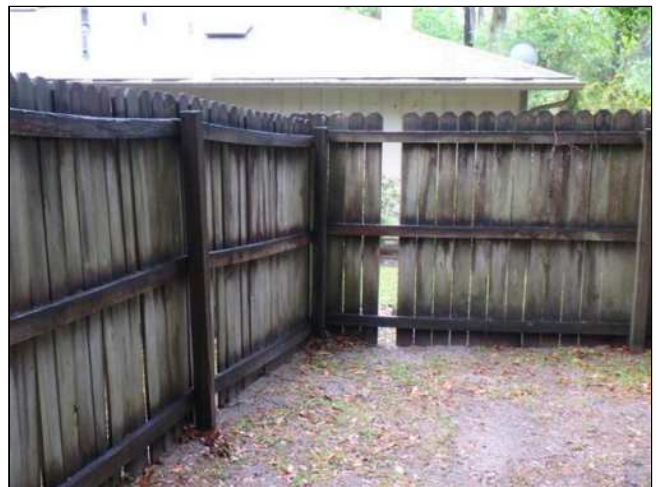
3.2 (2) WOOD DECAY AND/OR DAMAGE OBSERVED AT FENCING MATERIALS. *Wood decay / damage may deteriorate the integrity / rigidity of affected materials over time.*

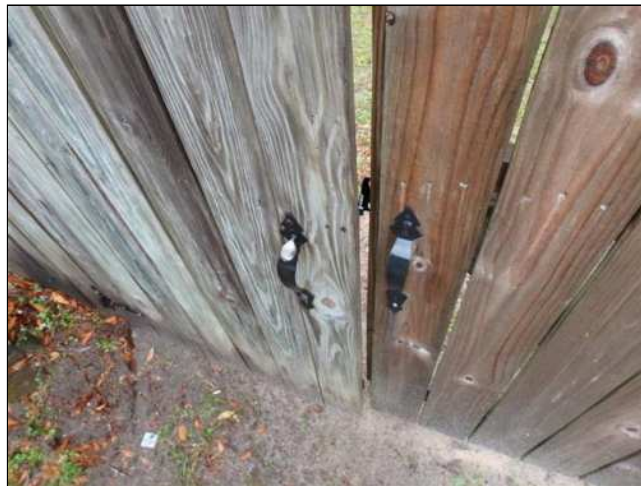
3.2 (3) RIGHT SIDE GATE LATCH DOES NOT LINE UP PROPERLY. *Adjustment may be necessary. Unsecured gates may allow unwanted pest intrusion into the yard.*

RECOMMEND HAVING A LICENSED HANDYMAN OR CONTRACTOR EVALUATE / REMEDY AS NEEDED.

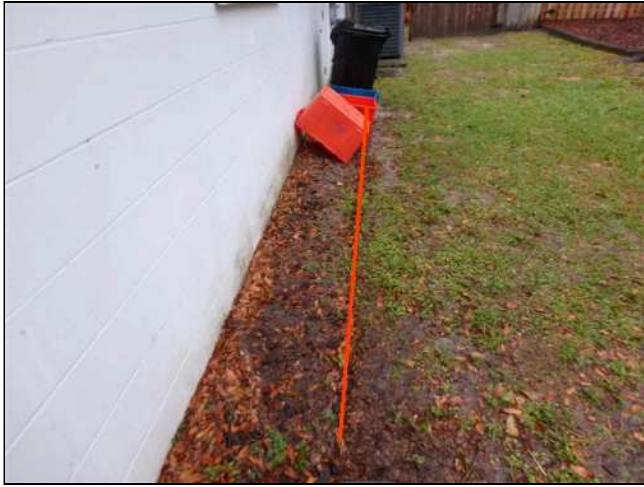
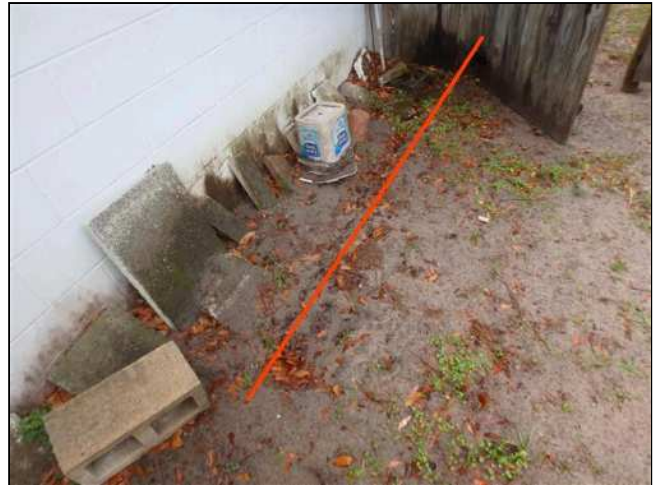
3.4 (1) GRADING EROSION OBSERVED AT THE PERIMETER OF THE ROOF LINE. *Evidence is indicative of roof rain water run-off. Over time, erosion may begin to affect / damage the adjacent exterior foundation walls / related elements. Pictures are a representative number of affected areas. All similar areas should be addressed accordingly.*

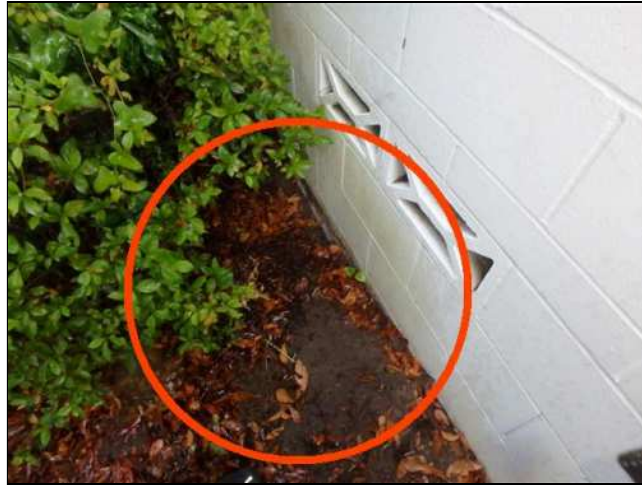
3.4 (2) DEPRESSION(S) / HOLE(S) OBSERVED IN THE YARD. *Hole(s) / depression(s) may pose a potential safety hazard / liability risk.*

RECOMMEND HAVING A LICENSED HANDYMAN OR CONTRACTOR EVALUATE / REMEDY AS NEEDED.

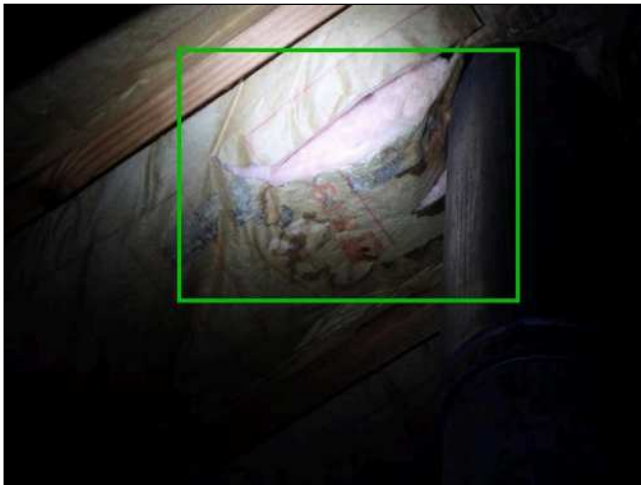
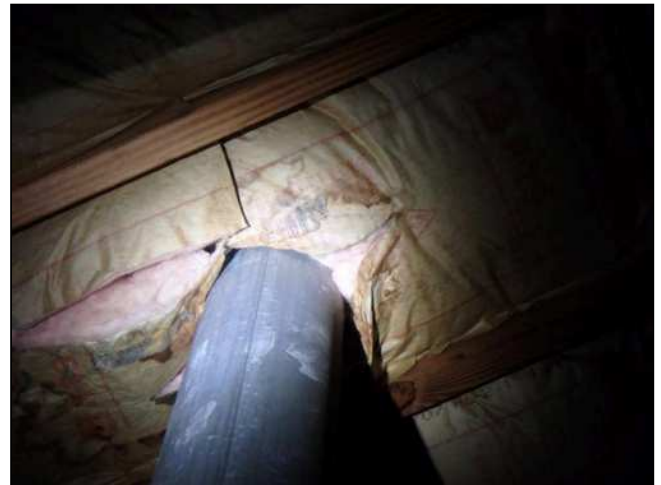
4.4 (1) MOISTURE STAINING OBSERVED AT THE INSULATION AT GARAGE CEILING, ADJACENT TO FLUE PIPING. *Moisture staining is an indication of moisture intrusion.*

AREA COULD NOT SAFELY BE REACHED AND COULD NOT BE INSPECTED UP CLOSE.

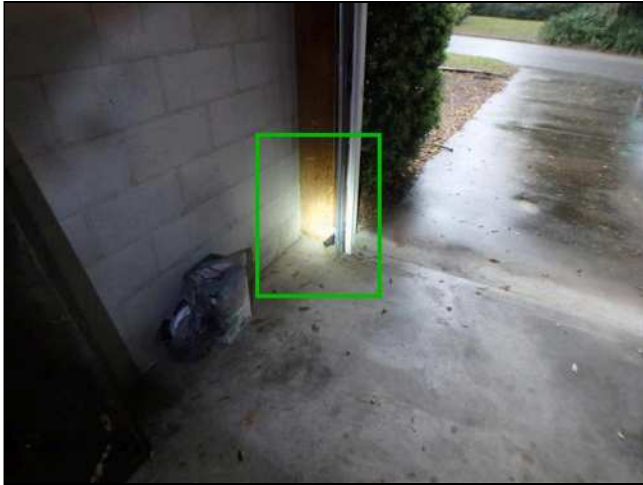
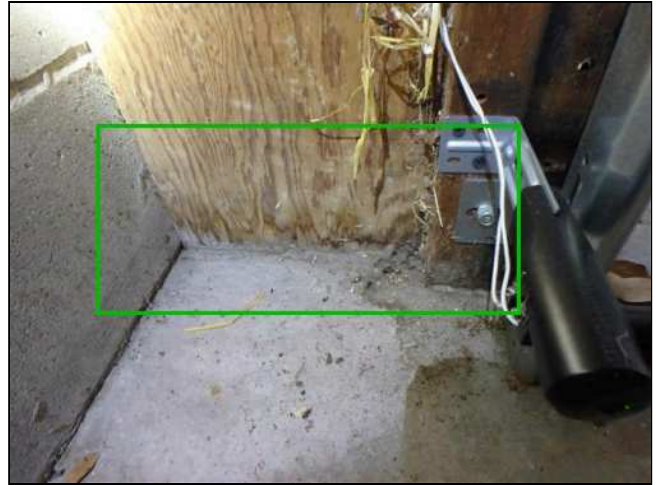
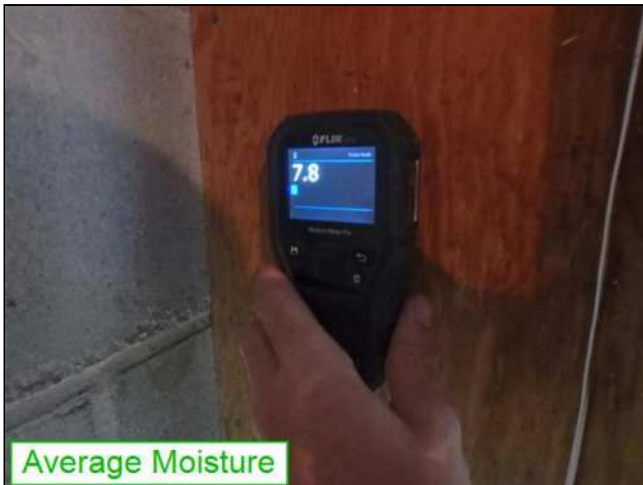
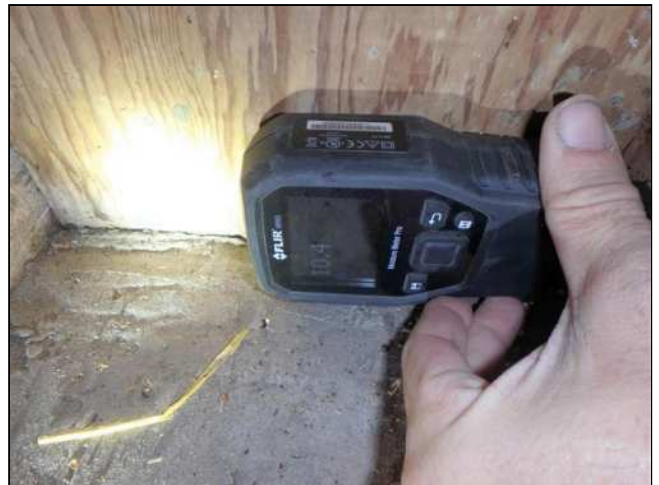
4.4 (2) MOISTURE STAINING OBSERVED AT GARAGE WALLS ADJACENT TO VEHICLE DOOR. *Condition is an indication of moisture intrusion. Condition of latent materials could not be seen and could not be inspected, hidden damage may exist.*

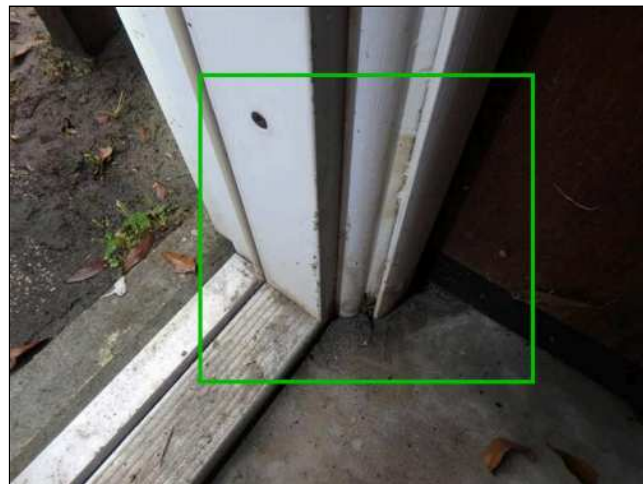
4.4 (3) MOISTURE STAINING / EVIDENCE OF MOISTURE INTRUSION OBSERVED AT WALL ADJACENT TO ENTRY DOOR. Condition of latent materials could not be seen and could not be inspected, hidden damage may exist. RECOMMEND HAVING A LICENSED HANDYMAN OR LICENSED CONTRACTOR EVALUATE AND REPAIR AS NEEDED.

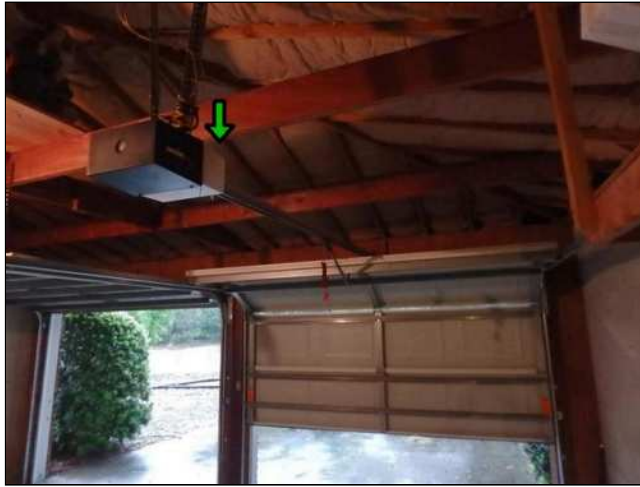
4.7 (1) LIGHT BULB AT LEFT SIDE GARAGE DOOR OPENER DID NOT FUNCTION AT TIME OF INSPECTION. *Condition may pose a safety hazard. Condition is most likely due to a defective bulb.*

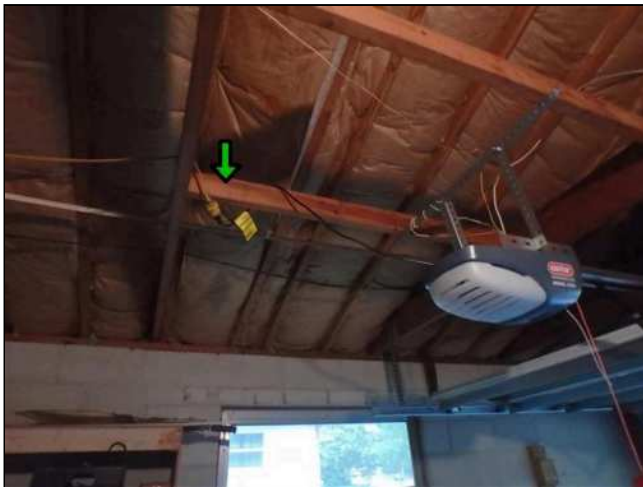
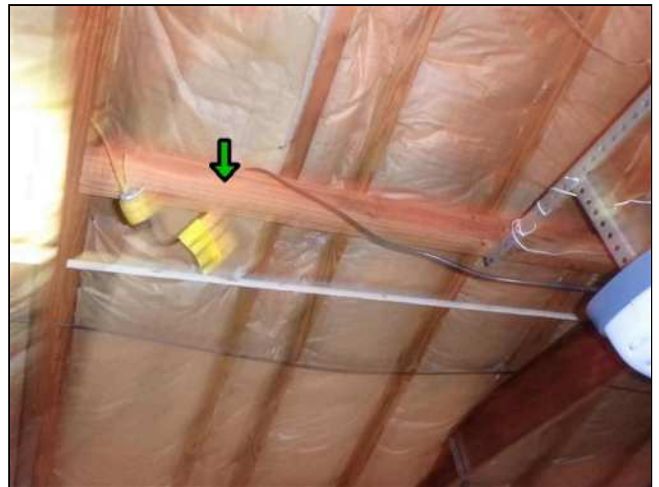
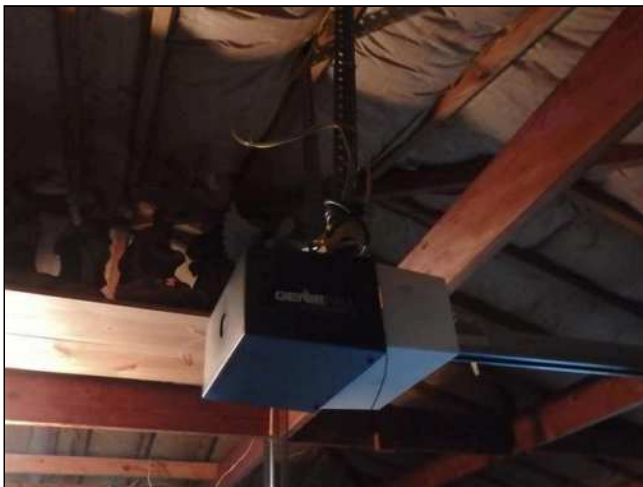
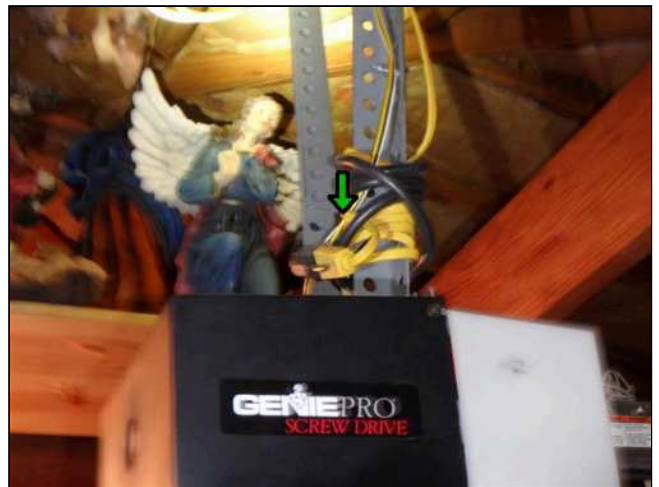
4.7 (2) GARAGE DOOR OPENER ARE POWERED VIA EXTENSION CORDS. *Extension cords may be susceptible to damage. RECOMMEND HAVING A LICENSED HANDYMAN OR LICENSED ELECTRICAL CONTRACTOR EVALUATE AND REPAIR AS NEEDED.*

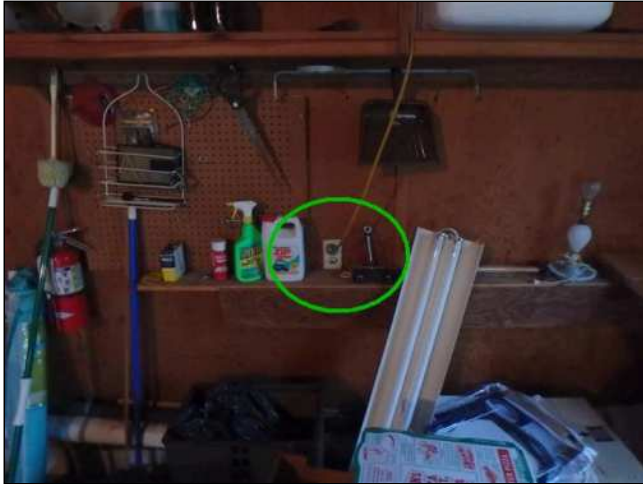
4.8 (Picture 1)

REAR WALL OUTLET IS RECESSED. *Recessed outlets may allow moisture and/or foreign elements to enter behind cover plate,*

which could lead to related damage / issues.

RECOMMEND HAVING A LICENSED HANDYMAN EVALUATE AND REPAIR AS NEEDED.
