INSPECTION INFORMATION

Standard Home Inspection

Single Family Dwelling

51 Years

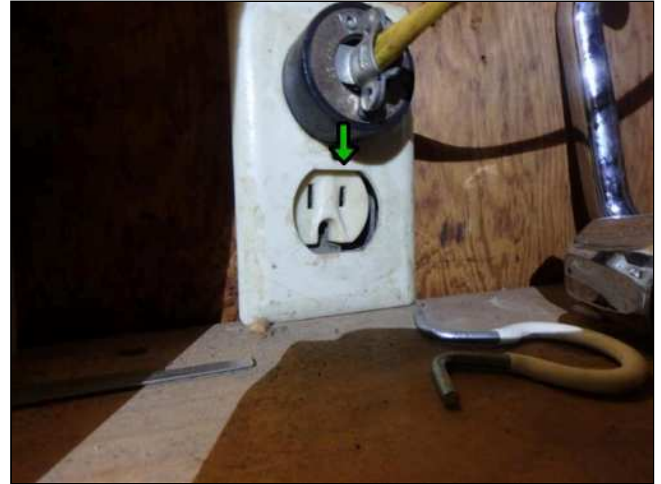
4.8 (Picture 2)

REAR WALL OUTLET IS RECESSED. *Recessed outlets may allow moisture and/or foreign elements to enter behind cover plate,*

which could lead to related damage / issues.

RECOMMEND HAVING A LICENSED HANDYMAN EVALUATE AND REPAIR AS NEEDED.

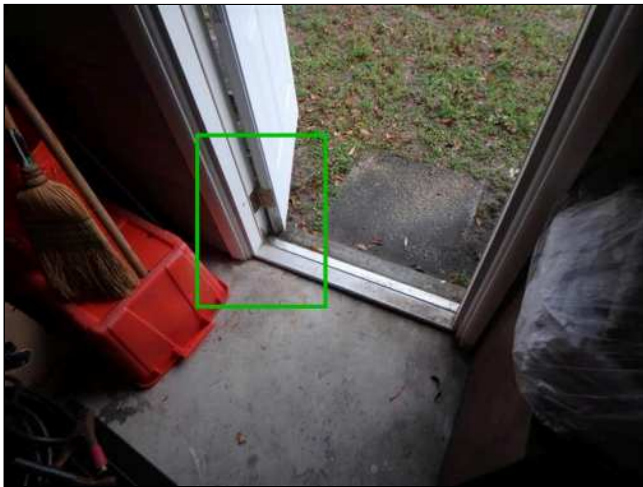
4.9 (Picture 1)

WOOD DECAY / DAMAGE OBSERVED A GARAGE ENTRY DOOR JAMB AND SPINE. *Wood decay may be due to roof drainage / moisture splash back. Condition may worsen, if left uncorrected. Condition of latent materials could not be seen and could not be inspected, hidden damage may exist.*

RECOMMEND HAVING A LICENSED HANDYMAN EVALUATE AND REPAIR AS NEEDED.

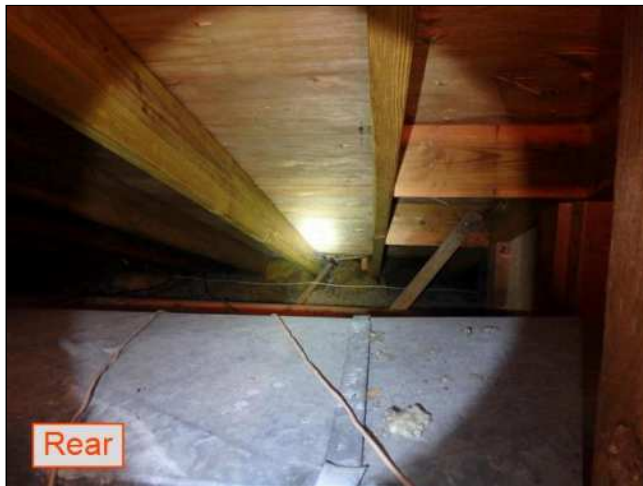
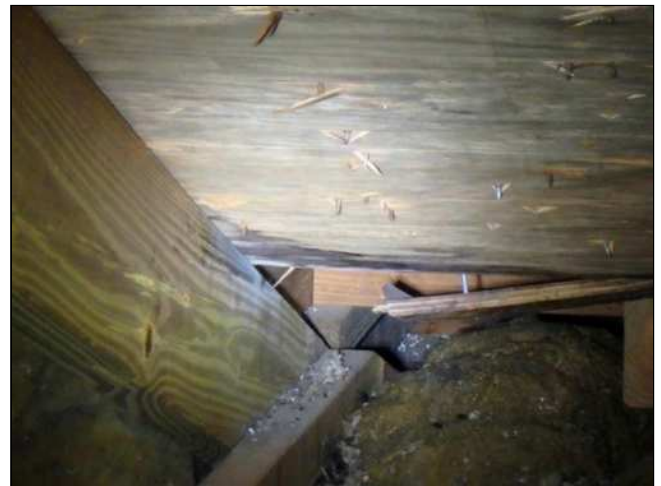
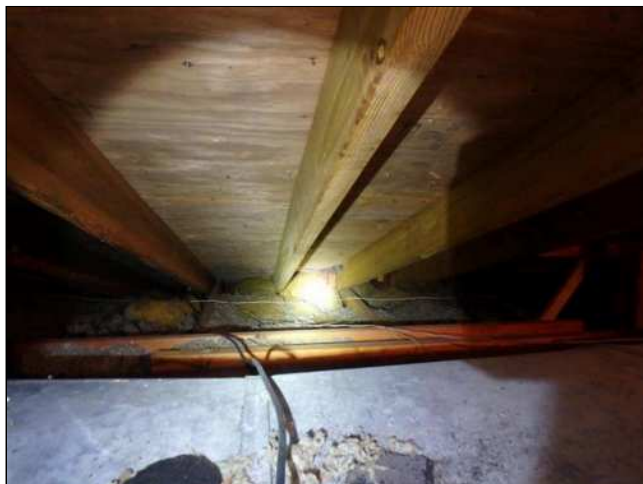
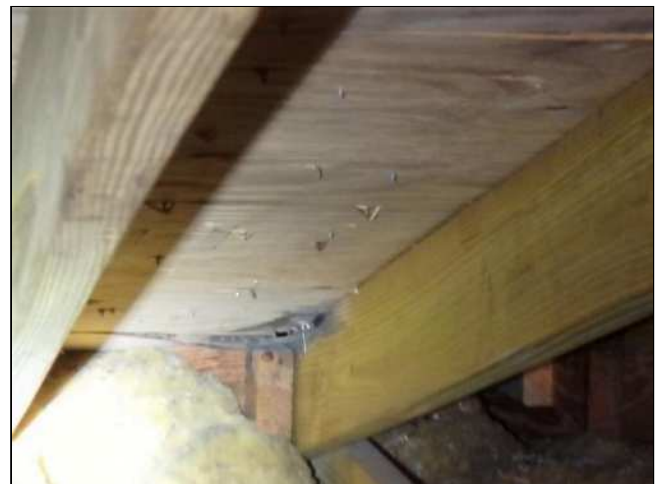
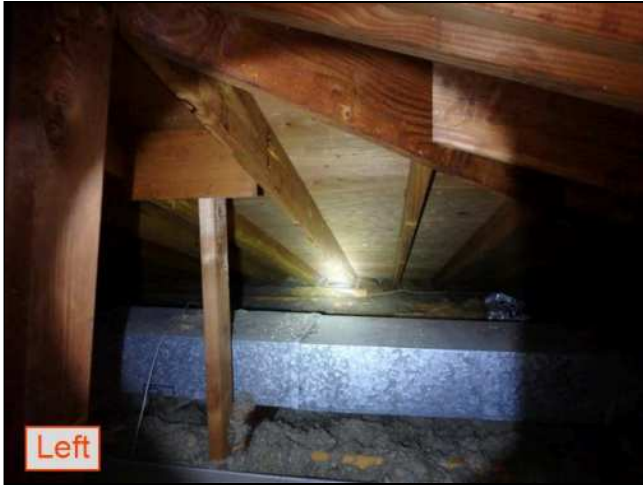
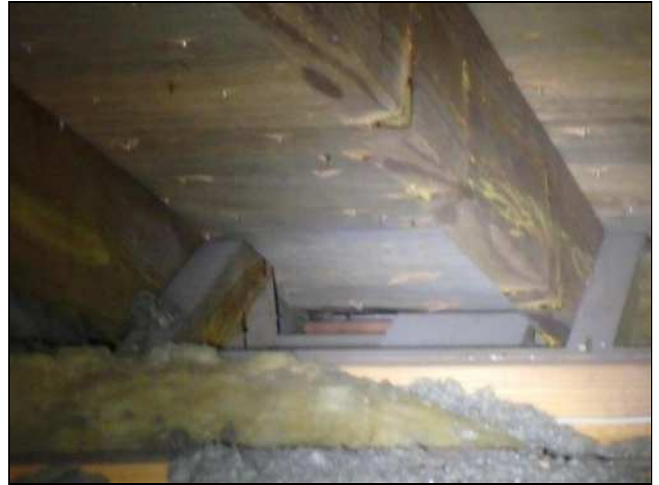
5.0 (1) STAINING / DISCOLORATION OBSERVED AT FASCIA / ROOF FRAMING & RELATED ELEMENTS. AREA(S) WERE INACCESSIBLE & COULD NOT BE PHYSICALLY REACHED / TESTED FOR MOISTURE CONTENT. *Condition of latent materials was not visible & could not be fully inspected. Hidden damage may exist.*

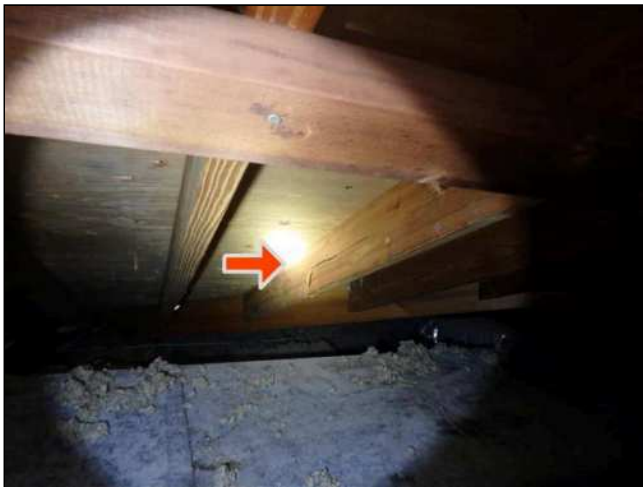
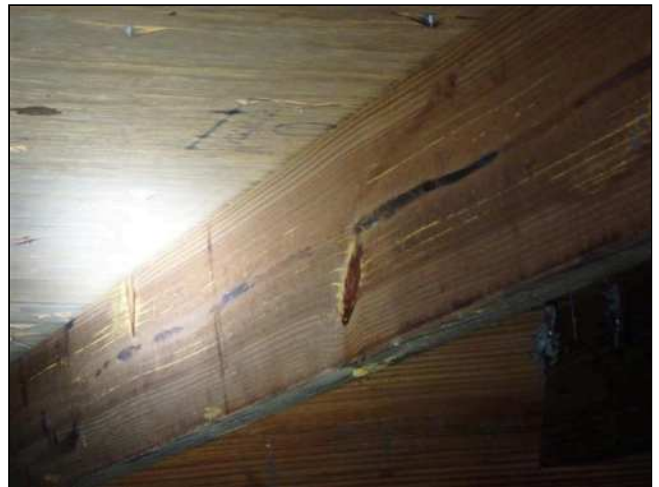
5.0 (2) DAMAGE / SUSPECT WOOD DESTROYING ORGANISM ACTIVITY OBSERVED AT THE REAR FRAMING. *Damage / suspect WDO activity may deteriorate the integrity of affected components. Extent of damage / activity was not determined. Condition of latent materials was not visible & could not be fully inspected. Hidden damage may exist.*

RECOMMEND HAVING A LICENSED ROOFING CONTRACTOR & PEST COMPANY EVALUATE / REMEDY AS NEEDED.

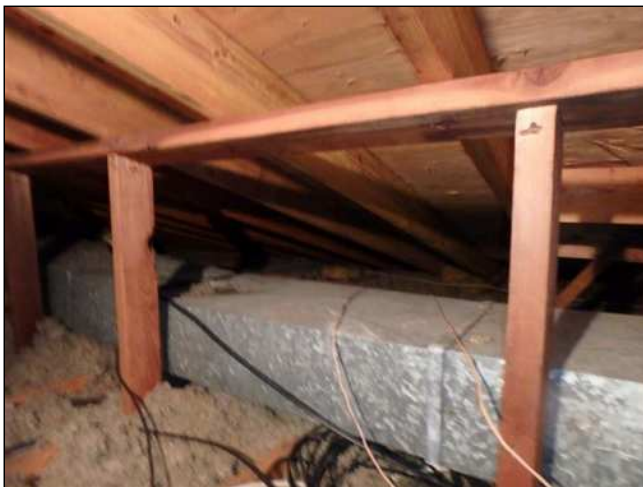
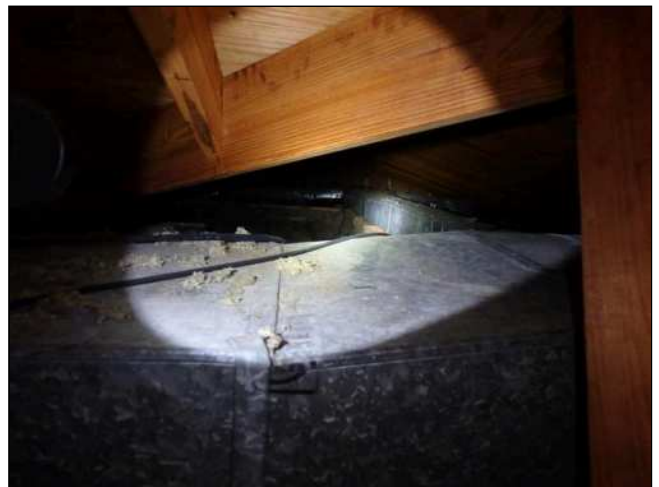
5.0 (4) DUE TO INSULATION / INSULATION BAFFLES & ATTIC DESIGN / HEIGHT LIMITATIONS, APPROXIMATELY 30% OF ROOF FRAMING / DECKING & RELATED ELEMENTS WERE NOT VISIBLE / ACCESSIBLE & COULD NOT BE PHYSICALLY REACHED / FULLY INSPECTED.

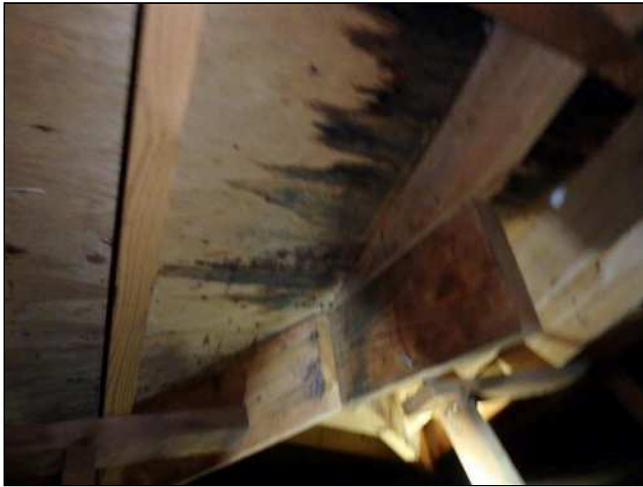
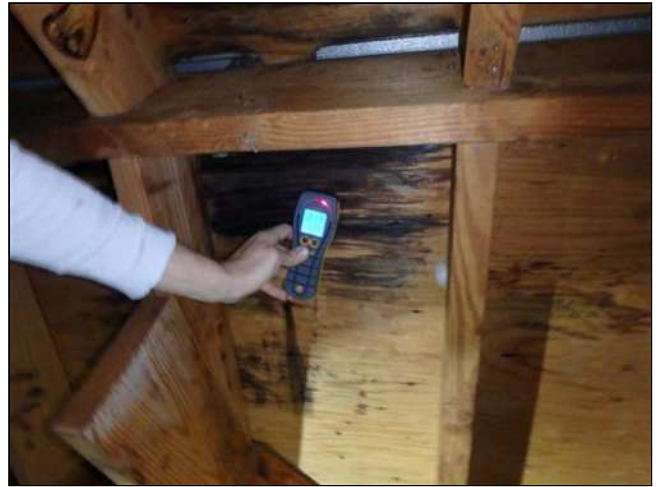
5.1 (1) STAINING / DISCOLORATION OBSERVED AT THE CENTER / REAR ROOF DECKING / FRAMING & RELATED ELEMENTS. AREA(S) TESTED POSITIVE FOR MOISTURE CONTENT USING A DIGITAL MOISTURE METER AT TIME OF INSPECTION. *Extent of moisture penetration / condition of latent materials was not visible & could not be fully inspected. Hidden damage may exist.*

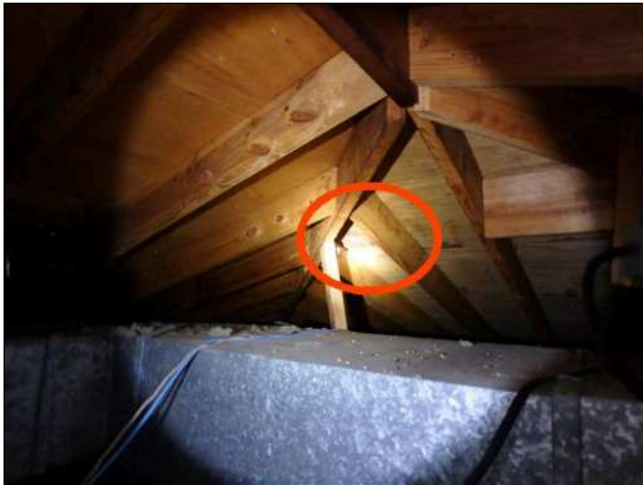
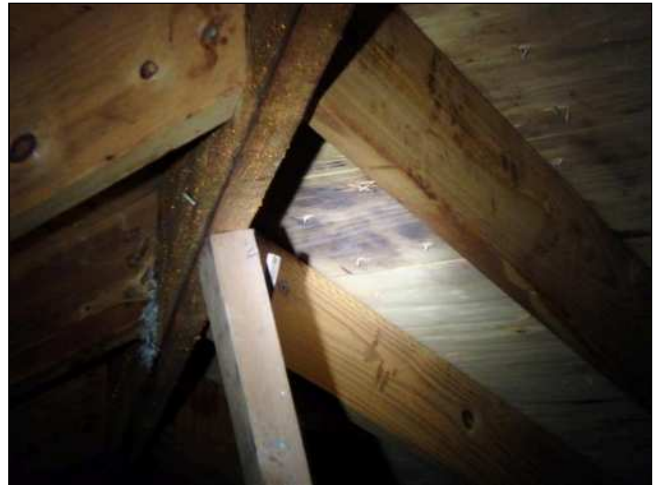
5.1 (2) STAINING / DISCOLORATION OBSERVED AT RIGHT / REAR ROOF DECKING AND/OR ROOF FRAMING. AREA(S) WERE INACCESSIBLE & COULD NOT BE PHYSICALLY REACHED / TESTED FOR MOISTURE CONTENT. *Condition of latent materials was not visible & could not be fully inspected. Hidden damage may exist.*

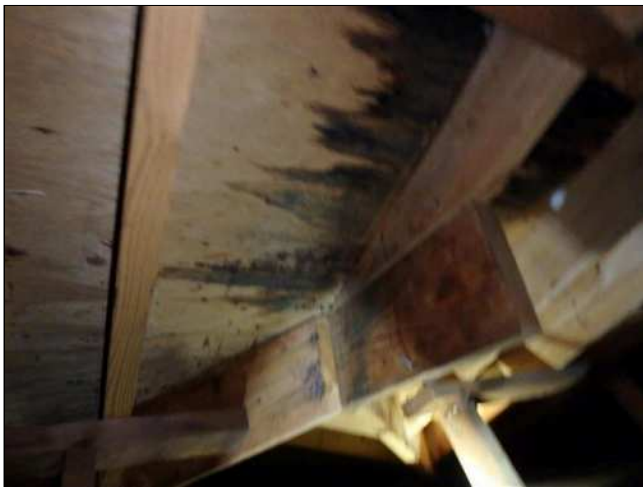
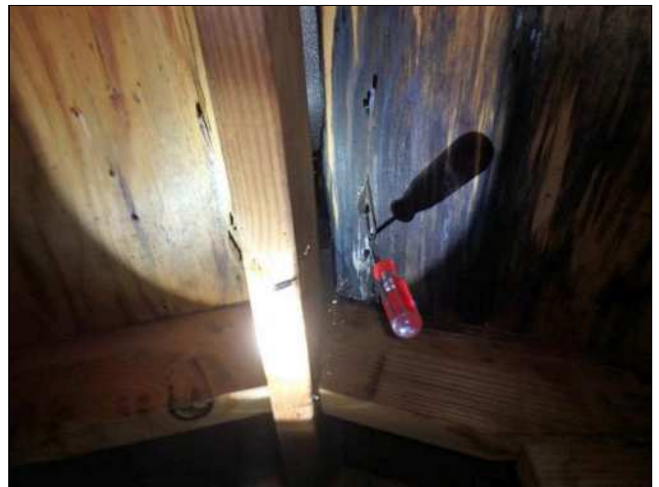
5.1 (3) WOOD DECAY AND/OR DAMAGE OBSERVED AT THE REAR CENTER DECKING . *Wood decay / damage may deteriorate the integrity of affected components. Condition of latent materials was not visible & could not be fully inspected. Hidden damage may exist.*

RECOMMEND HAVING A LICENSED ROOFING CONTRACTOR EVALUATE / REMEDY AS NEEDED.

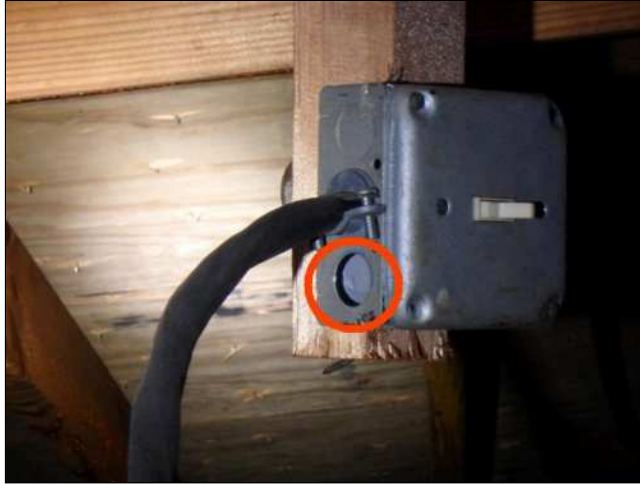
5.3 (Picture 1)

JUNCTION / FIXTURE BOX IS LACKING A TAB / KNOCK-OUT. *Lack of equipment may promote accidental damage to occur.*
RECOMMEND HAVING A LICENSED HANDYMAN OR CONTRACTOR EVALUATE / REMEDY AS NEEDED.

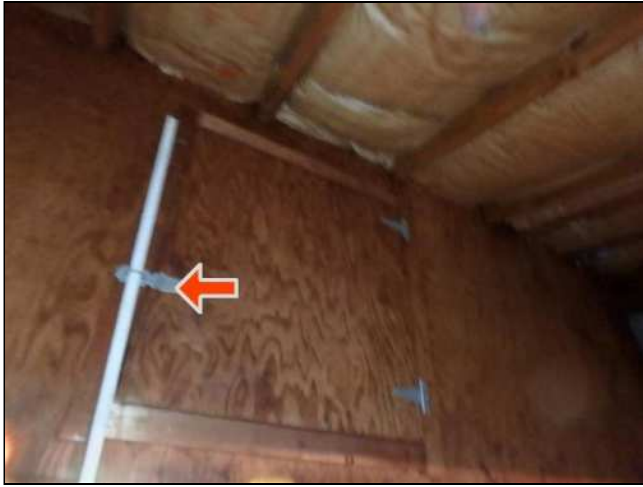
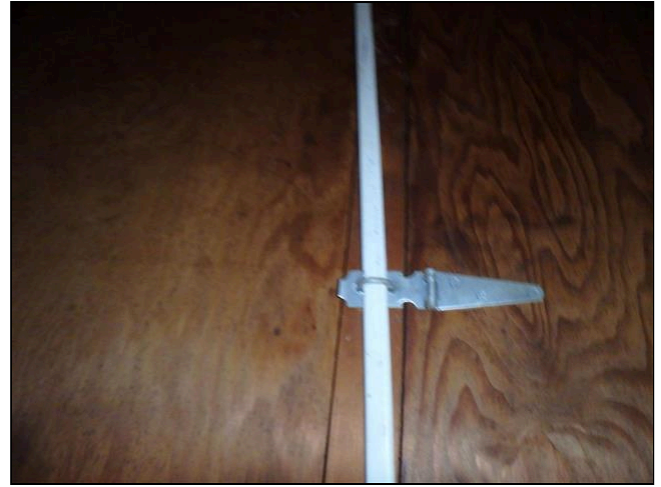
5.4 (2) IMPROPER MATERIALS IN USE AT THE GARAGE ATTIC ACCESS DOOR. *Use of improper components may promote accidental damage to occur.*

RECOMMEND HAVING A LICENSED HANDYMAN OR CONTRACTOR EVALUATE / REMEDY AS NEEDED.

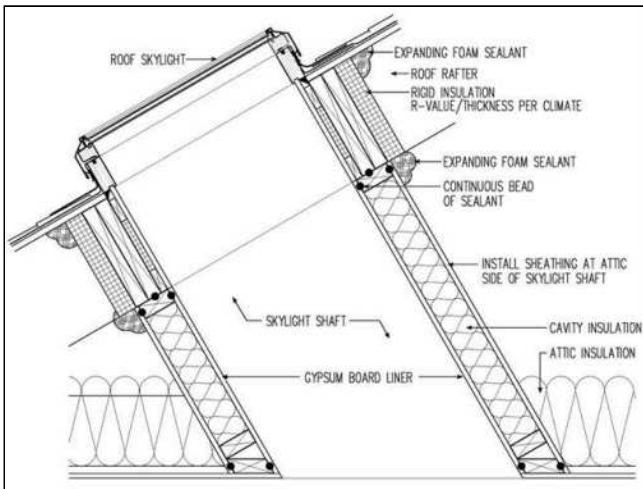
5.6 (Picture 1)

SKYLIGHT ENCLOSURE(S) APPEAR TO BE LACKING INSULATION MATERIALS. *Lack of insulation may result in unwanted heat transfer.*

RECOMMEND HAVING A LICENSED HANDYMAN OR CONTRACTOR EVALUATE / REMEDY AS NEEDED.

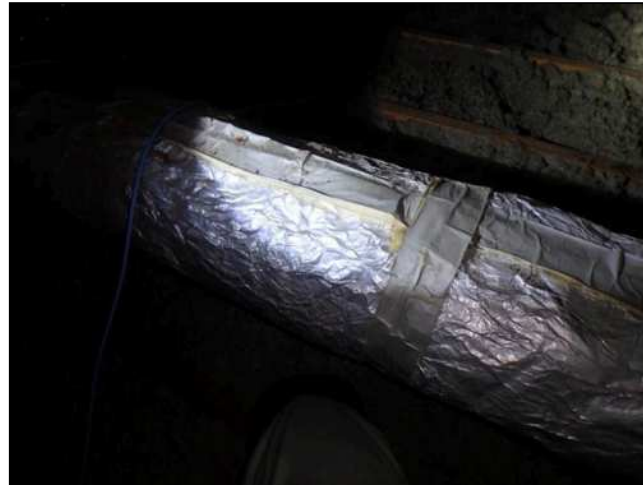
5.7 (Picture 1)

DUCT TAPE / IMPROPER SEALANT MATERIALS OBSERVED IN USE AT THE HVAC SYSTEM DUCTING & RELATED ELEMENTS. *Duct tape / improper sealant materials can loose adhesiveness due to the moisture content and heat found in Florida attics, which can lead to air leaks / energy loss.*

RECOMMEND HAVING A LICENSED HVAC COMPANY EVALUATE / REMEDY AS NEEDED.

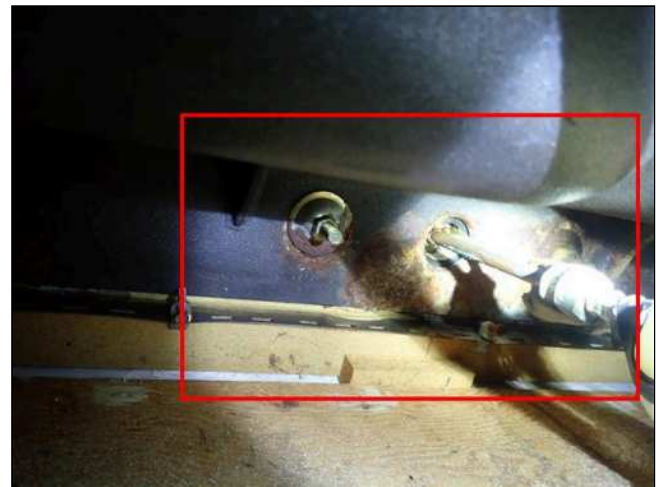
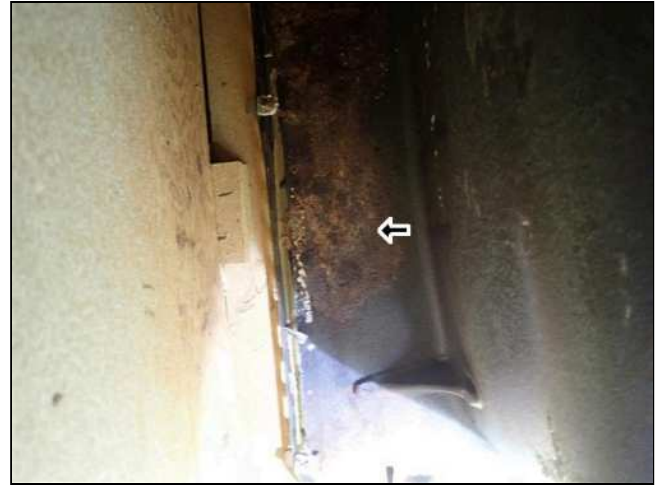
6.0 (1) EXCESSIVE RUST/CORROSION OBSERVED BELOW SINK AT SINK SURFACES. NO LEAKS OBSERVED AT TIME OF INSPECTION.

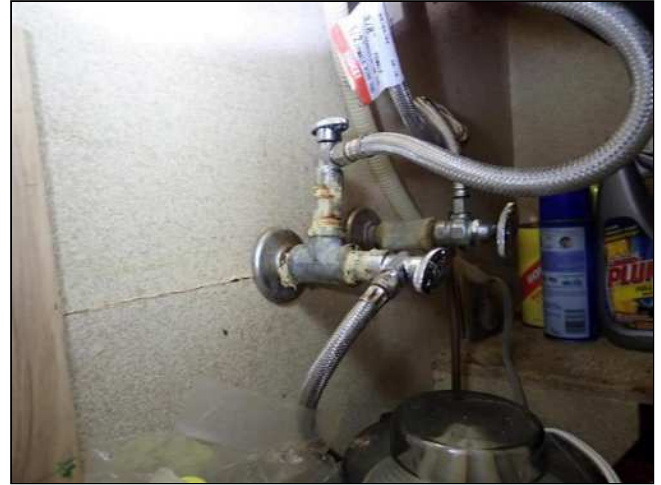
6.0 (3) CORROSION OBSERVED AT THE WATER SUPPLY SHUT OFF VALVES AND/OR RELATED ELEMENTS. *No leaks observed at time of inspection; however, prolonged exposure to corrosion may result in premature wear / failure of affected components. Removal of corrosion may result in exposure of leak. Condition of latent materials was not visible & could not be fully inspected. Hidden damage may exist.*

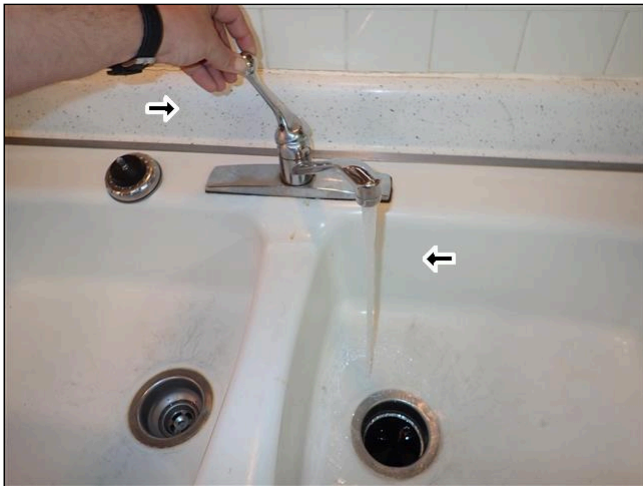
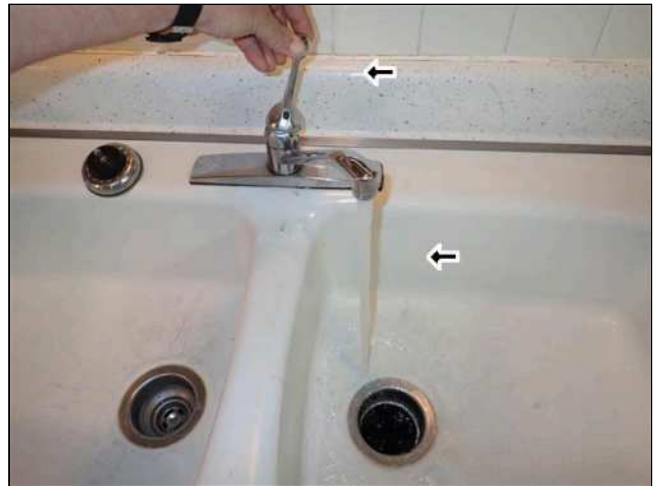
6.0 (5) HOT WATER PRESSURE IS POOR WHILE COLD WATER PRESSURE IS SATISFACTORY.
SUGGEST HAVING A LICENSED PLUMBER OR CONTRACTOR EVALUATE AND REMEDY AS NEEDED.

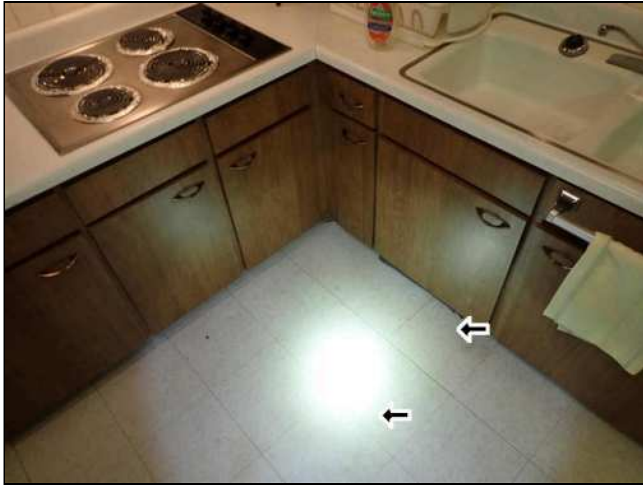
6.1 (Picture 1)

SCATTERED DAMAGED BUCKLING FLOORING OBSERVED. LATENT MATERIALS CAN NOT BE FULLY SEEN AND HIDDEN DAMAGE MAY EXIST. ALSO SEE FOUNDATION/SUBSTRUCTURE COMMENTS.

SUGGEST HAVING A LICENSED CONTRACTOR EVALUATE AND REPAIR AS NEEDED.

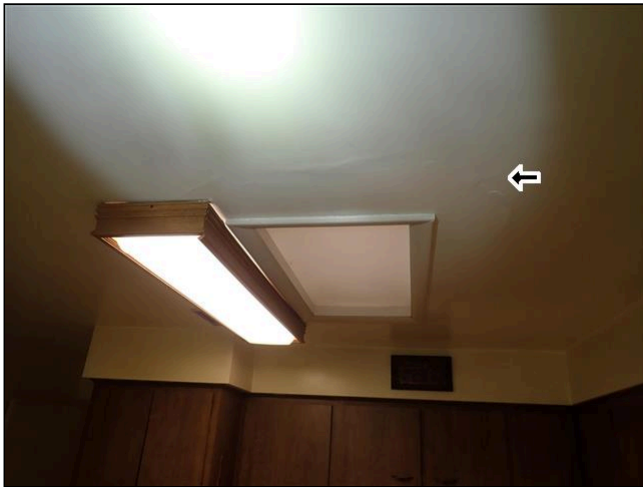
6.2 (Picture 1)

DAMAGE AND STAINING / DISCOLORATION OBSERVED AT THE KITCHEN CEILING NEAR SKYLIGHT. AREA TESTED DRY USING A DIGITAL MOISTURE METER AT TIME OF INSPECTION. *Condition of latent materials was not visible and could not be fully inspected. Hidden damage may exist.*

SUGGEST HAVING A LICENSED CONTRACTOR EVALUATE AND REPAIR AS NEEDED.

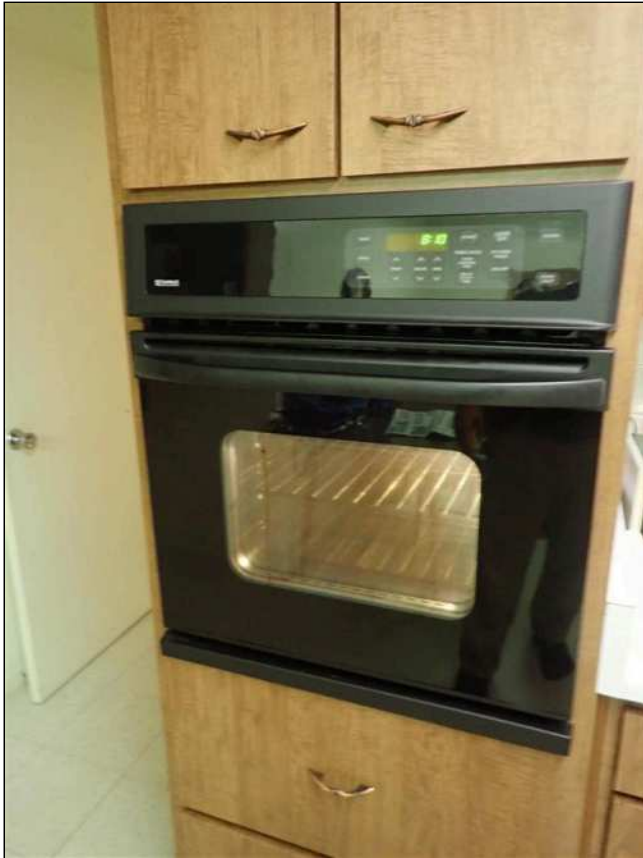
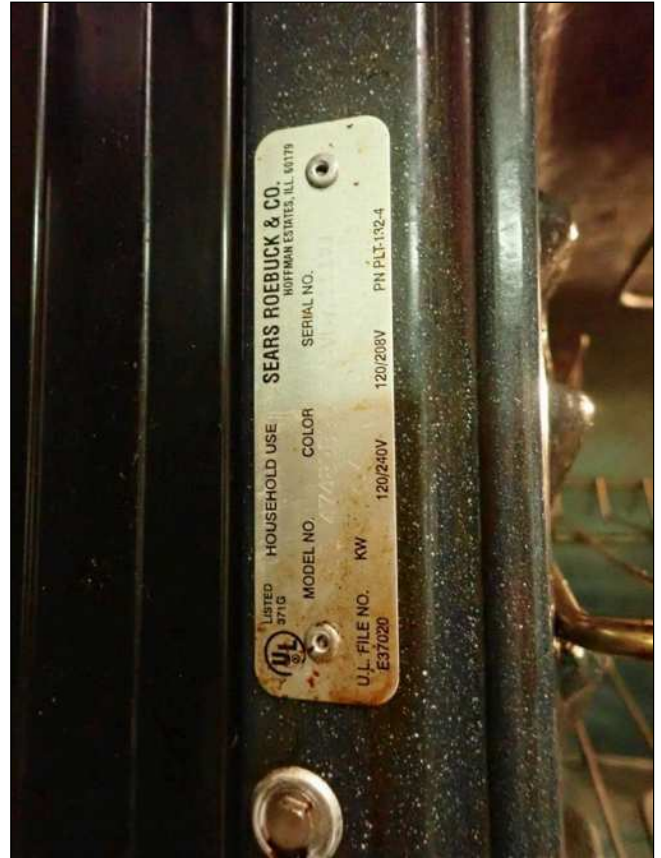
6.5 (1) ALTHOUGH UNIT WAS FUNCTIONAL AT TIME OF INSPECTION, UNIT HAS SURPASSED THE DESIGNED LIFE RANGE. IT IS RECOMMENDED TO ANTICIPATE REPAIR / REPLACEMENT NEEDS IN THE NEAR FUTURE. *Due to age of the*

unit, although standard functionality was achieved at time of inspection, unit & related components are at the end of their intended life span & may fail at any time.

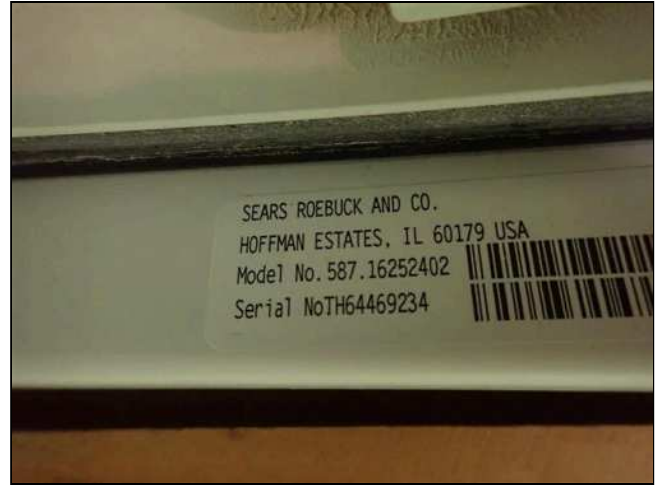
6.6 (2) UNIT MANUFACTURED 2006. ALTHOUGH UNIT WAS FUNCTIONAL AT TIME OF INSPECTION, UNIT HAS SURPASSED THE DESIGNED LIFE RANGE. IT IS RECOMMENDED TO ANTICIPATE REPAIR / REPLACEMENT NEEDS IN THE NEAR FUTURE. *Due to age of the unit, although standard functionality was achieved at time of inspection, unit & related components are at the end of their intended life span & may fail at any time.*

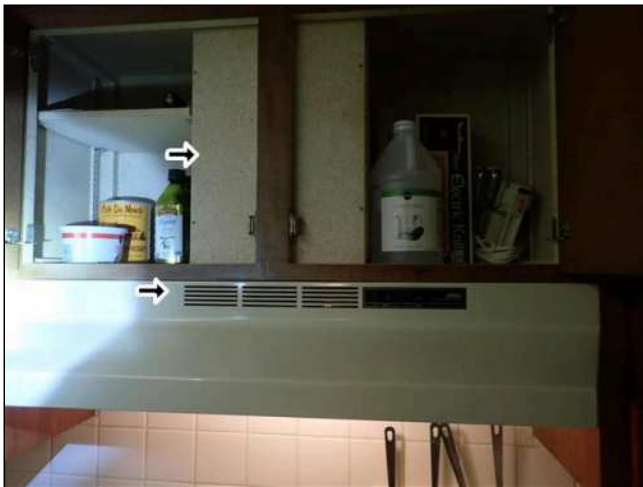
6.8 (Picture 1)

VENTILATOR IS A RE-CIRCULATING TYPE THAT IS NOT CONNECTED TO FLUE FOR EXHAUST VENTILATION. THERE IS NO REQUIREMENT TO HAVE A MECHANICAL EXHAUST WHEN ELECTRIC COOKING APPLIANCES ARE USED. SUGGEST HAVING A HANDYMAN OR A LICENSED CONTRACTOR EVALUATE AND REMEDY AS DESIRED.

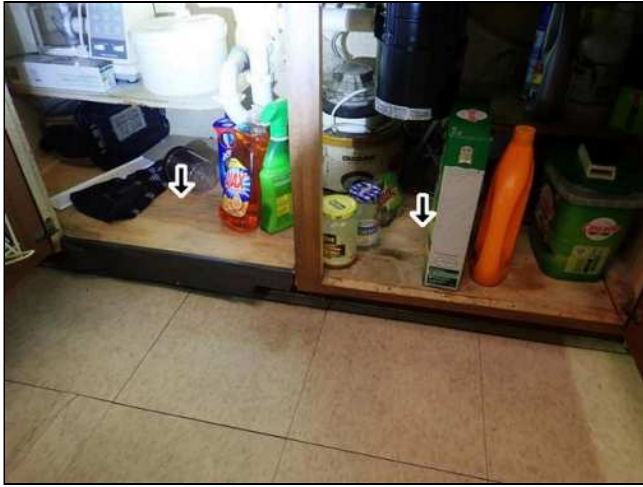
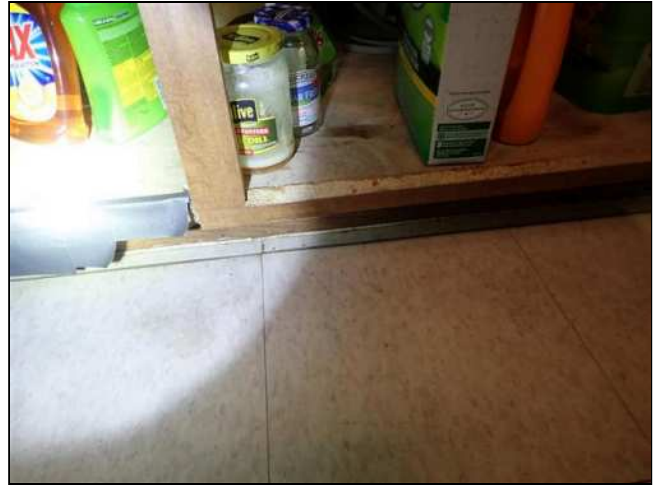
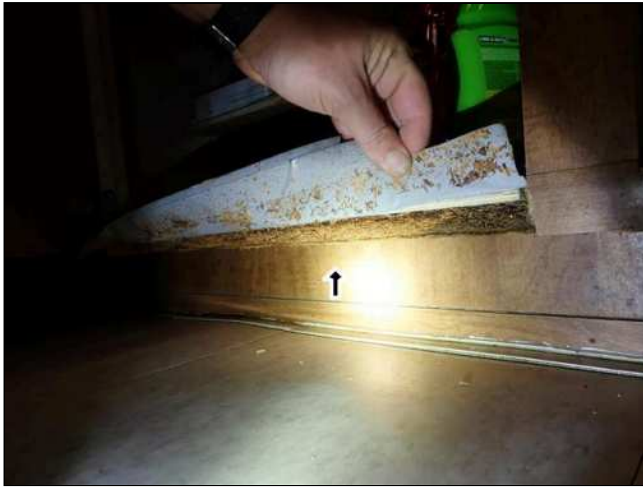
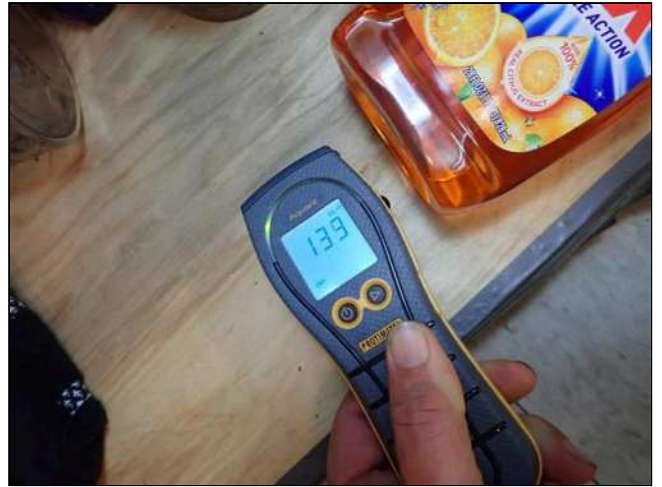
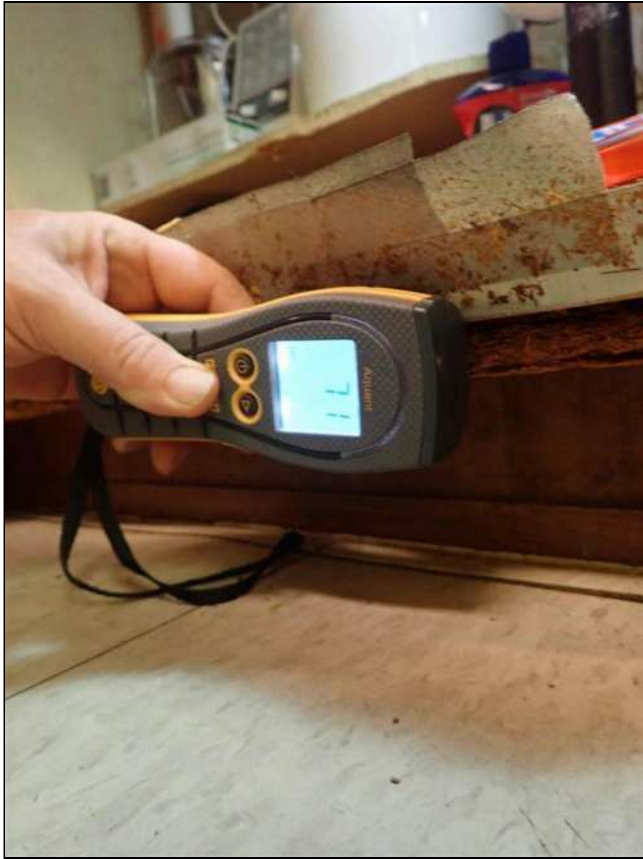
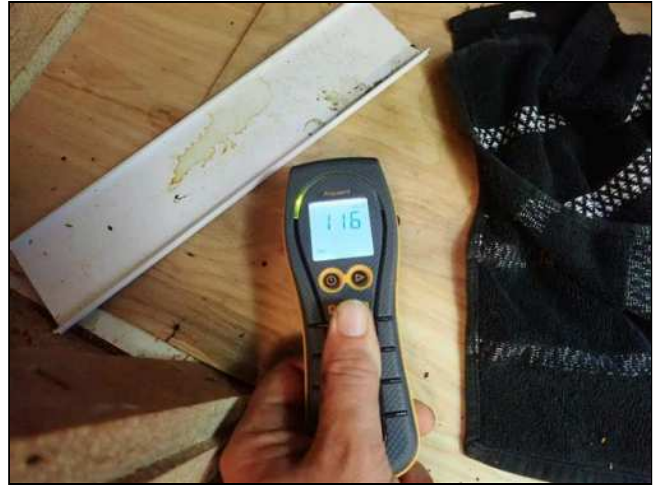
6.9 (1) PREVIOUS WATER DAMAGE AND WOOD DECAY OBSERVED AT BASE OF SINK CABINET. THE BOTTOM OF CABINET HAS BEEN PREVIOUSLY REPLACED WITH NEWER MATERIAL AND AREAS WHERE NEWER MATERIAL APPEARS SIMPLY PLACED ON TOP OF OLDER MATERIAL. AREAS TESTED DRY AT TIME OF INSPECTION USING A DIGITAL MOISTURE METER. *The condition of latent materials can not be seen and hidden damage may exist.*

SUGGEST HAVING A HANDYMAN OR A LICENSED CONTRACTOR EVALUATE AND REPAIR OR REPLACE AS NEEDED.

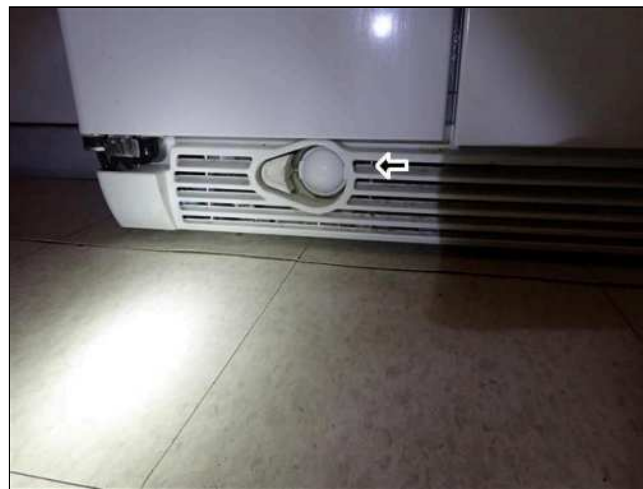
6.11 (2) IT APPEARS THAT A PORTION OF THE FILTER COVER/CAP PART OF THE FILTER RELEASE IS MISSING OR BROKEN. FILTER MAY BE DIFFICULT FOR REMOVAL. SUGGEST HAVING A LICENSED APPLIANCE SERVICE COMPANY OR CONTRACTOR EVALUATE AND REPAIR OR REPLACE AS NEEDED.

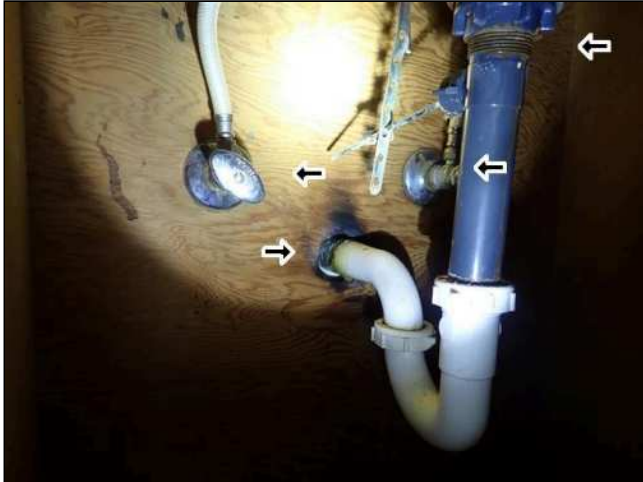
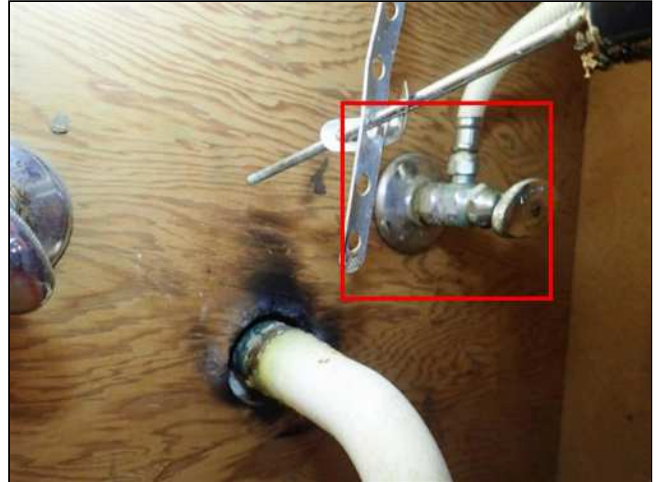
7.1 (1)

- CORROSION OBSERVED AT THE WATER SUPPLY SHUT-OFF VALVES AND/OR RELATED ELEMENTS. *No leaks observed at time of inspection; however, prolonged exposure to corrosion may result in premature wear / failure of affected components. Removal of corrosion may result in exposure of leak. Condition of latent materials was not visible & could not be fully inspected. Hidden damage may exist.*
- IMPROPER DRAIN LINE CONNECTION OBSERVED.
- EVIDENCE OF PREVIOUS DRAINAGE PROVISIONS LEAKS. *No leaks observed at time of inspection; however, moderate amount of water may be needed to expose leaks.*

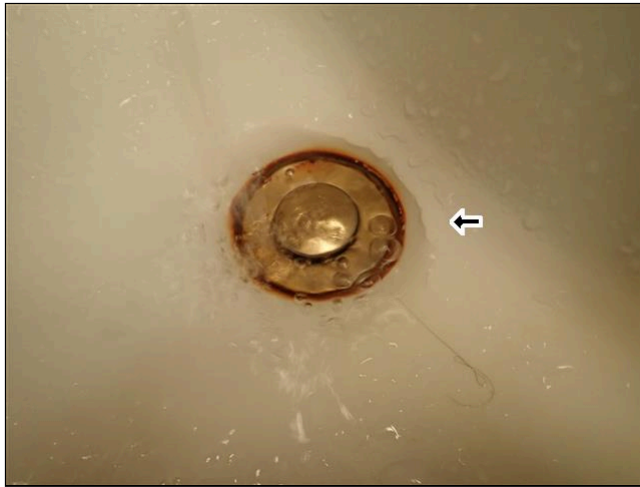
7.1 (3) RUST/CORROSION OBSERVED AT DRAIN OPENING AND DRAIN HARDWARE.

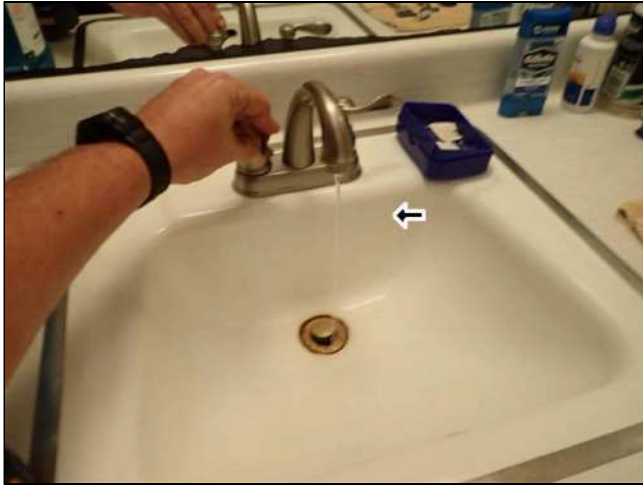
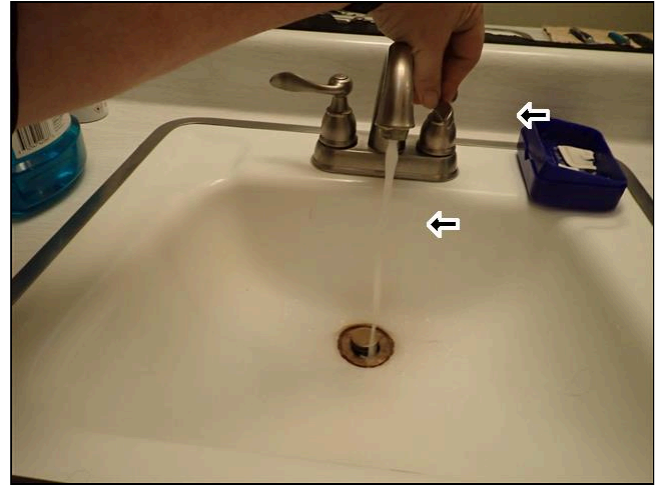
7.1 (4) HOT WATER PRESSURE IS POOR WHILE COLD WATER PRESSURE IS FAIR TO POOR. GALVANIZED WATER PIPING OBSERVED AT BATHROOMS AND KITCHEN. ALSO SEE PLUMBING COMMENTS. SUGGEST HAVING A LICENSED PLUMBER OR CONTRACTOR EVALUATE AND REPAIR OR REPLACE AS NEEDED.

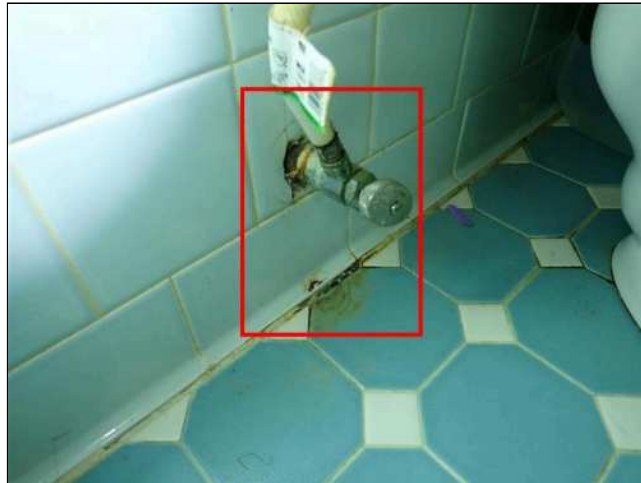
7.2 (1) CORROSION OBSERVED AT THE TOILET MAIN WATER SHUT-OFF VALVE AND/OR RELATED ELEMENTS. *Prolonged exposure to corrosion may result in premature wear / failure of components. No leaks observed at time of inspection; however, removal of corrosions may result in exposure of leak. Indications of previous leak(s) observed and hidden damage may exist.*

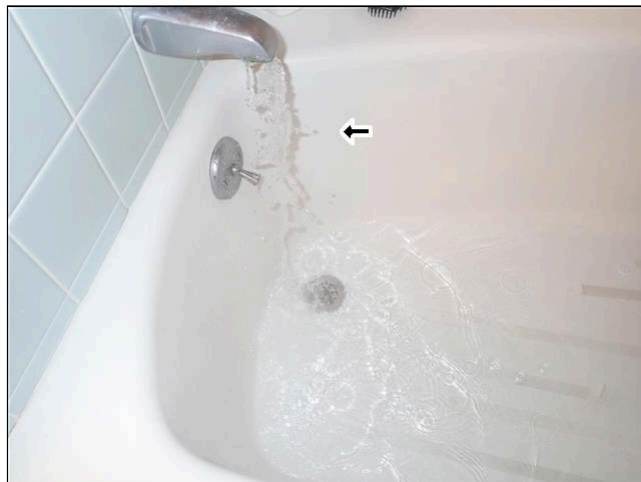
7.3 (1) WATER PRESSURE IS FAIR TO POOR AND POOR WITH ANOTHER FIXTURE RUNNING.

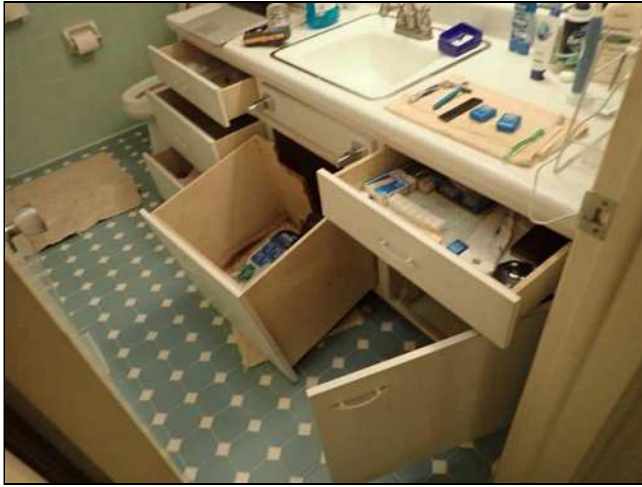
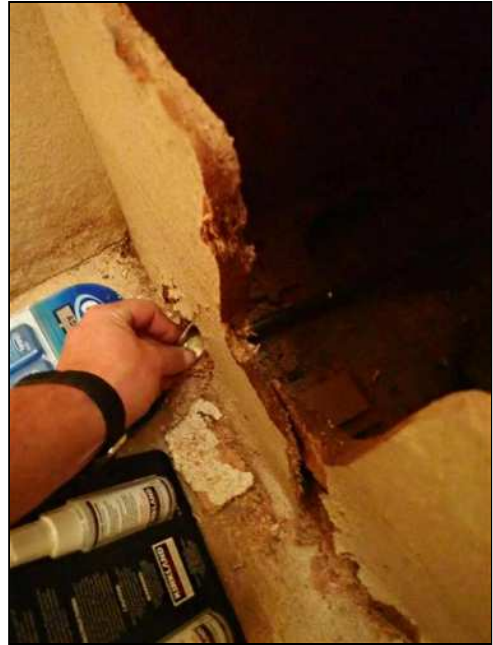
7.5 (1) EXCESSIVE DAMAGE HAS CAUSED THE BOTTOM DRAWER TO BECOME INOPERABLE.

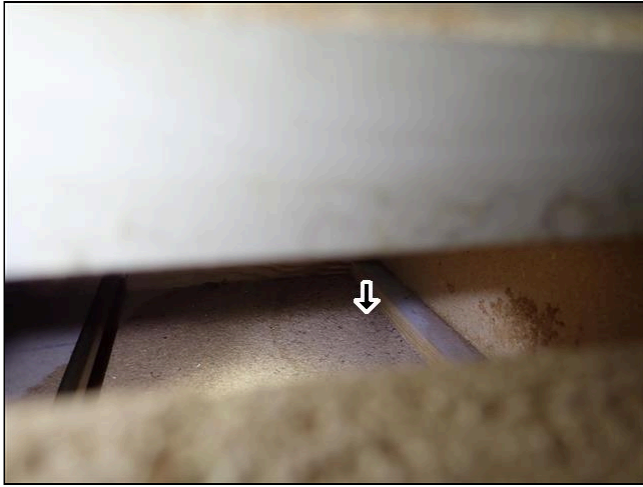
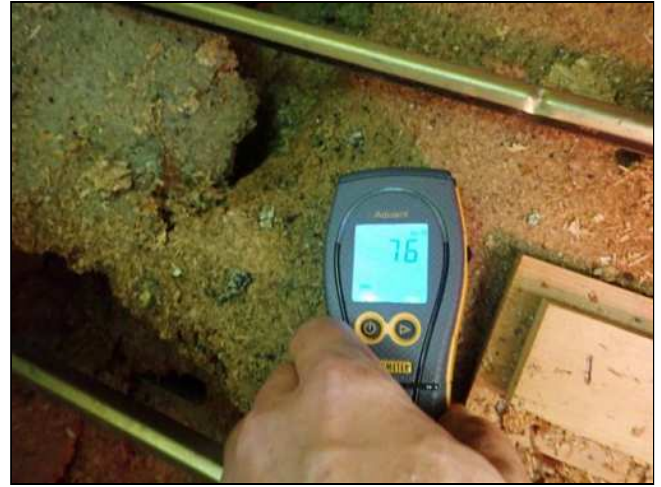
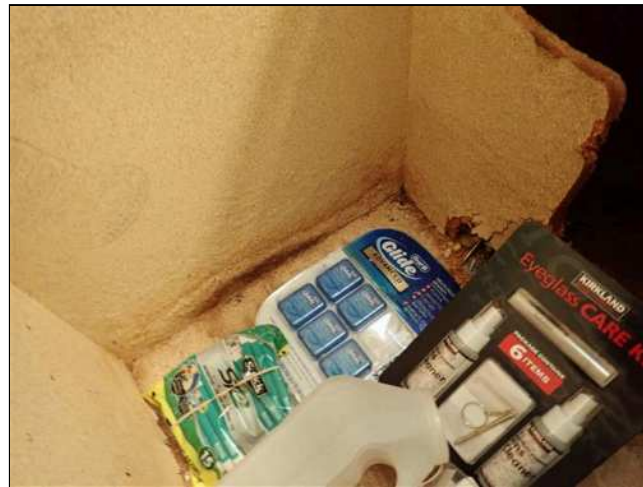
7.5 (2) EXCESSIVE WOOD DECAY AND MICROBIAL GROWTH OBSERVED. FLOORING DAMAGE AND DETERIORATION OBSERVED AT BELOW THE CABINET AND CRAWLSPACE AREA CAN BE SEEN WITH SEVERAL FLOOR JOISTS EXPOSED. *The condition of latent materials can not be seen and addition and/or hidden damage may exist.* AREAS TESTED DRY AT TIME OF INSPECTION USING A DIGITAL MOISTURE METER.

SUGGEST HAVING A LICENSED CONTRACTOR EVALUATE AND REPAIR OR REPLACE AS NEEDED.

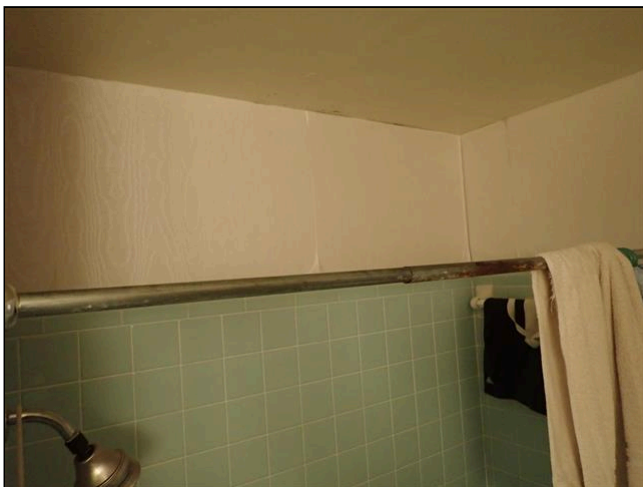
7.7 (Picture 1)

MICROBIAL GROWTH OBSERVED AT THE BATHROOM WALLS / CEILING. *Current condition is indicative of poor / improper ventilation of high moisture / humidity areas. Microbial growth may also hold excessive moisture against attached building materials potentially promoting premature wear / failure of affected components. The condition of latent materials can not be seen and hidden damage may exist.*

SUGGEST HAVING A LICENSED CONTRACTOR EVALUATE AND REPAIR OR REPLACE AS NEEDED.

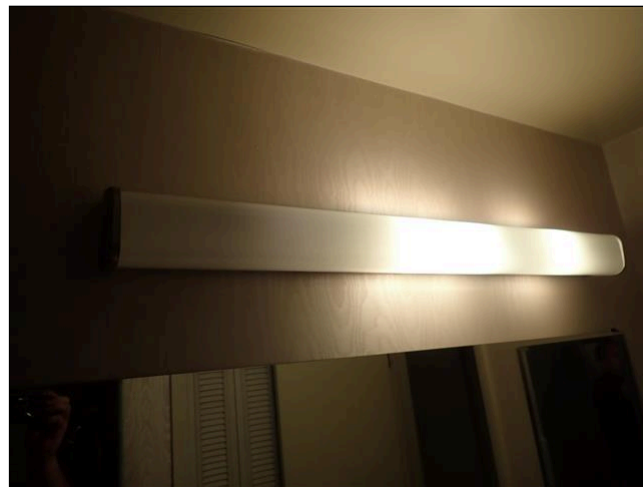
7.9 (2) SEVERAL VANITY LIGHTS NOT WORKING - BULBS? - POWER CONFIRMED.
SUGGEST HAVING A HANDYMAN OR A LICENSED CONTRACTOR EVALUATE AND REPAIR OR REPLACE AS NEEDED.

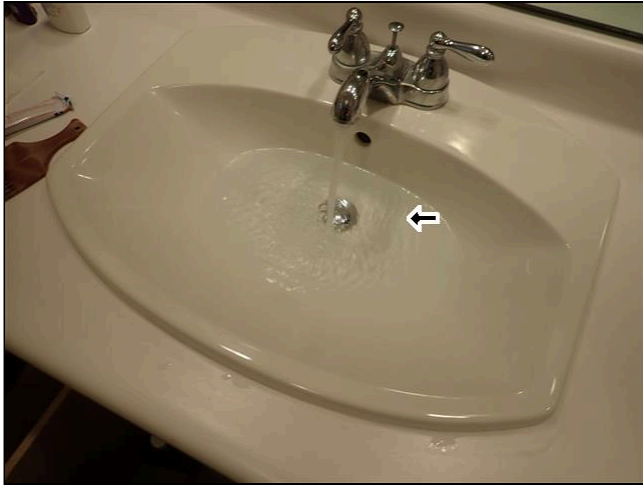
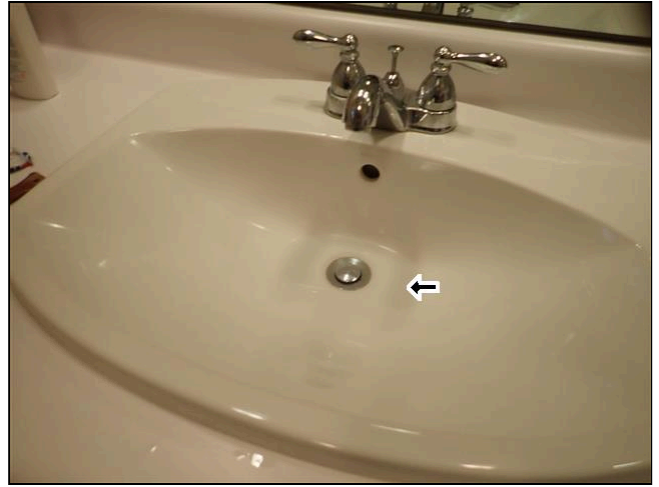
7.12 (1) SINK IS SLOW TO DRAIN. A slow or blocked drain may indicate a localized concern or may be related to the condition or flow of branch or main waste lines. A licensed plumbing contractor should be consulted in order to determine whether cleaning or other corrective measures are required.

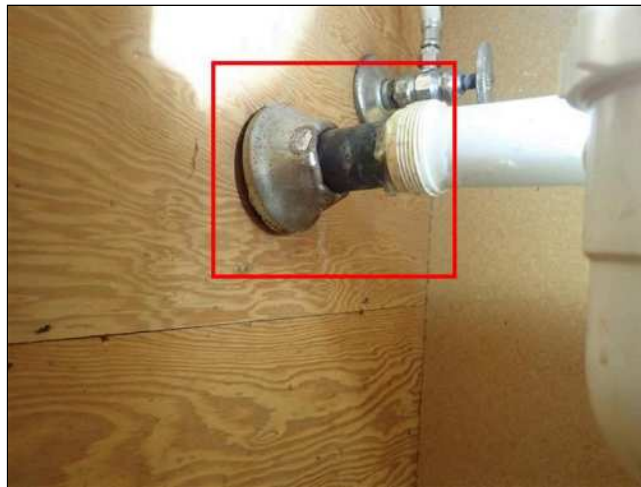
7.12 (2) EVIDENCE OF PREVIOUS DRAINAGE PROVISIONS LEAK(S). *No leak(s) observed at time of inspection; however, moderate amount of water may be needed to expose leak(s).*

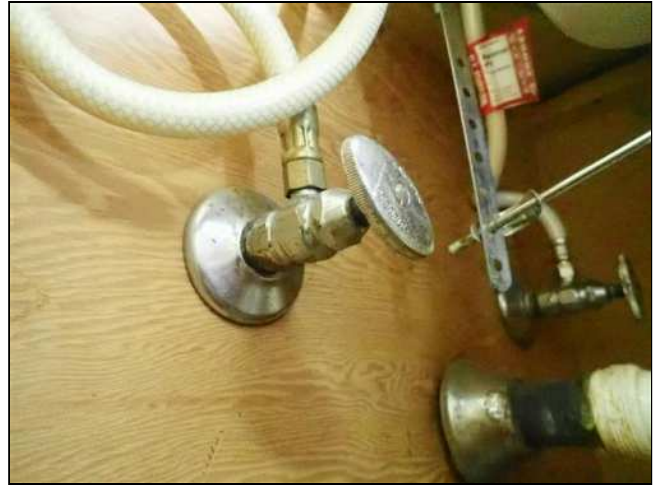
7.12 (3) CORROSION OBSERVED AT THE WATER SUPPLY SHUT-OFF VALVES AND/OR RELATED ELEMENTS. *No leaks observed at time of inspection; however, prolonged exposure to corrosion may result in premature wear / failure of affected components. Removal of corrosion may result in exposure of leak. Condition of latent materials was not visible & could not be fully inspected. Hidden damage may exist.*

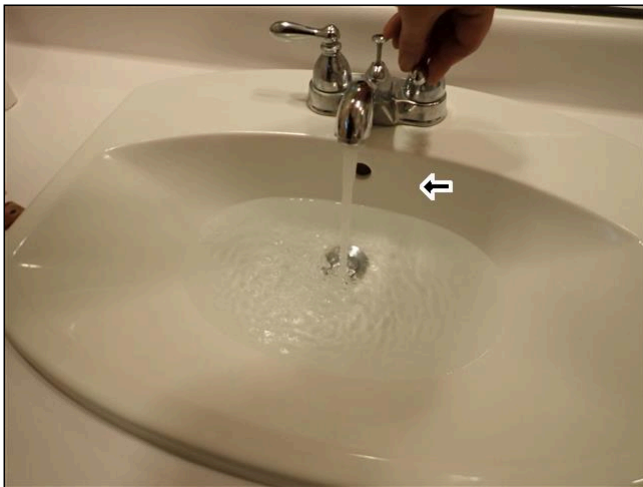
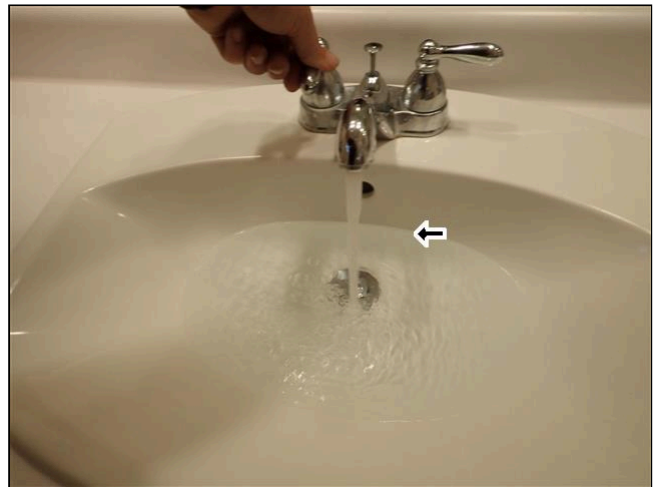
7.12 (4) HOT AND COLD WATER PRESSURE IS FAIR THEN POOR WITH 2 OR MORE FIXTURES RUNNING. ALSO SEE PLUMBING COMMENTS.
SUGGEST HAVING A LICENSED PLUMBER OR CONTRACTOR EVALUATE AND REPAIR OR REPLACE AS NEEDED.
