INSPECTION INFORMATION

Standard Home Inspection

Single Family Dwelling

51 Years

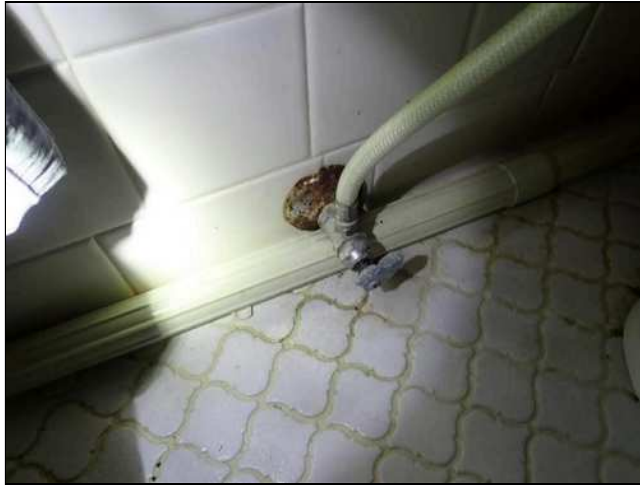
7.13 (1) BROKEN CONTROL KNOB AND CORROSION OBSERVED AT THE TOILET MAIN WATER SHUT-OFF VALVE AND/OR RELATED ELEMENTS. *Prolonged exposure to corrosion may result in premature wear / failure of components. Active leak observed at time of inspection; however, removal of corrosions may result result in exposure of the leak.*

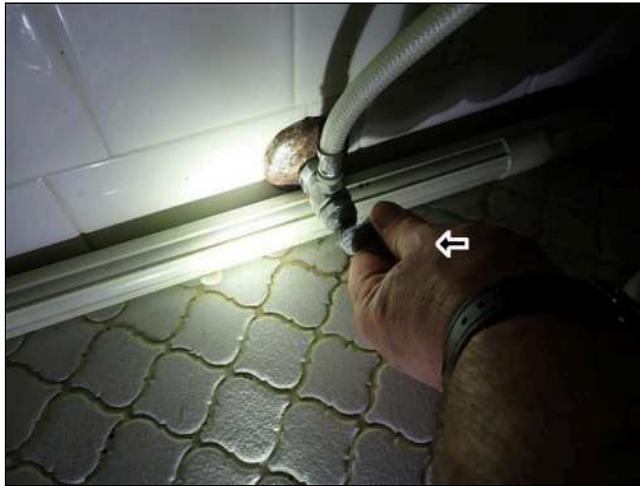
7.13 (2) MAIN WATER SHUT-OFF VALVE IS STUCK / FROZEN IN THE **OPEN** POSITION. Shut-off valves often freeze in place due to lack of use movement. Shut-off valves should not be forced due to possibility of damage / leak. It may be difficult to shut down individual water supply lines in the case of repair or damage.

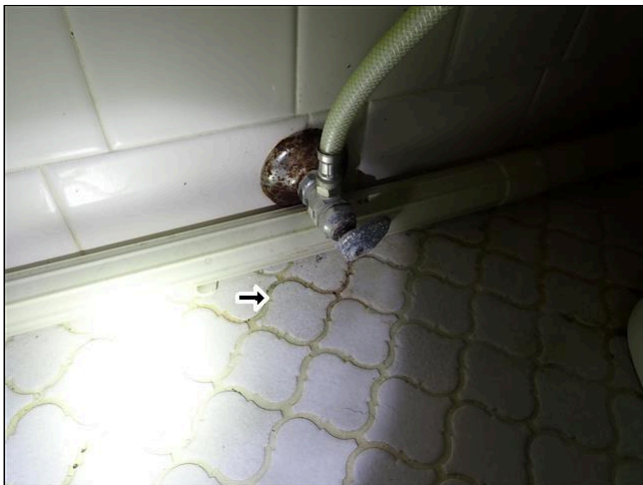
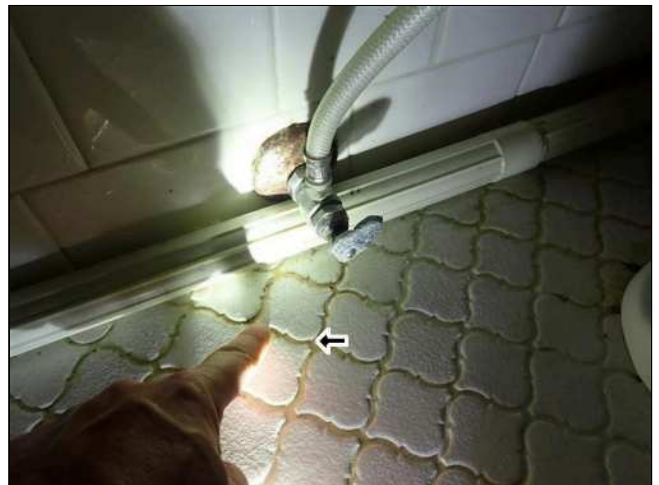
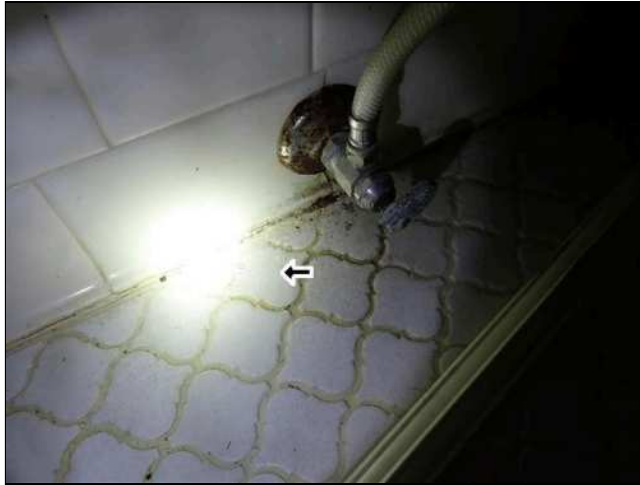
7.13 (3) ACTIVE LEAK OBSERVED AT THE TOILET WATER SHUT OFF VALVE. WATER WAS OBSERVED SITTING ON THE FLOOR BELOW VALVE. SUGGEST HAVING A LICENSED CONTRACTOR EVALUATE AND REPAIR OR REPLACE AS NEEDED.

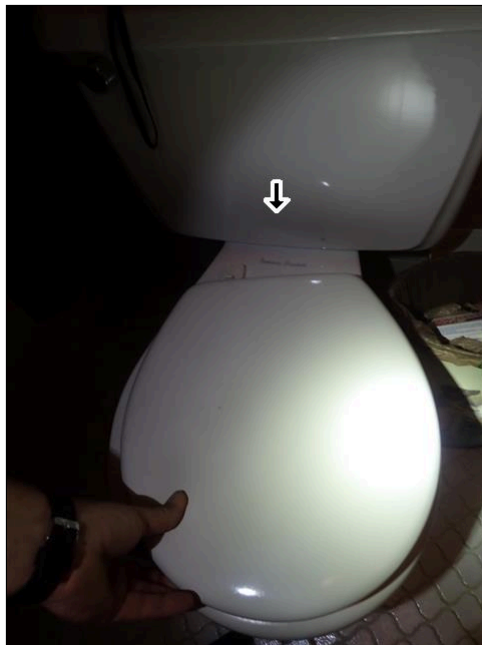
7.13 (4) TOILET SEAT WAS FOUND BROKEN AT TIME OF INSPECTION.

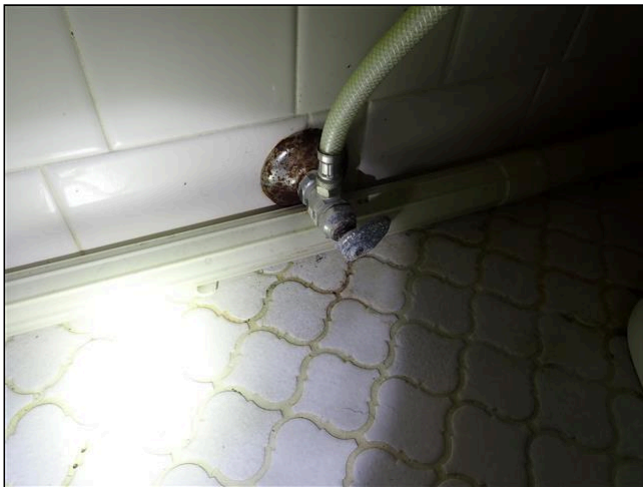
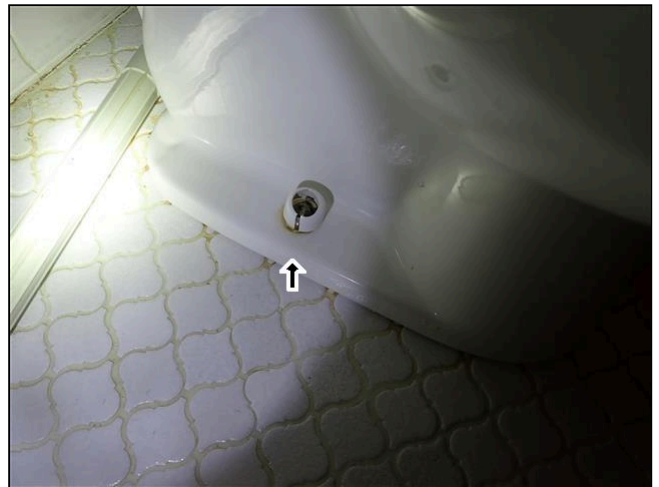
7.13 (6) CORROSION OBSERVED AT THE TOILET MAIN WATER SHUT-OFF VALVE AND/OR RELATED ELEMENTS. Prolonged exposure to corrosion may result in premature wear / failure of components. No leaks observed at time of inspection; however, removal of corrossions may result result in exposure of leak.

SUGGEST HAVING A LICENSED PLUMBER OR CONTRACTOR EVALUATE AND REPAIR OR REPLACE AS NEEDED.

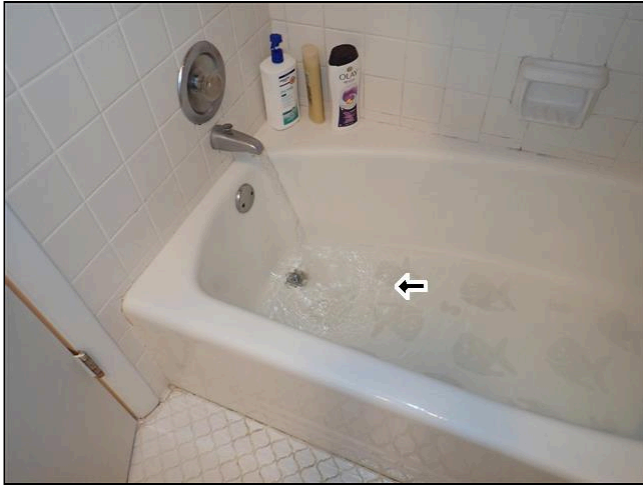
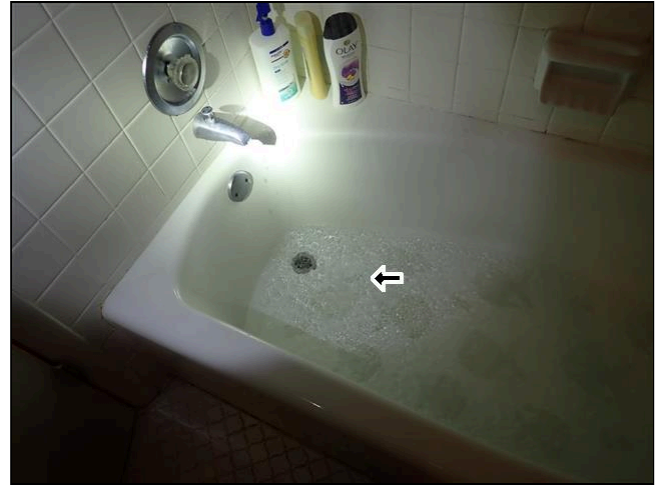
7.14 (1) BATHTUB IS VERY SLOW TO DRAIN. A slow or blocked drain may indicate a localized concern or may be related to the condition or flow of branch or main waste lines. A licensed plumbing contractor should be consulted in order to determine whether cleaning or other corrective measures are required.

SUGGEST HAVING A HANDYMAN OR A LICENSED CONTRACTOR EVALUATE AND REPAIR AS NEEDED.

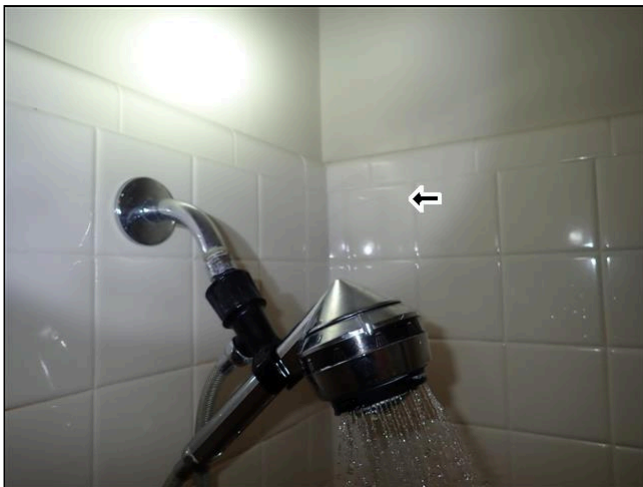
7.15 (Picture 1)

SEVERAL CRACKED/BROKEN TILES OBSERVED AND SEVERAL OPENINGS SEEN IN THE GROUT/CAULK LINES OF SEVERAL CORNER TILES. TILES SHOULD BE REPAIRED OR RE-SEALED TO PREVENT THE INTRUSION OF WATER. *The condition of latent materials can not be seen and hidden damage may exist.*

SUGGEST HAVING A HANDYMAN OR A LICENSED CONTRACTOR EVALUATE AND REPAIR AS NEEDED.

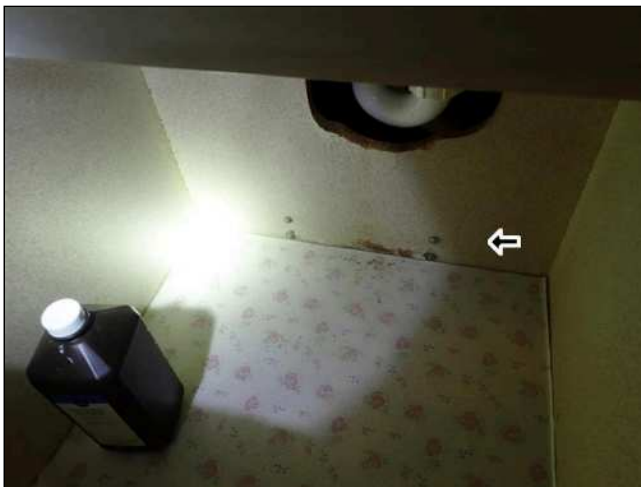
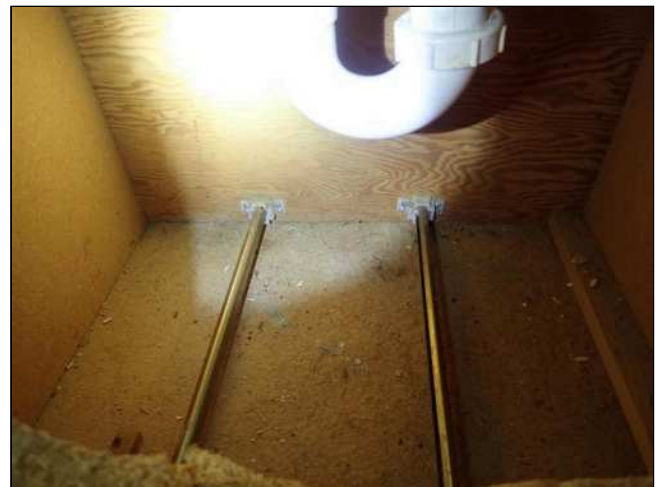
7.16 (1) PREVIOUS WATER DAMAGE AND WOOD DECAY OBSERVED AT BASE OF SINK CABINET AND DRAWER. SUGGEST HAVING A HANDYMAN OR A LICENSED CONTRACTOR EVALUATE AND REPAIR OR REPLACE AS NEEDED.

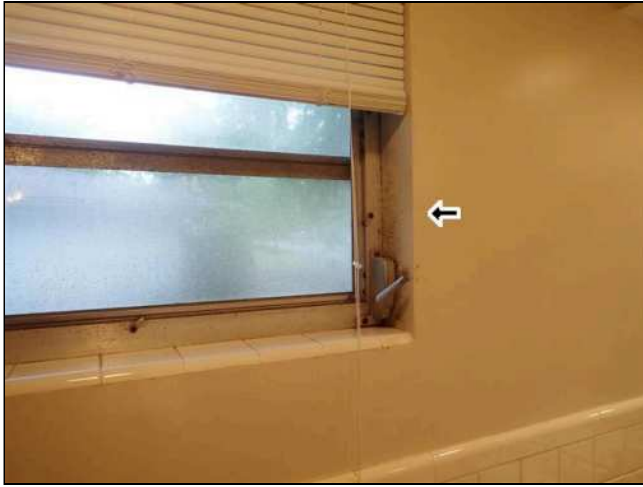
7.18 (Picture 1)

MICROBIAL GROWTH OBSERVED AT THE BATHROOM WALLS / CEILING. *Current condition is indicative of poor / improper ventilation of high moisture / humidity areas. Areas tested wet at time of inspection. Microbial growth may also hold excessive moisture against attached building materials potentially promoting premature wear / failure of affected components. The condition of latent materials can not be seen and hidden damage may exist.*

SUGGEST HAVING A LICENSED CONTRACTOR EVALUATE AND REPAIR OR REPLACE AS NEEDED.

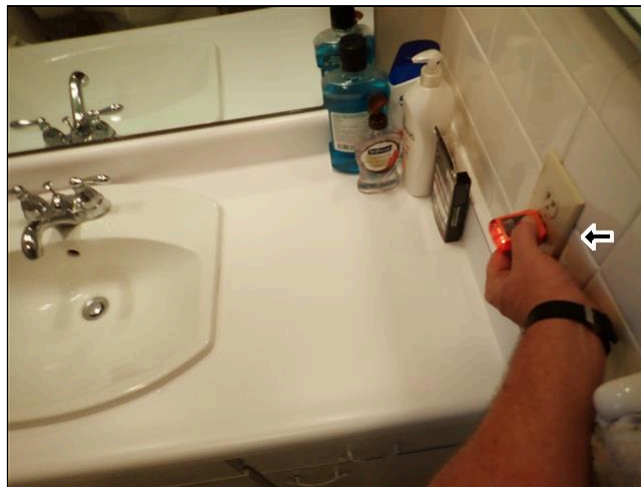
7.20 (Picture 1)

BATHROOM OUTLETS ARE NOT GFCI PROTECTED / DID NOT TRIP WHEN MANUALLY TESTED. *According to the National Electric Code, All homes built after 1975 should have GFCI protection at all outlets in the bathroom. Due to age of home, no updates are required as the home is **grand-fathered** into previous code. However, for protection of the home occupants, it is recommend to add GFCI protection at all bathroom outlets.*

SUGGEST HAVING A HANDYMAN OR A LICENSED CONTRACTOR EVALUATE AND REMEDY AS NEEDED.

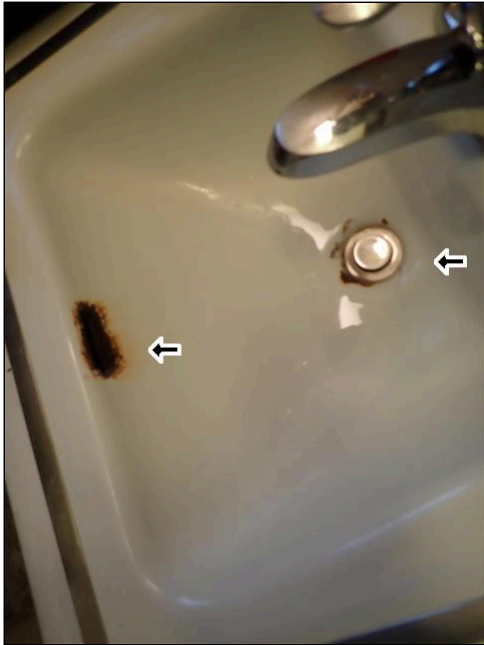
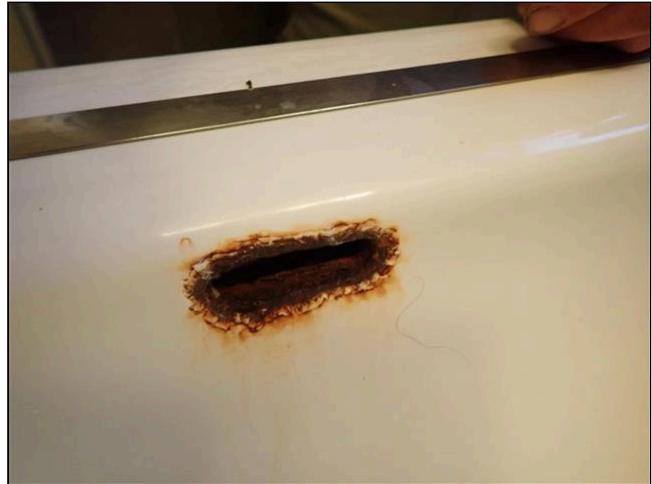
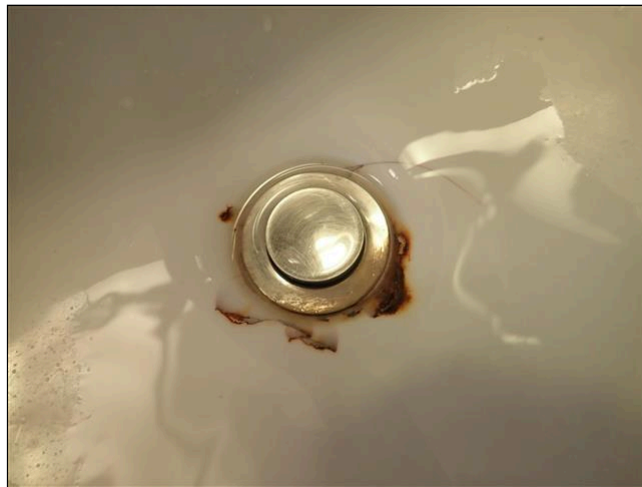
7.22 (1) RUST/CORROSION OBSERVED AT BASE OF SINK AND AT SINK OVER-FLOW. SINK APPEARS TO BE BROKEN AT BASE OF BOWL AND WHAT APPEARS TO BE A PREVIOUS REPAIR ATTEMPT.

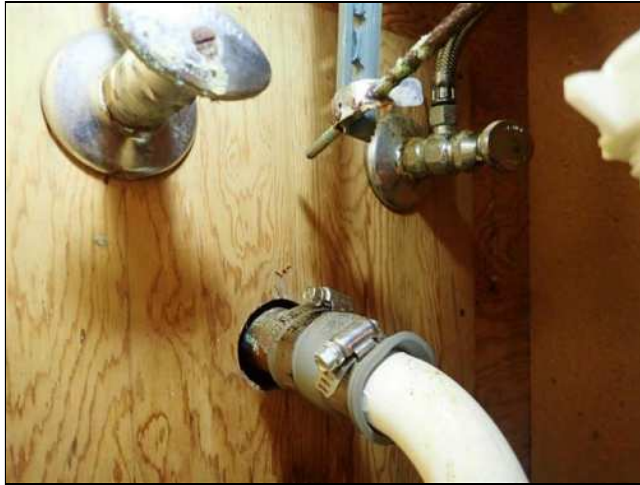
7.22 (2) CORROSION OBSERVED AT THE WATER SUPPLY SHUT-OFF VALVES AND/OR RELATED WATER PIPING, SINK, AND DRAIN LINE ELEMENTS. *No leaks observed at time of inspection; however, prolonged exposure to corrosion may result in premature wear / failure of affected components. Removal of corrosion may result in exposure of leak. Condition of latent materials was not visible & could not be fully inspected. Hidden damage may exist.*

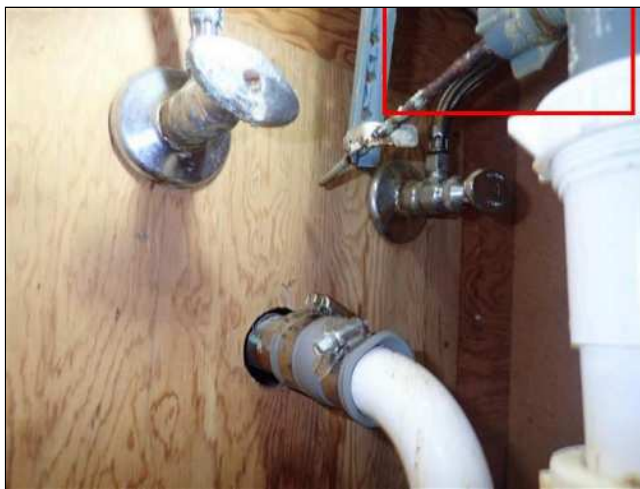
7.22 (3) EVIDENCE OF PREVIOUS DRAINAGE PROVISIONS LEAK(S). No leak(s) observed at time of inspection; however, moderate amount of water may be needed to expose leak(s).

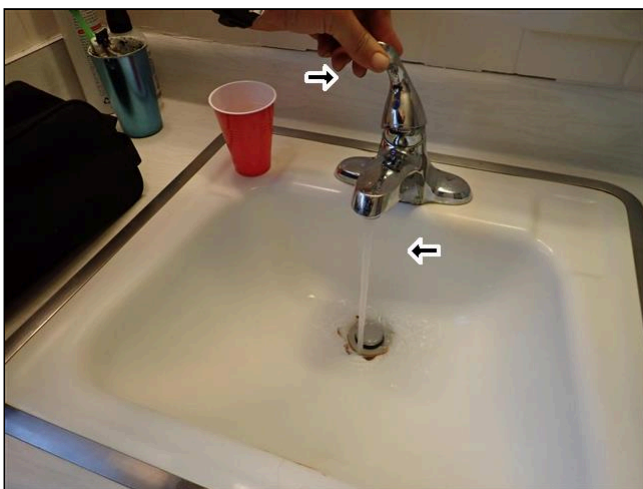
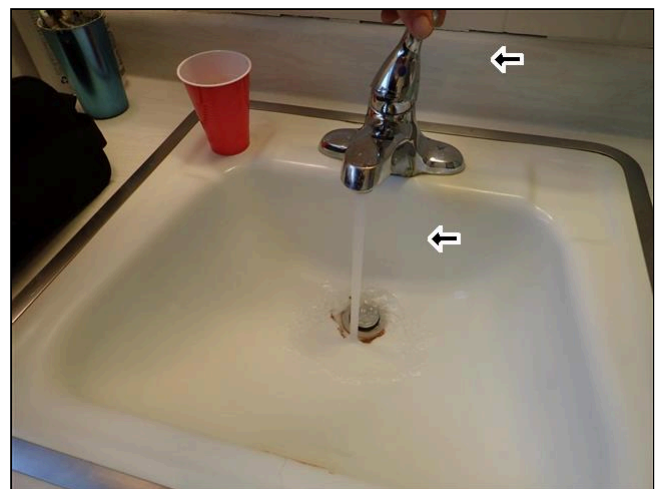
7.22 (4) HOT AND COLD WATER PRESSURE IS FAIR THEN POOR WITH 2 OR MORE FIXTURES RUNNING. ALSO SEE PLUMBING COMMENTS. SUGGEST HAVING A LICENSED PLUMBER OR CONTRACTOR EVALUATE AND REPAIR OR REPLACE AS NEEDED.

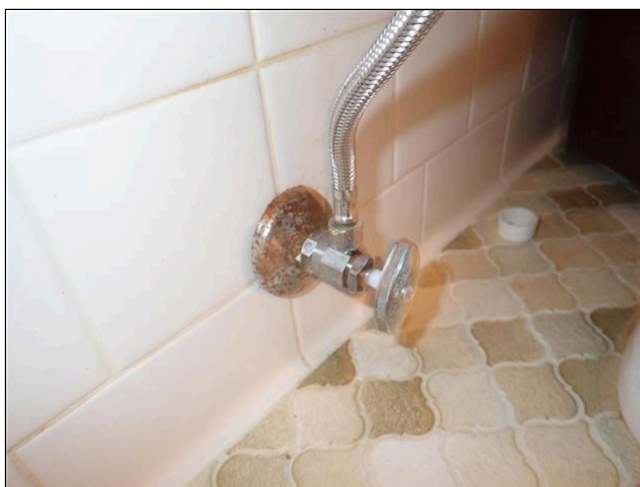
7.23 (Picture 1)

CORROSION OBSERVED AT THE TOILET MAIN WATER SHUT-OFF VALVE AND/OR RELATED ELEMENTS. Prolonged exposure to corrosion may result in premature wear / failure of components. No leaks observed at time of inspection; however, removal of corrosions may result result in exposure of leak.

SUGGEST HAVING A HANDYMAN OR A LICENSED CONTRACTOR EVALUATE AND REPAIR OR REPLACE AS NEEDED.

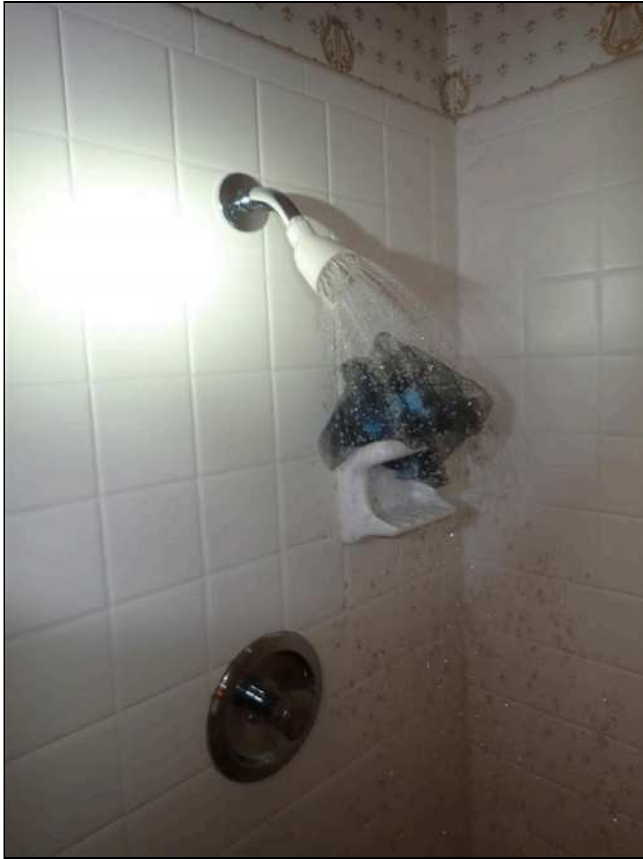
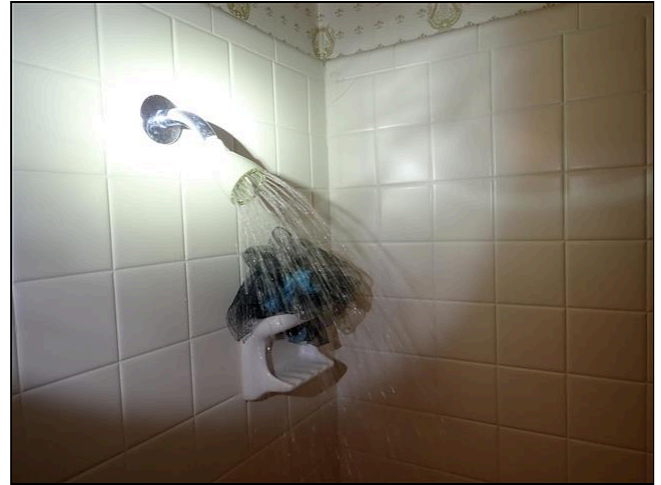
7.24 (2) WATER PRESSURE IS POOR. ALSO SEE RELATED PLUMBING COMMENTS THROUGHOUT REPORT. SUGGEST HAVING A LICENSED PLUMBER OR CONTRACTOR EVALUATE AND REPAIR OR REPLACE AS NEEDED.

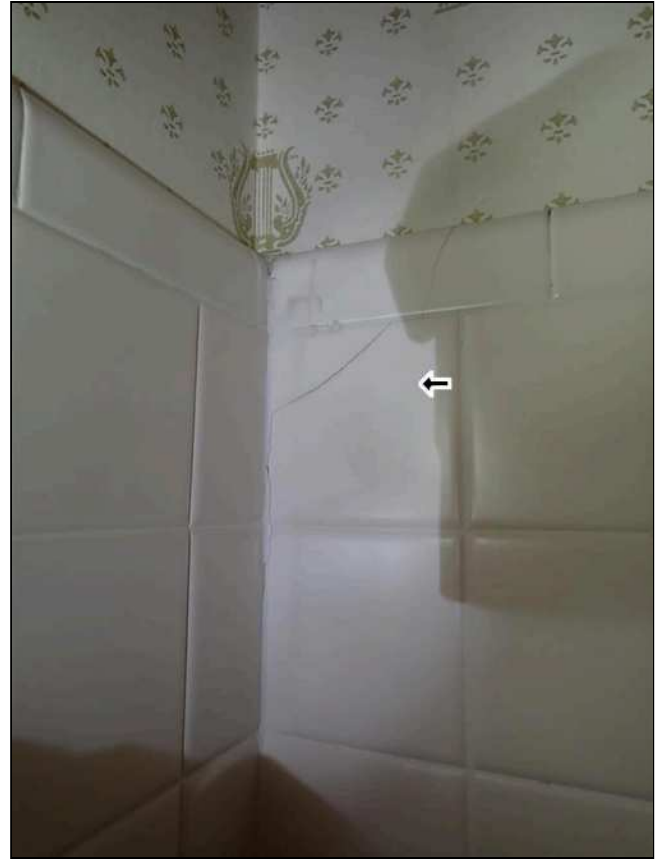
7.25 (Picture 2)

SEVERAL CRACKED WALL TILES OBSERVED.

SUGGEST HAVING A HANDYMAN OR A LICENSED CONTRACTOR EVALUATE AND REPAIR OR REPLACE AS NEEDED.

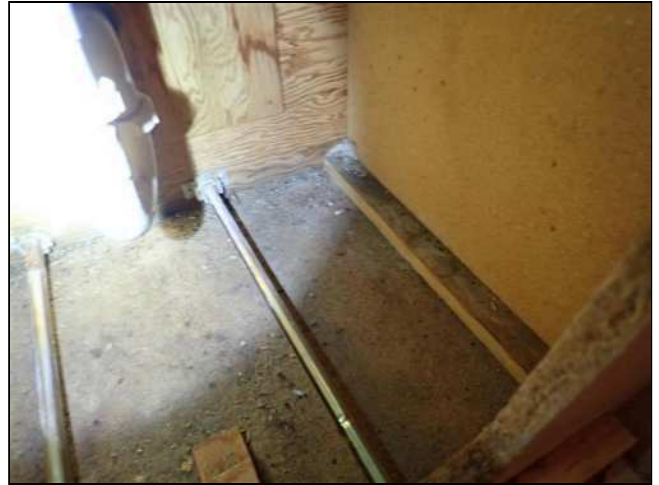
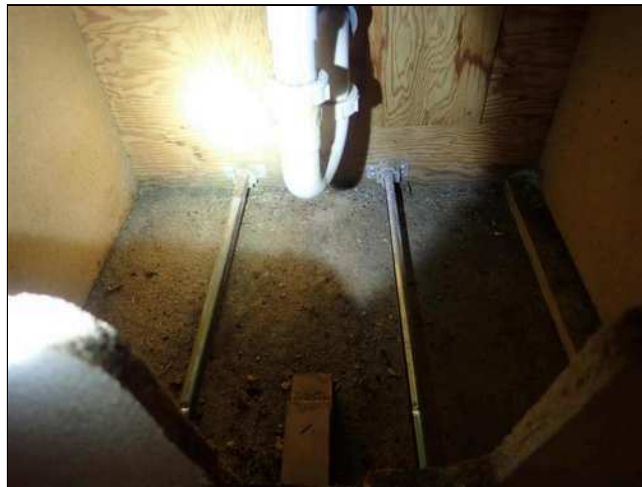
7.26 (1) PREVIOUS WATER DAMAGE, WOOD DECAY, AND MICROBIAL GROWTH OBSERVED AT BASE OF SINK CABINET AND DRAWER.

SUGGEST HAVING A HANDYMAN OR A LICENSED CONTRACTOR EVALUATE AND REPAIR OR REPLACE AS NEEDED.

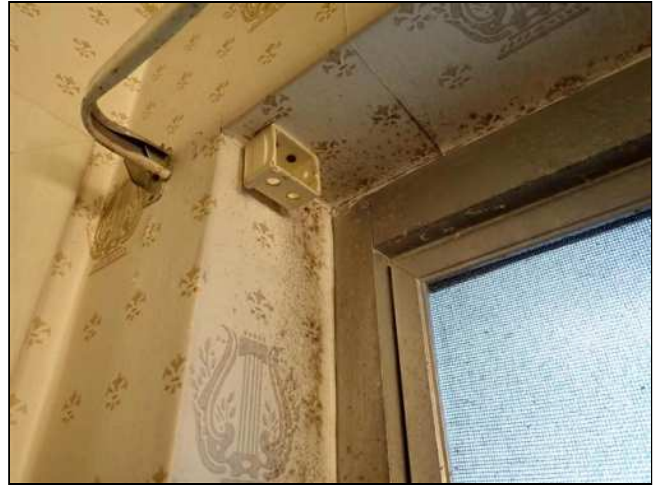
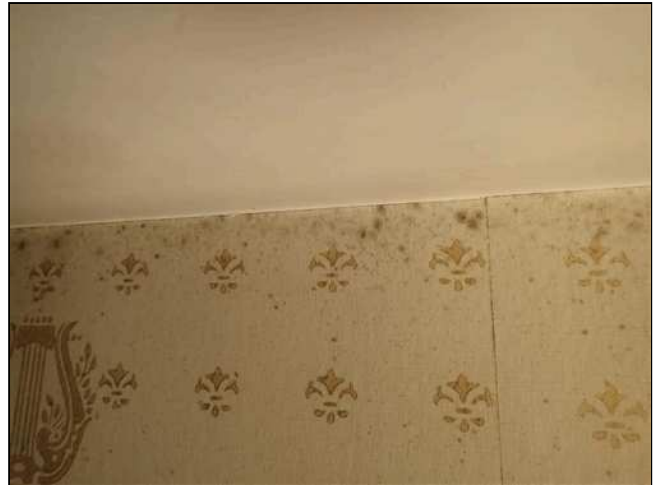
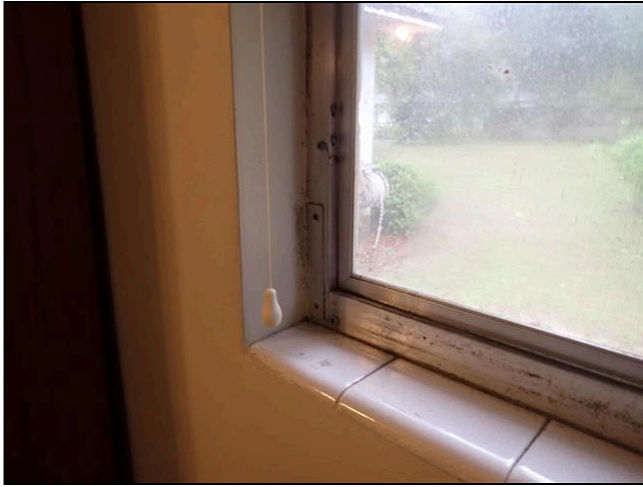
7.27 (1) MICROBIAL GROWTH OBSERVED AT THE BATHROOM WALLS / CEILING. *Current condition is indicative of poor / improper ventilation of high moisture / humidity areas. Microbial growth may also hold excessive moisture against attached building materials potentially promoting premature wear / failure of affected components. The condition of latent materials can not be seen and hidden damage may exist.*

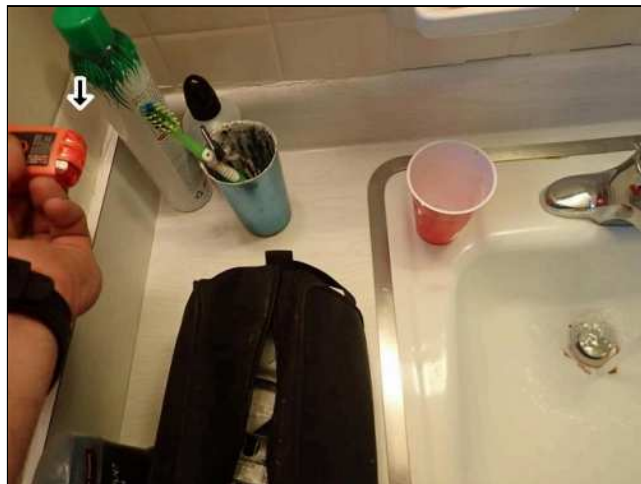
7.28 (Picture 1)

BATHROOM OUTLETS ARE NOT GFCI PROTECTED / DID NOT TRIP WHEN MANUALLY TESTED. *According to the National Electric Code, All homes built after 1975 should have GFCI protection at all outlets in the bathroom. Due to age of home, no updates are required as the home is **grand-fathered** into previous code. However, for protection of the home occupants, it is recommend to add GFCI protection at all bathroom outlets.*

SUGGEST HAVING A HANDYMAN OR A LICENSED CONTRACTOR EVALUATE AND REMEDY AS NEEDED.

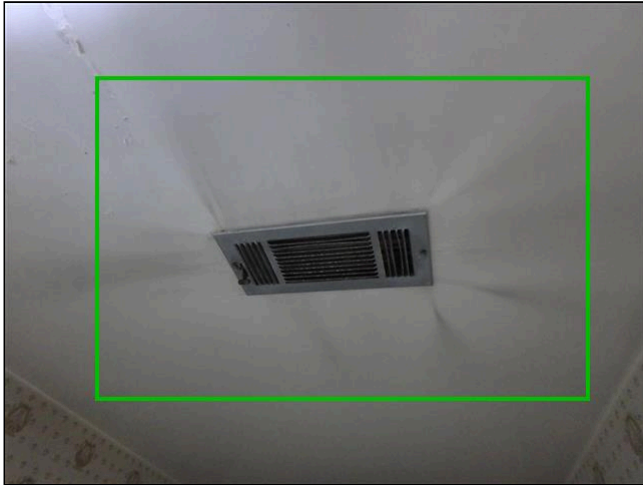
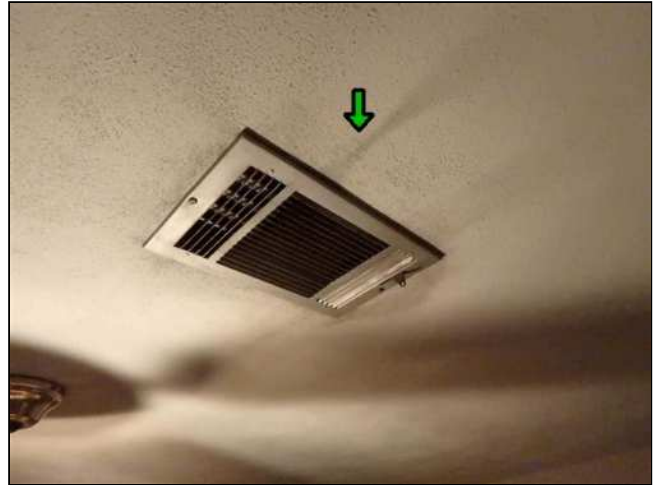
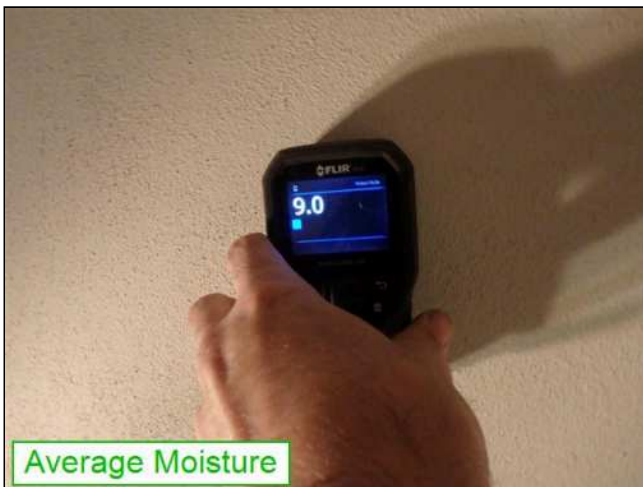
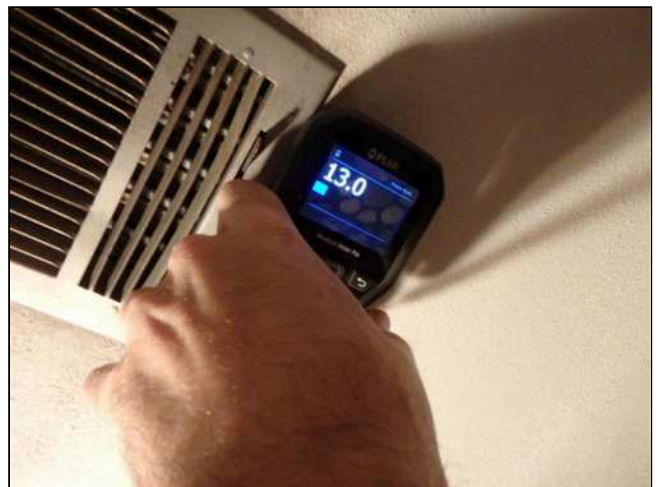
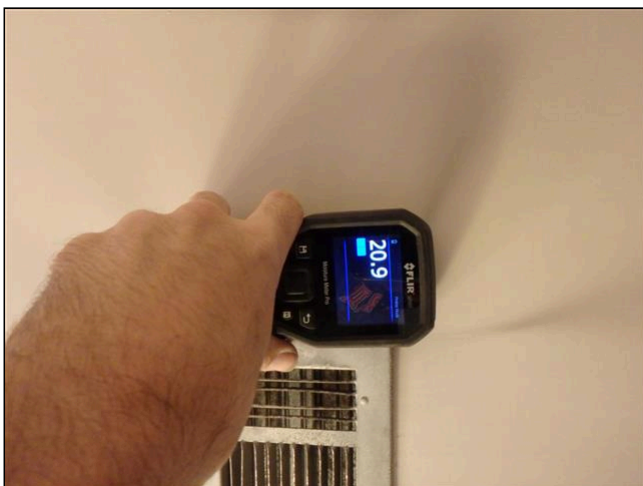
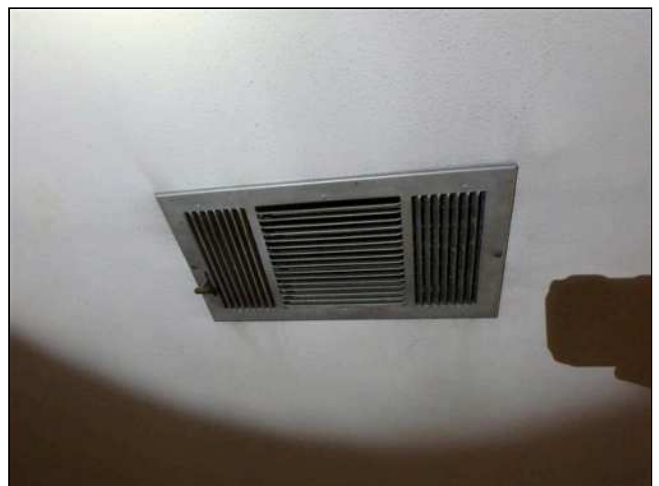
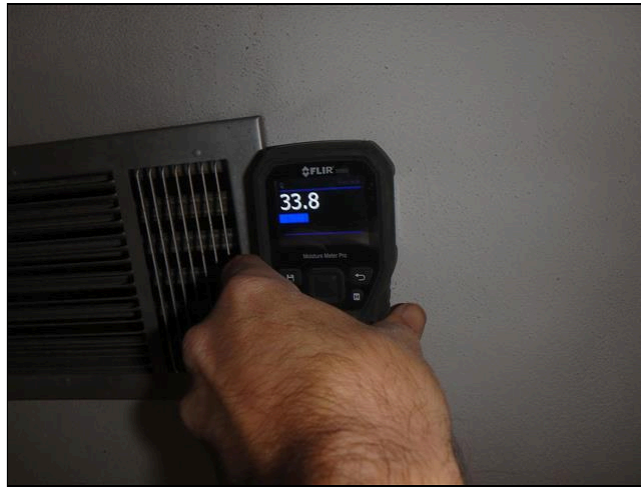
8.0 (1) STAINING OBSERVED ADJACENT TO SEVERAL AIR VENTS / REGISTERS. *Condition may be an indication of dirty*

ductwork and/or ductwork leaks .

AREAS TESTED HIGHER THAN AVERAGE (MODERATE) FOR MOISTURE, USING A DIGITAL MOISTURE METER AT TIME OF INSPECTION.

RECOMMEND HAVING A LICENSED HANDYMAN EVALUATE AND REPAIR AS NEEDED.

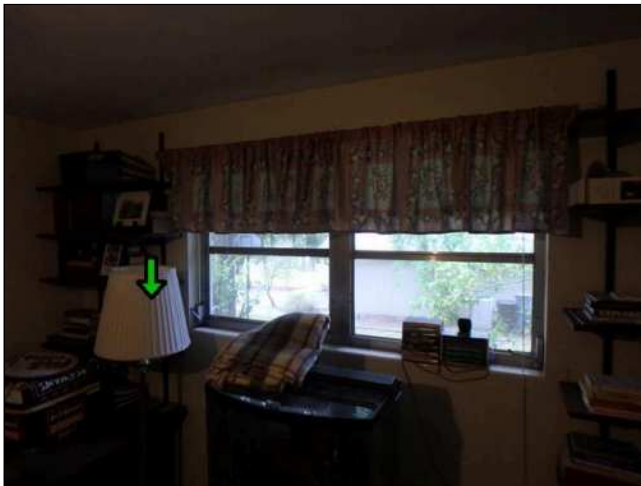
8.1 (Picture 1)

EXCESSIVE DIAGONAL CRACKING OBSERVED AT THE WALL ADJACENT TO CENTER LEFT SIDE BEDROOM WINDOW. *Diagonal cracking is an indication of settlement and/or moving of materials. Extent of settlement could not be determined at time of inspection.*

RECOMMEND HAVING A LICENSED CONTRACTOR OR LICENSED STRUCTURAL ENGINEER EVALUATE AND REPAIR AS NEEDED.

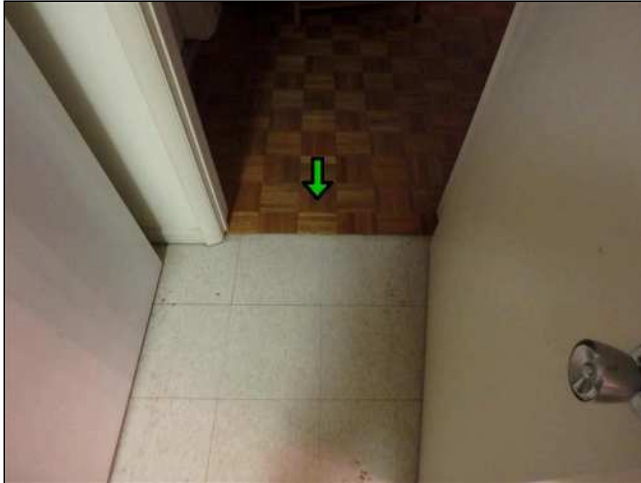
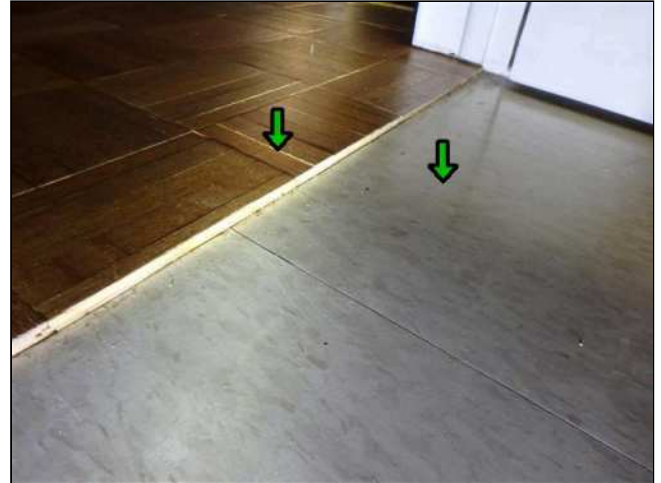
8.2 (1) MISSING FLOORING TRANSITION OBSERVED AT THE KITCHEN FAMILY ROOM DOOR WAY. UNEVEN SURFACES WERE ALSO OBSERVED. *Uneven surfaces may pose a trip / injury hazard.*

RECOMMEND HAVING A LICENSED HANDYMAN EVALUATE AND REPAIR AS NEEDED.

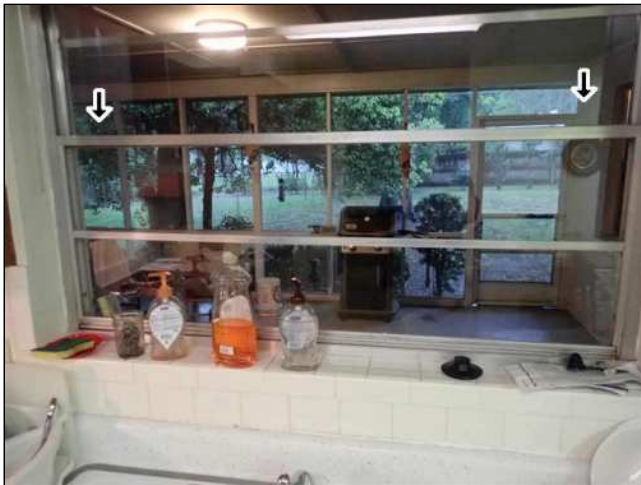
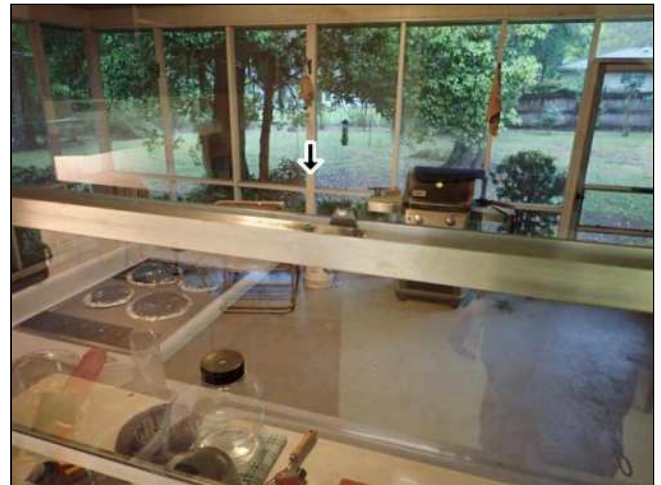
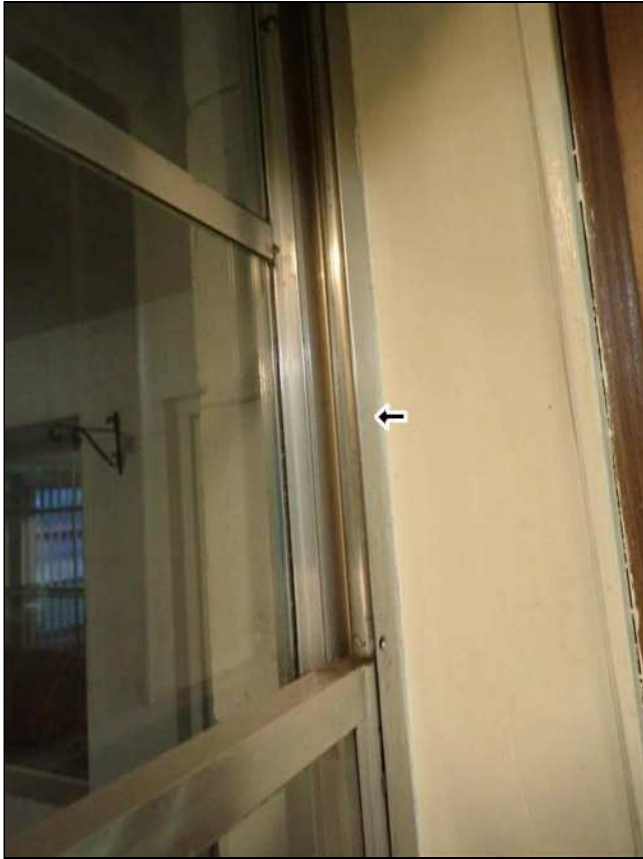
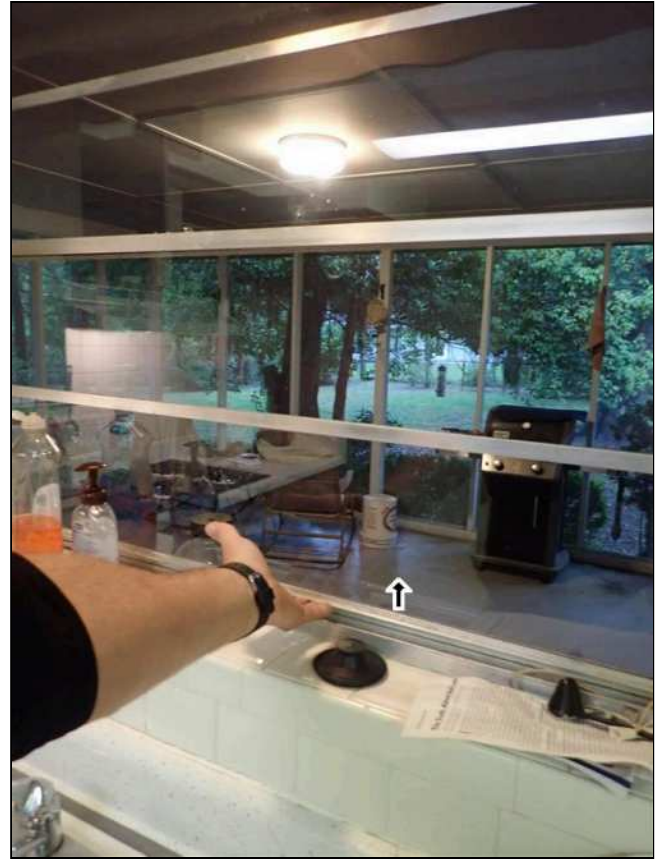
8.3 (1) KITCHEN WINDOW WAS FOUND CLOSED CROOKED AND WAS OBSERVED TO HAVE A BROKEN/MISSING LOCK AS WELL AS BROKEN BALANCER/SPRING AT RIGHT SIDE. WINDOW WOULD NOT OPEN AT TIME OF INSPECTION.

RECOMMEND HAVING A LICENSED HANDYMAN OR LICENSED WINDOW COMPANY EVALUATE AND REPAIR AS NEEDED.

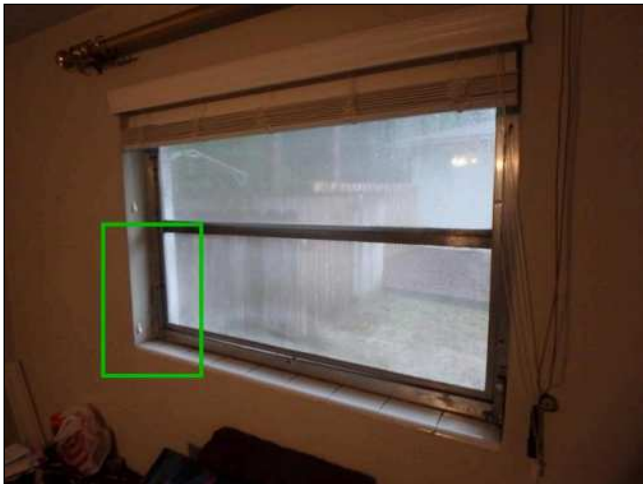
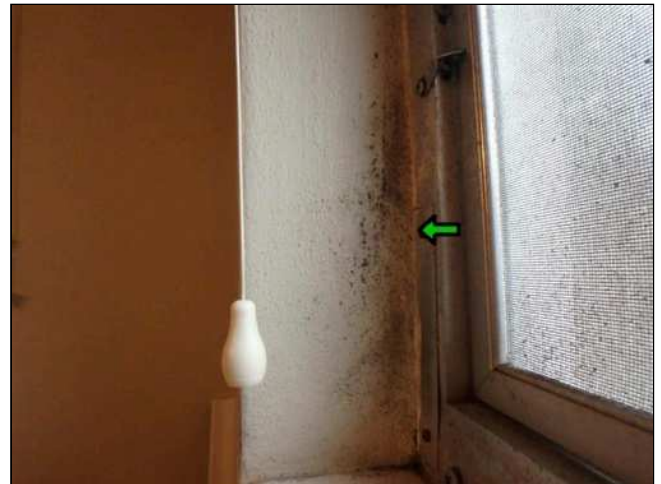
8.3 (2) MICROBIAL GROWTH / MILDEW OBSERVED AT THE RIGHT SIDE WINDOW OF RIGHT FRONT BEDROOM. *Condition is normal due to sweating from thermal variation / non-insulated windows.*

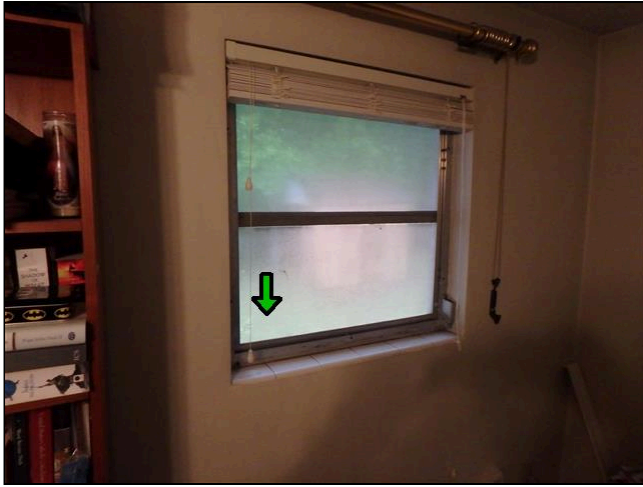
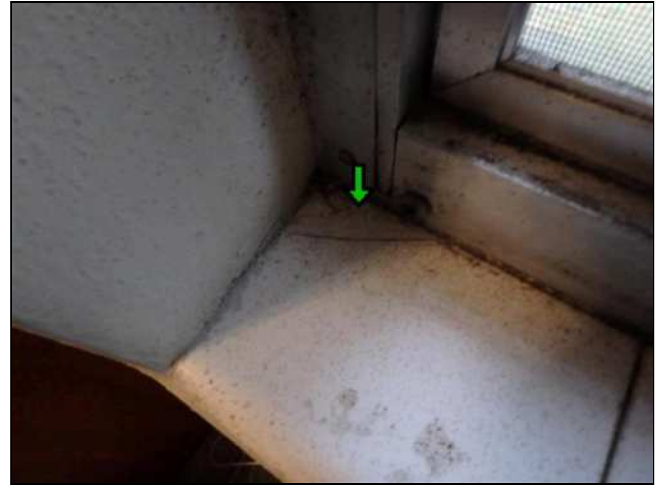
8.3 (3) CRACKED / DAMAGE TILES OBSERVED AT THE RIGHT REAR WINDOW OF RIGHT FRONT BEDROOM AND REAR FAMILY ROOM WINDOW. *Condition is normal , due to age of home. Cracking may worsen, if left uncorrected.*

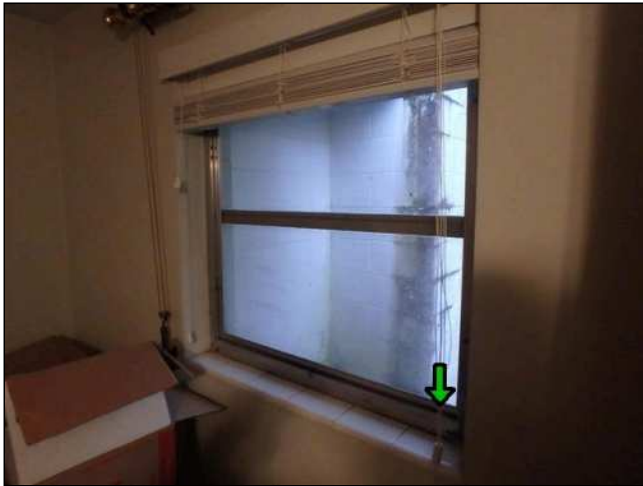
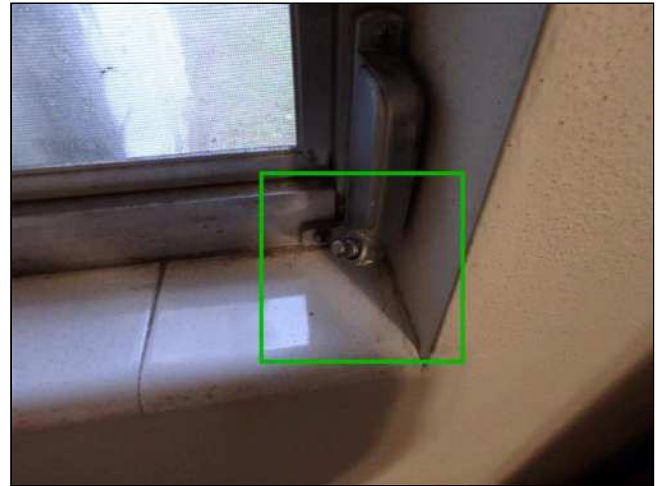
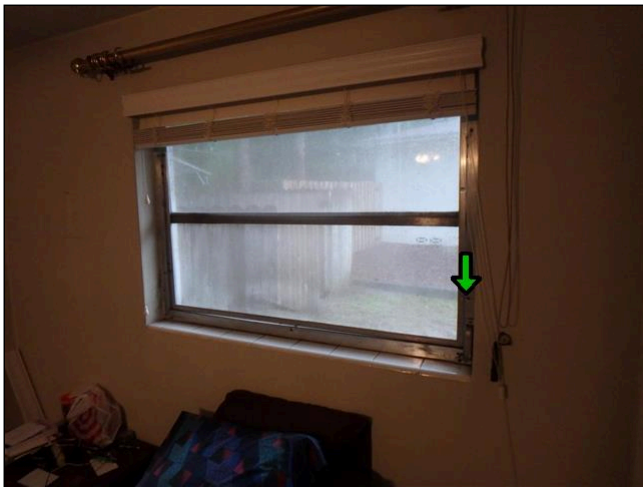
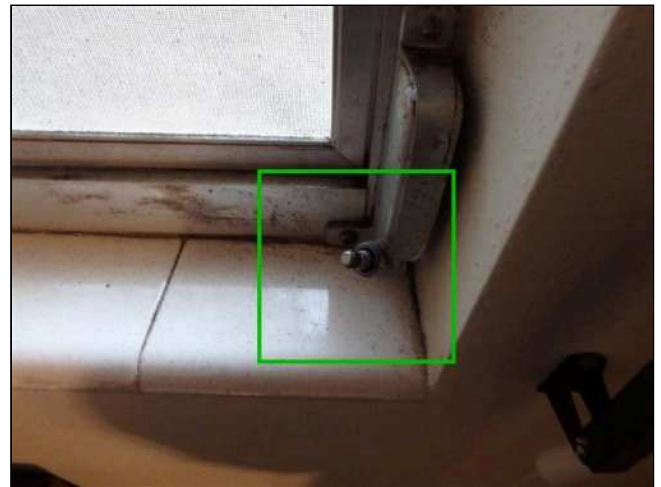
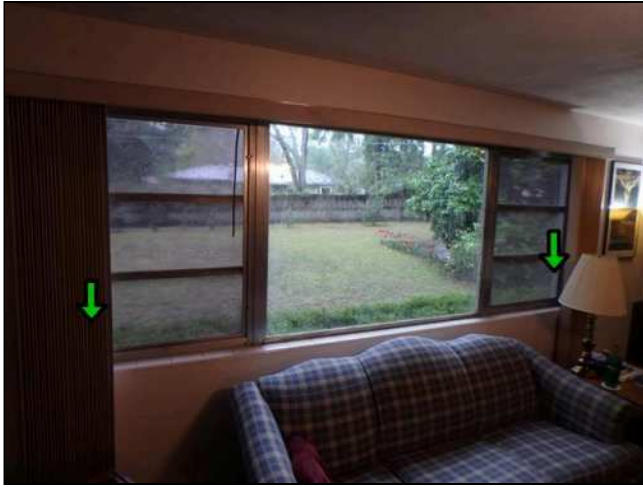
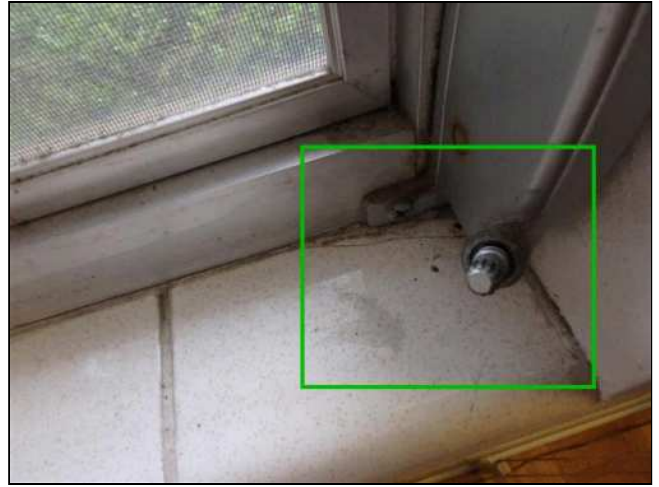
8.3 (4) MISSING CRANKS / HARDWARE OBSERVED AT REAR AND RIGHT SIDE WINDOWS OF RIGHT FRONT BEDROOM, THE REAR FAMILY ROOM WINDOWS AND THE FRONT WINDOWS AT LEFT FRONT BEDROOM. *Condition may make window difficult to operate. Windows functioned normally at time of inspection.*

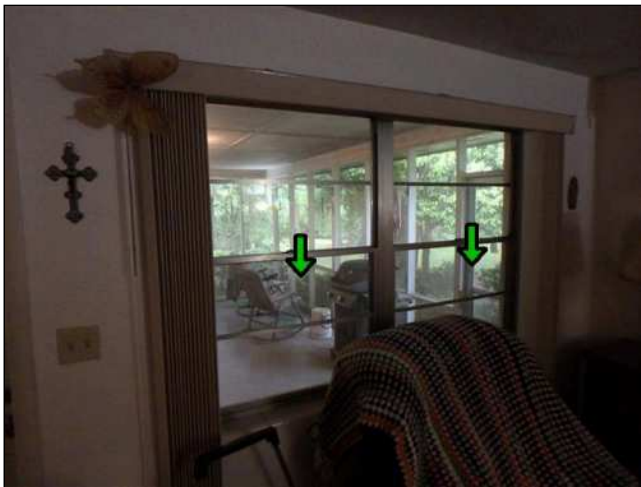
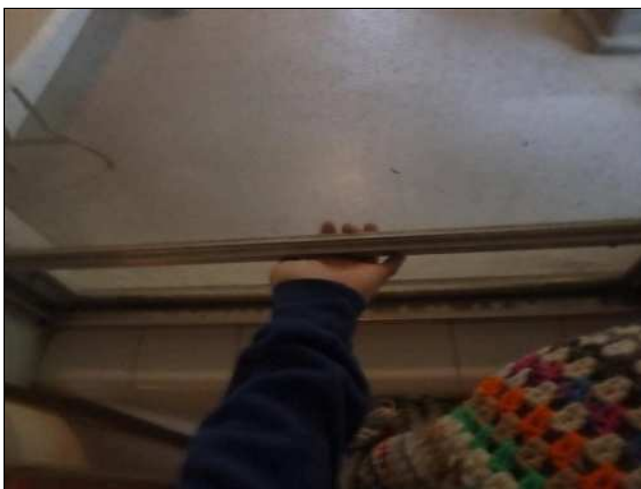
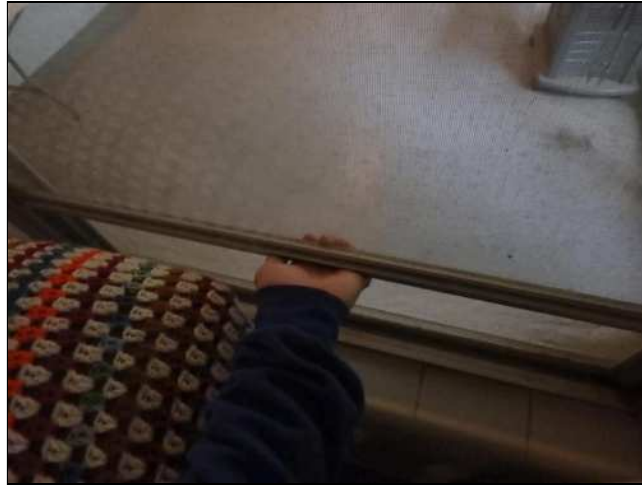
8.3 (5) LEFT SIDE FAMILY ROOM WINDOWS DO NOT REMAIN IN THE "UP" POSITION. Condition may be due to damaged / detached balancer springs.
