INSPECTION INFORMATION

Standard Home Inspection

Single Family Dwelling

51 Years

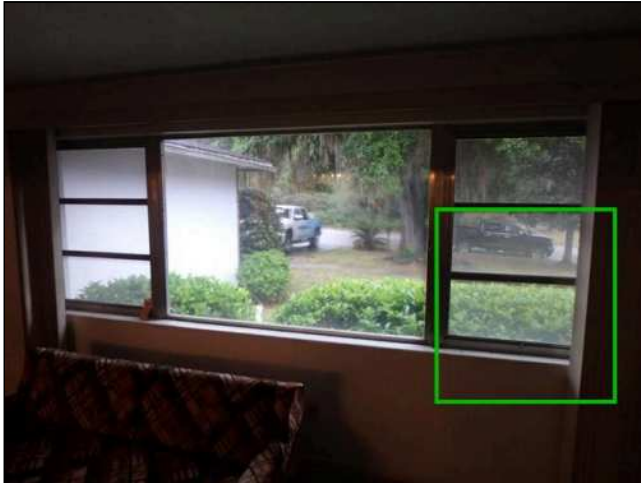
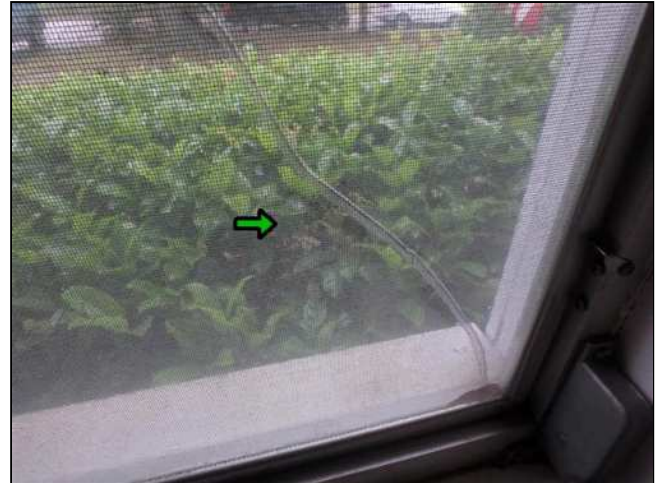
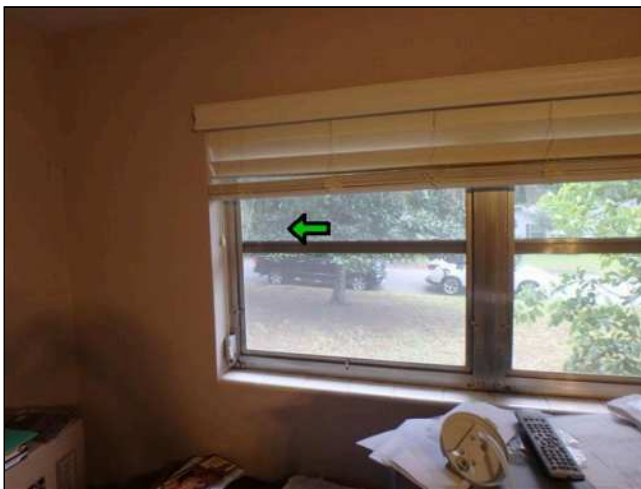
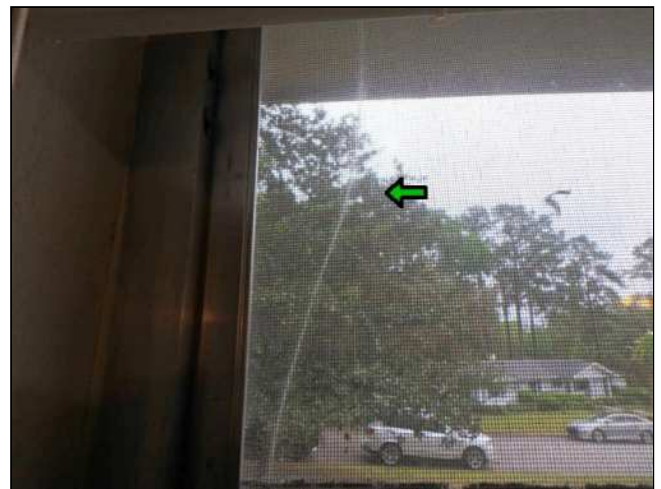
8.3 (6) LEFT SIDE WINDOW AT LIVING ROOM DID NOT OPEN / FUNCTION AT TIME OF INSPECTION. *Condition may be due to damaged hardware.*

8.3 (7) CRACKED / DAMAGED PANE OBSERVED AT THE RIGHT SIDE LIVING ROOM WINDOW AND THE RIGHT FRONT WINDOW AT LEFT FRONT BEDROOM. DUE TO DAMAGE, WINDOWS WERE NOT TESTED FOR FUNCTIONALITY.

RECOMMEND HAVING A LICENSED HANDYMAN OR LICENSED WINDOW COMPANY EVALUATE AND REPAIR AS NEEDED.

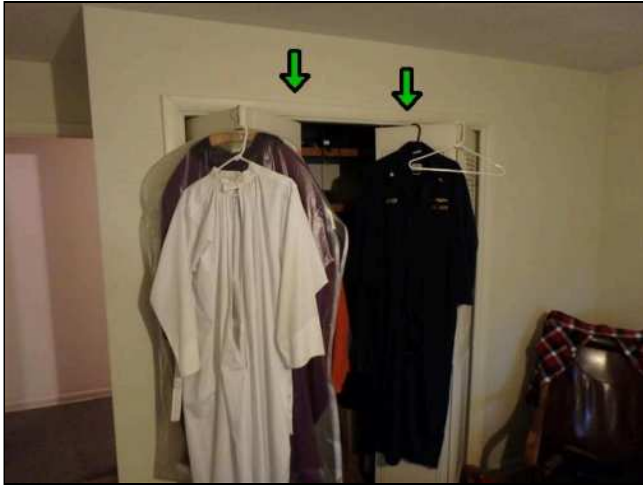
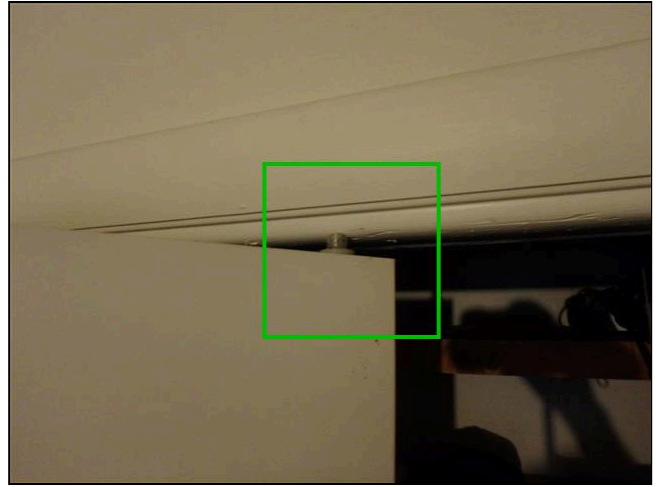
8.5 (1) CLOSET DOOR AT CENTER LEFT SIDE BEDROOM DO NOT REMAIN IN TRACK WHEN OPENED / CLOSED. *Condition may be due to adjustments needed at doors / hardware and/or weight that has been applied to doors.*

8.5 (2) LEFT SIDE CLOSET DOOR AT LEFT FRONT BEDROOM AND CLOSET DOOR AT LEFT REAR BEDROOM DO NOT REMAIN IN TRACK WHEN OPENED / CLOSED.. *Condition may be due to adjustments needed at door and / or hardware.* RECOMMEND HAVING A LICENSED HANDYMAN EVALUATE AND REPAIR AS NEEDED.

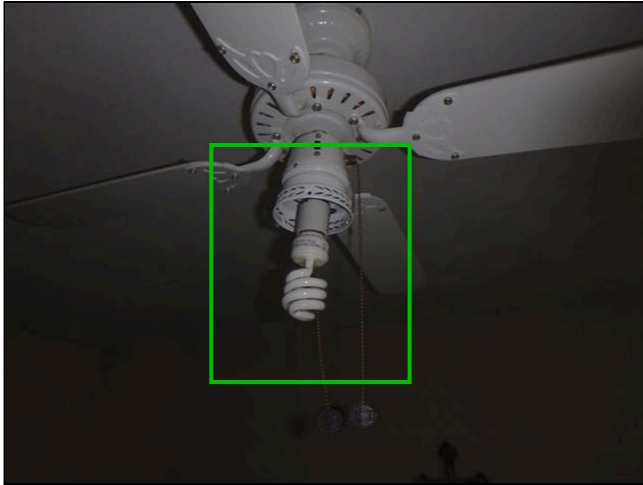
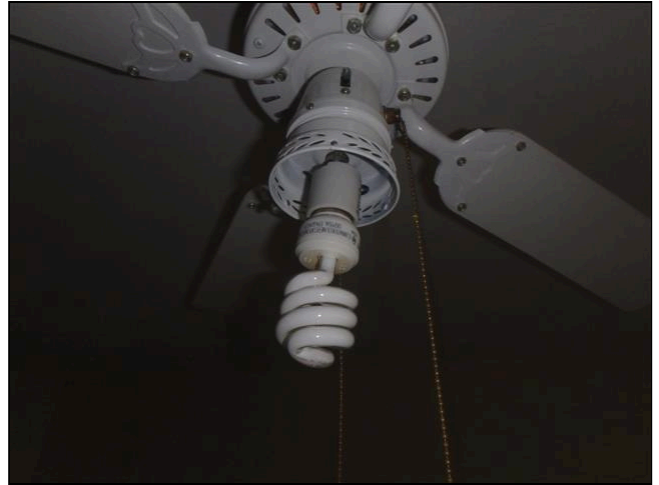
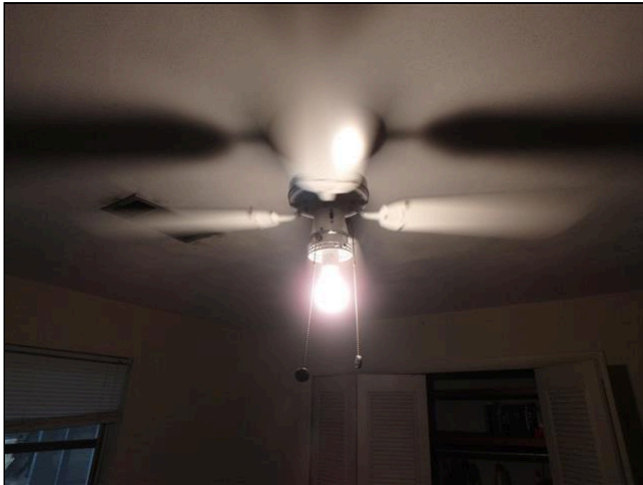
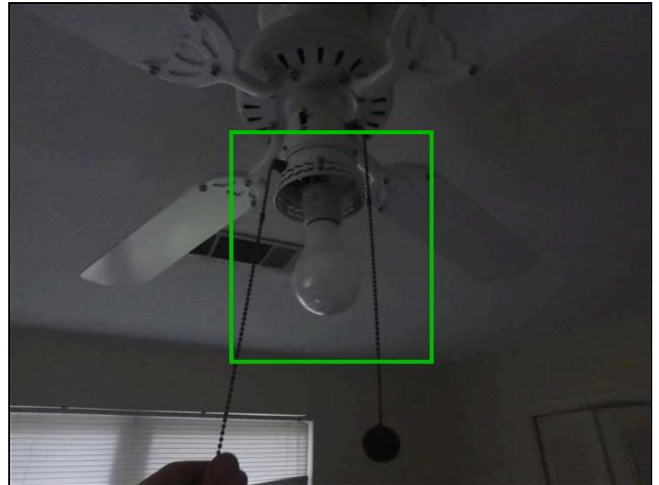
8.6 (1) CENTER LEFT SIDE BEDROOM AND LEFT REAR BEDROOM CEILING FANS LACK GLOBES / COVERS. *Condition may leave bulbs susceptible to contact damage.*

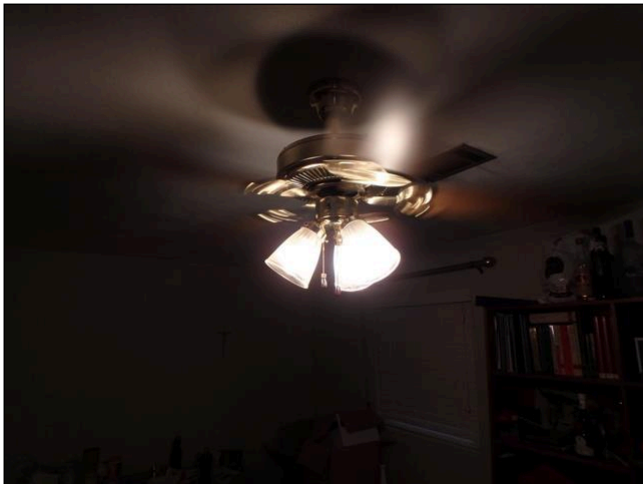
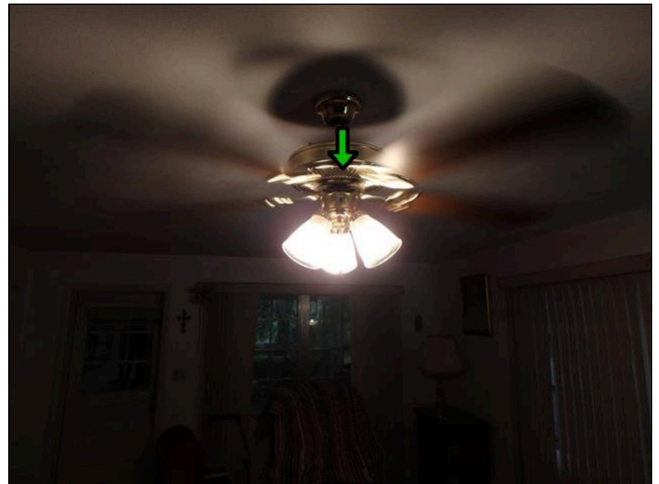
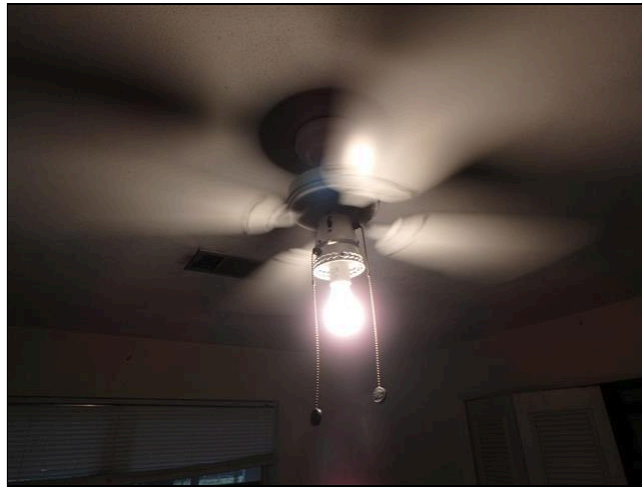
8.6 (2) WOBBLES WERE OBSERVED AT THE RIGHT FRONT BEDROOM CEILING FAN, THE FAMILY ROOM CEILING FAN AND THE LEFT REAR BEDROOM CEILING FAN. *Units may need balancing and/or repair. Condition may worsen, with regular use.* RECOMMEND HAVING A LICENSED HANDYMAN EVALUATE AND REPAIR AS NEEDED.

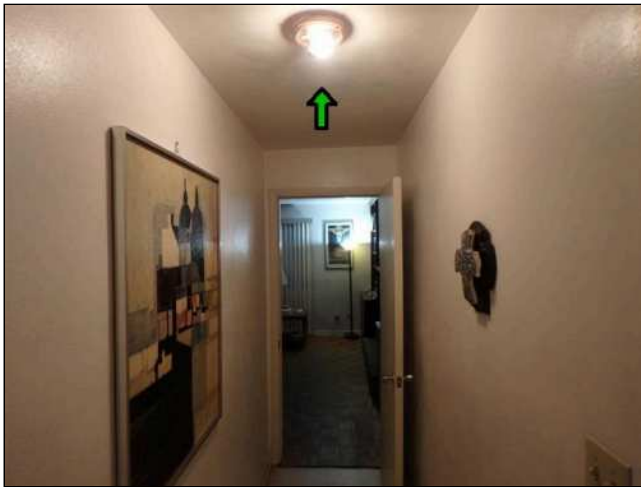
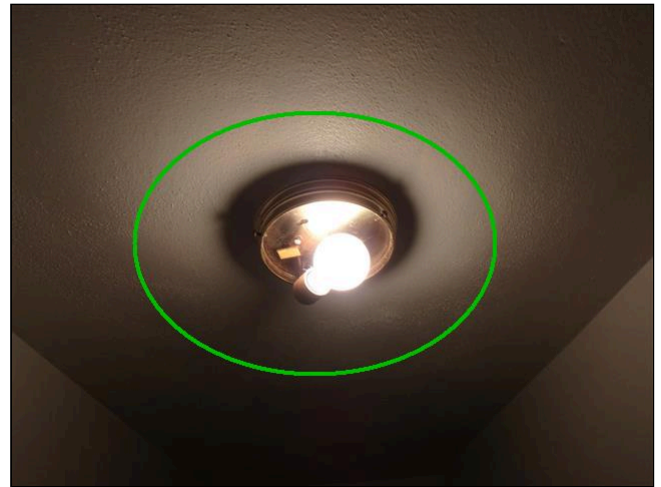
8.7 (2) RIGHT SIDE HALLWAY LIGHT FIXTURE LACKS A COVER. *Lack of a cover may make bulbs susceptible to contact damage.*

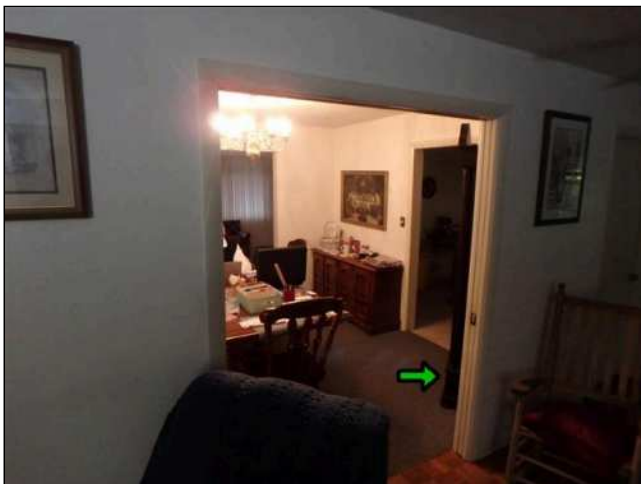
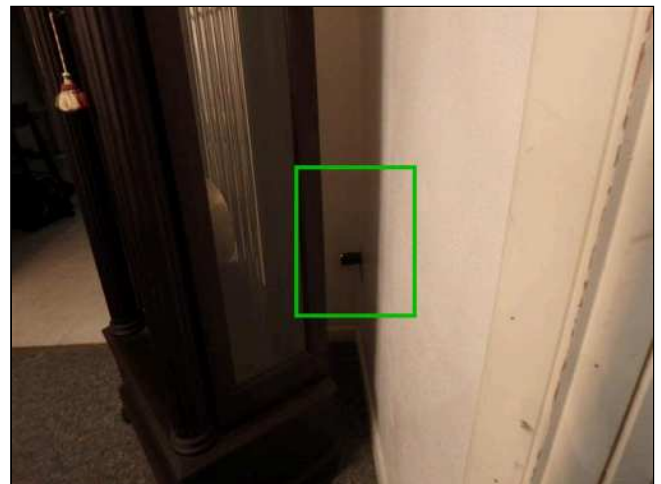
8.7 (3) DINING ROOM OUTLETS AND LEFT FRONT OUTLET AT LIVING ROOM HAVE "OPEN GROUNDS". *Outlet may not be protected in the case of a lightning strike and/or surge. Condition may be due to a loose / damaged ground wire and/or improper grounded outlet.*

RECOMMEND HAVING A LICENSED HANDYMAN OR LICENSED ELECTRICAL CONTRACTOR EVALUATE AND REPAIR AS NEEDED.

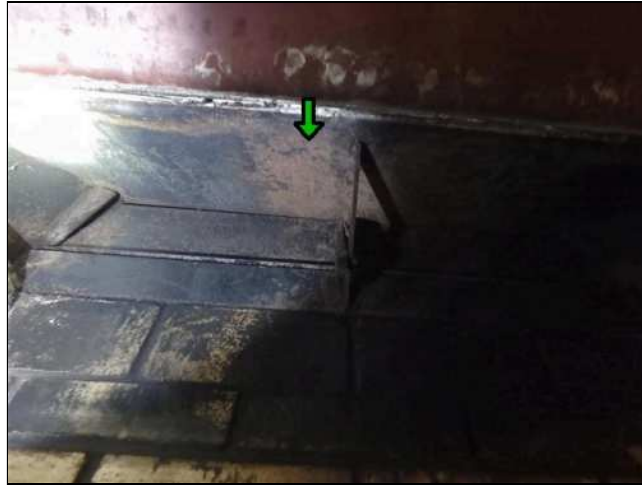
8.9 (1) MINOR CORROSION OBSERVED AT DAMPER DOOR FOR FIREPLACE. *Condition may be an indication of moisture entry from top of roof.*

Prolonged corrosion may result in further damage and/or related issues.

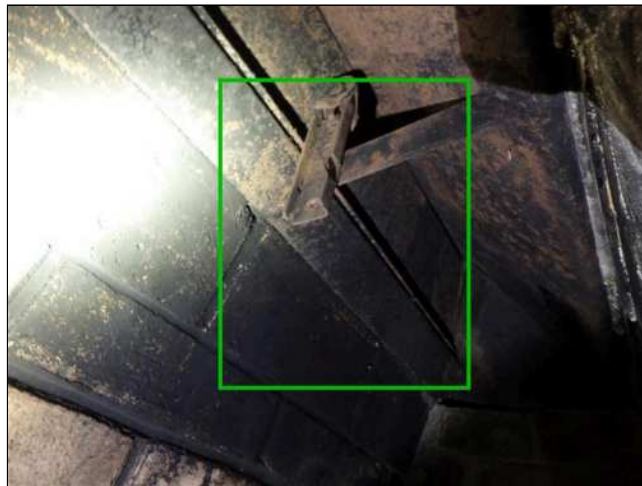
8.9 (2) HARDWARE / ARM FOR FIREPLACE DAMPER WAS MISSING / NOT INSTALLED. *Condition may make damper door difficult to open / operate.*

RECOMMEND HAVING A LICENSED CONTRACTOR OR LICENSED CHIMNEY SWEEP EVALUATE AND REPAIR AS NEEDED.

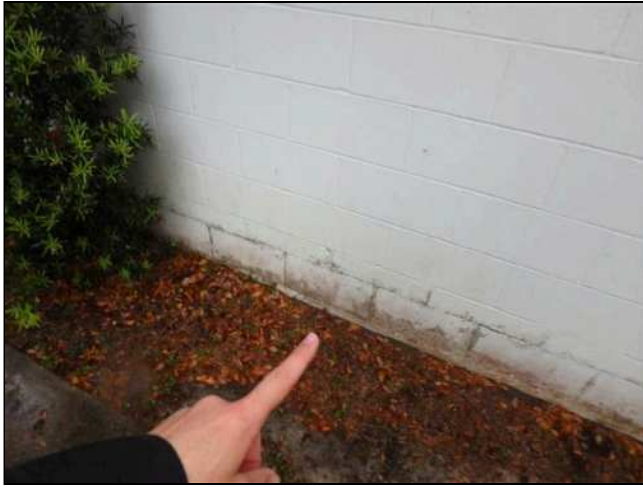
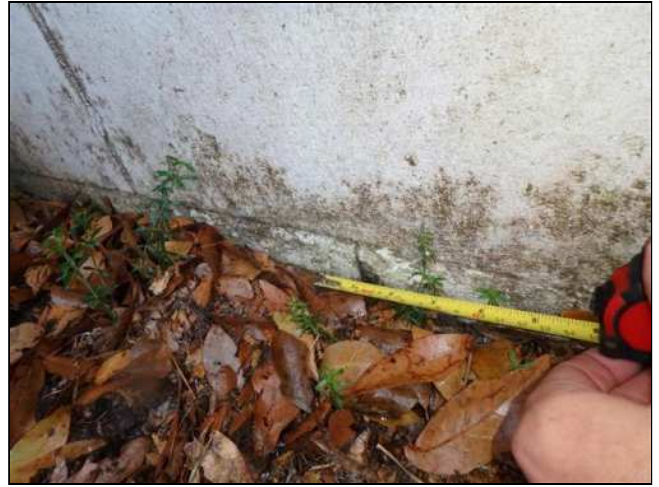
9.0 (1) DAMAGE AND/OR DETERIORATED SEALANT MATERIALS OBSERVED AT THE CRAWLSPACE FOUNDATION WALLS. *Damage / deteriorated sealant may affect the integrity of affected materials. Condition of latent materials was not visible & could not be fully inspected. Hidden damage may exist.*

RECOMMEND HAVING A LICENSED HANDYMAN OR CONTRACTOR EVALUATE / REMEDY AS NEEDED.

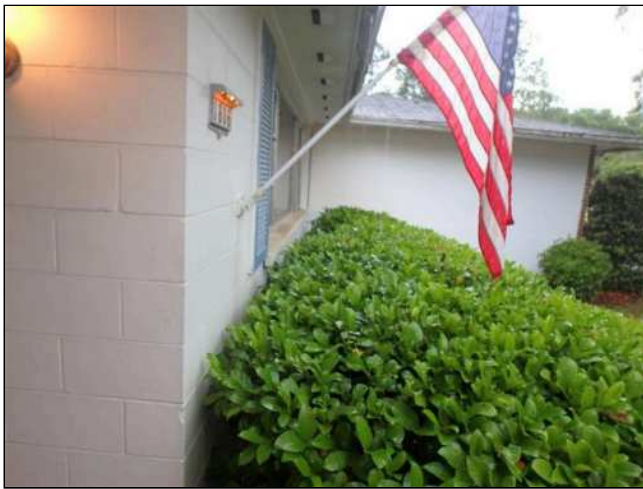
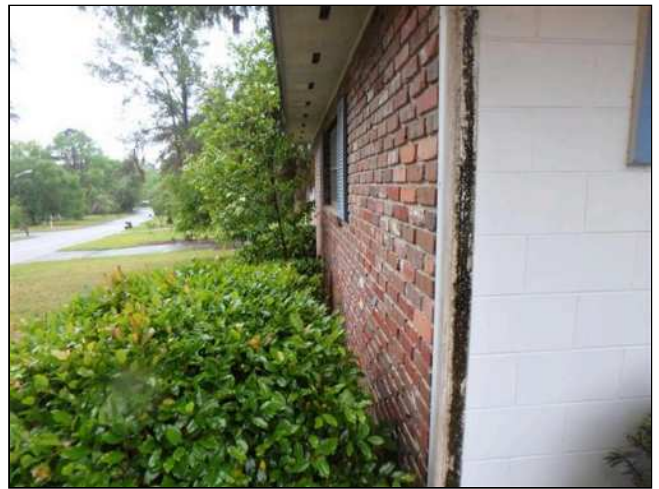
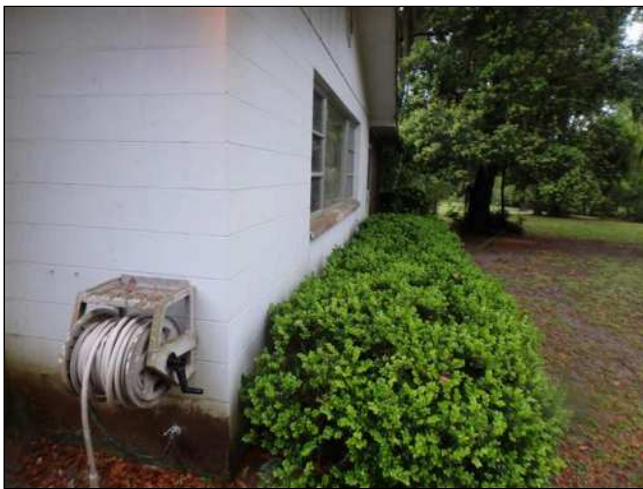
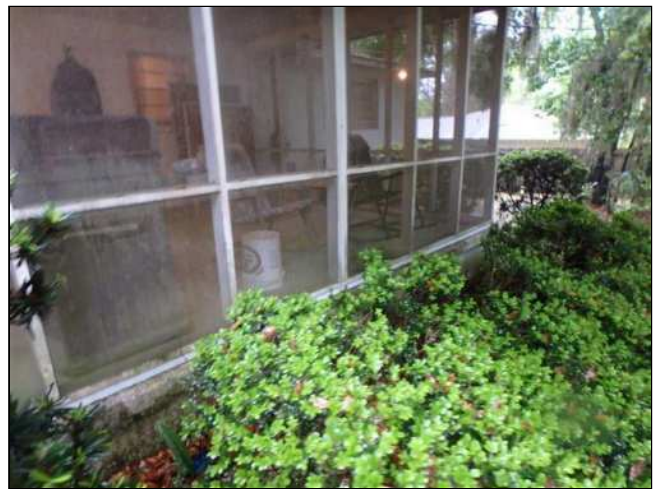
9.0 (2) DUE TO GRADING AND/OR FOUNDATION PLANTINGS & VEGETATION, ENTIRE EXTERIOR FOUNDATION WALLS & SIDING / TRIM MATERIALS, EXTERIOR FAUCETS WERE NOT VISIBLE / ACCESSIBLE & COULD NOT BE FULLY INSPECTED.

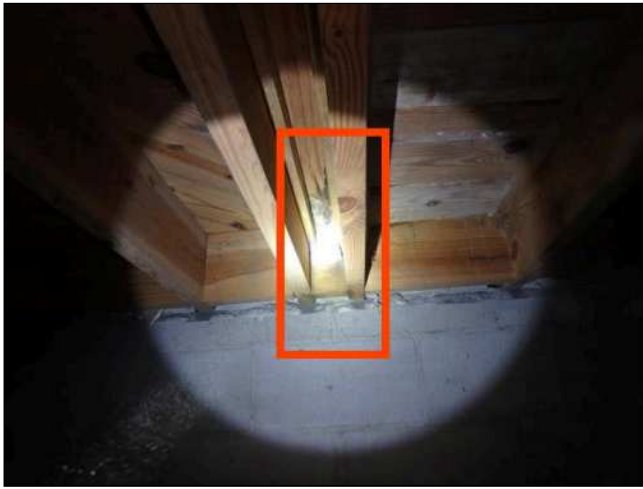
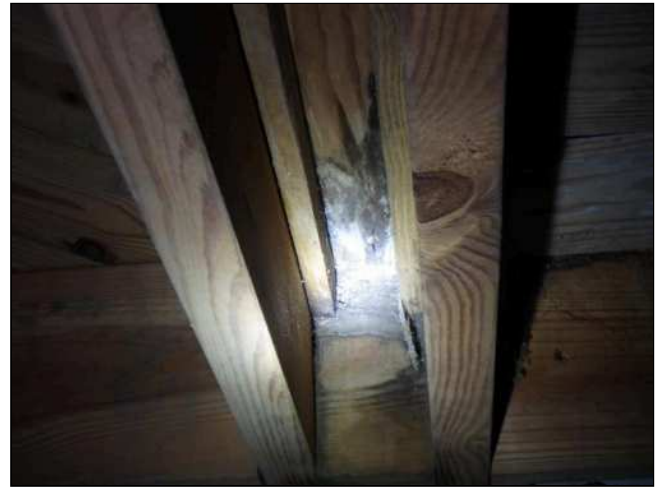
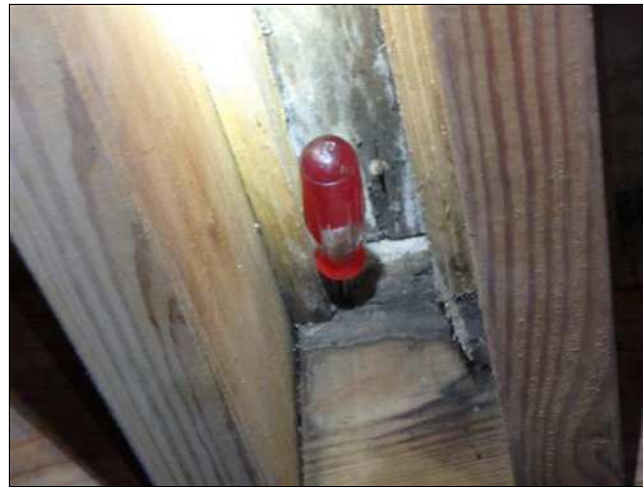
9.2 (1) STAINING / WOOD DECAY AND/OR DAMAGE OBSERVED AT THE REAR FLOORING / FRAMING. *Wood decay / damage may deteriorate the integrity of affected components. Condition of latent materials was not visible & could not be fully*

inspected. Hidden damage may exist.

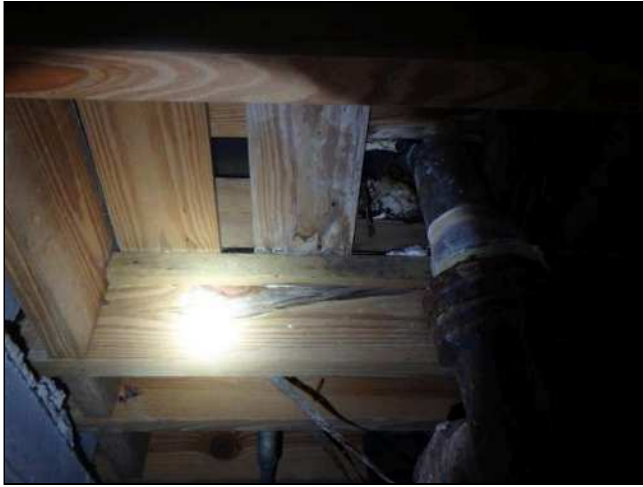
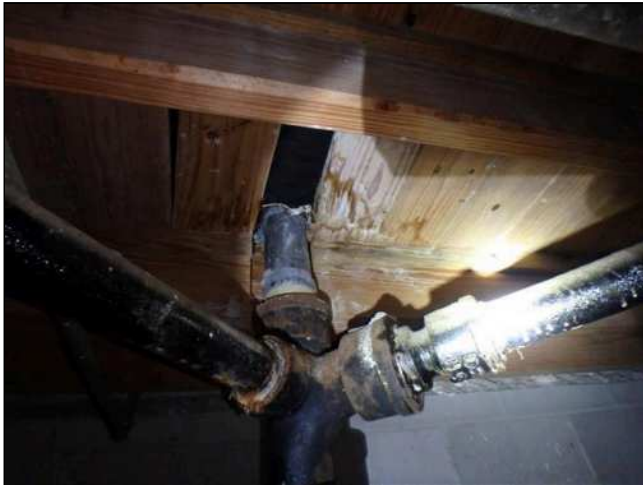
9.2 (2) STAINING OBSERVED AT THE SUB-FLOORING, MAINLY ADJACENT TO PLUMBING PROVISIONS. AREAS TESTED POSITIVE FOR MOISTURE CONTENT USING A DIGITAL MOISTURE METER AT TIME OF INSPECTION. *Extent of moisture penetration / condition of latent materials was not visible and could not be fully inspected. Hidden damage may exist.*

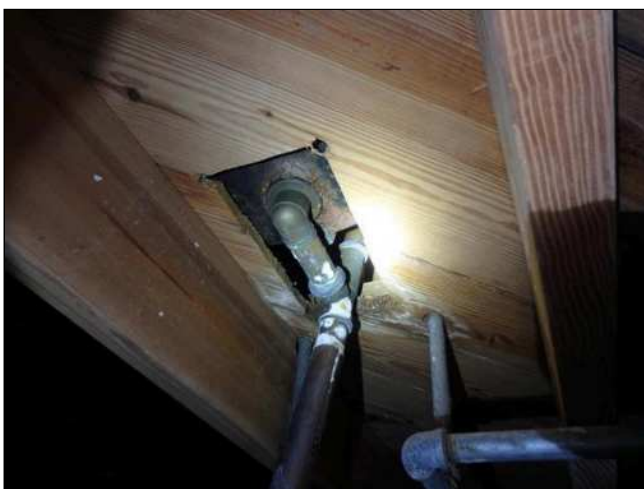
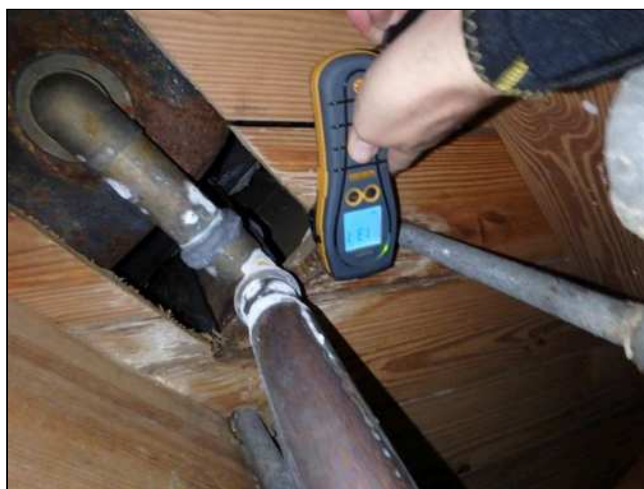
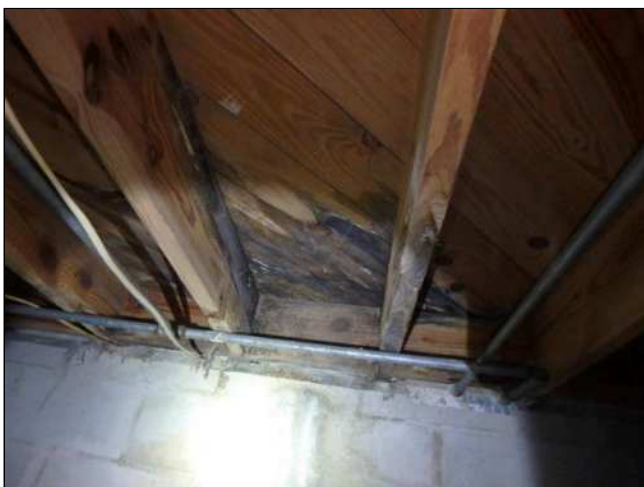
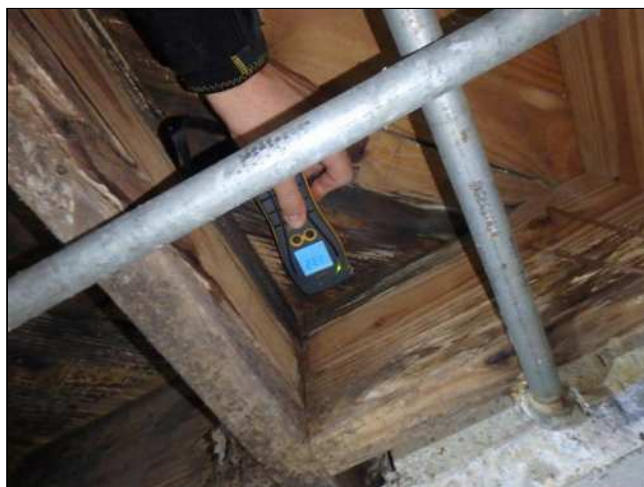
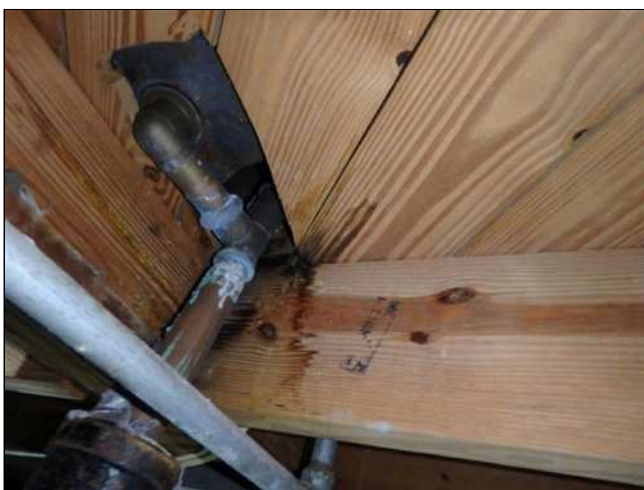
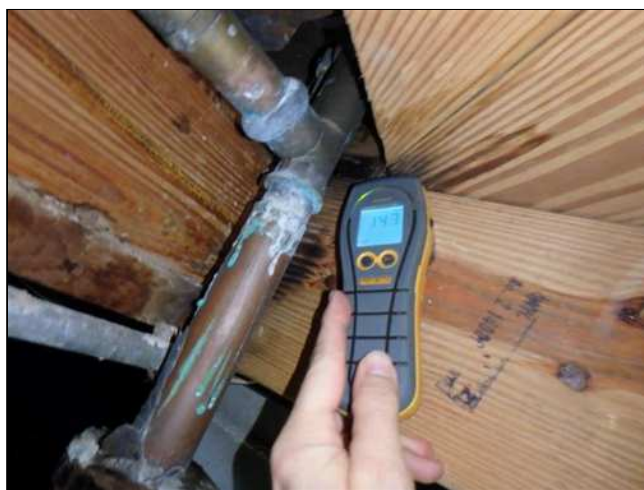
9.2 (3) STAINING & WOOD DECAY / DAMAGE OBSERVED AT THE SUB-FLOOR & FRAMING MATERIALS, MAINLY ADJACENT TO PLUMBING PROVISIONS. AREA(S) TESTED DRY USING A DIGITAL MOISTURE METER AT TIME OF INSPECTION. *Wood decay / damage may deteriorate the integrity / rigidity of affected components over time. Condition of latent materials was not visible & could not be fully inspected. Hidden damage may exist.*

RECOMMEND HAVING A LICENSED HANDYMAN OR CONTRACTOR EVALUATE / REMEDY AS NEEDED.

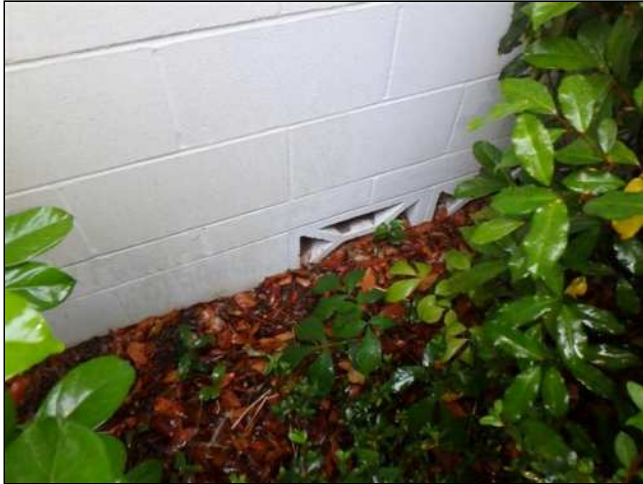
LEAVES / DEBRIS OBSERVED AT THE CRAWLSPACE VENTILATION PROVISIONS. *Excessive debris build-up may result in improper air flow / poor ventilation.*

RECOMMEND REMOVAL OF DEBRIS & PERIODIC MONITORING / MAINTENANCE TO ENSURE PROPER AIR FLOW.

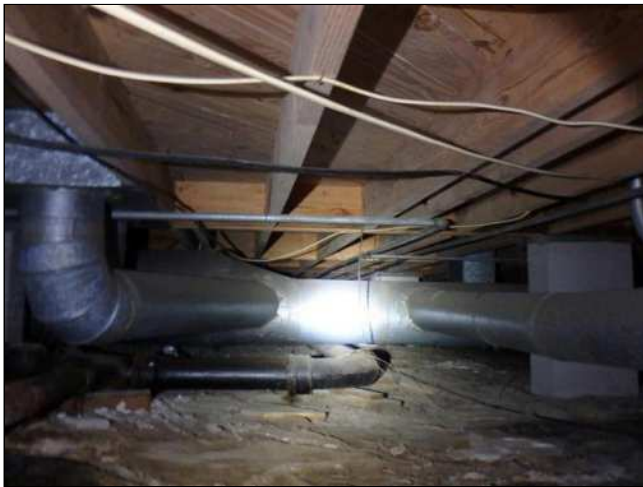
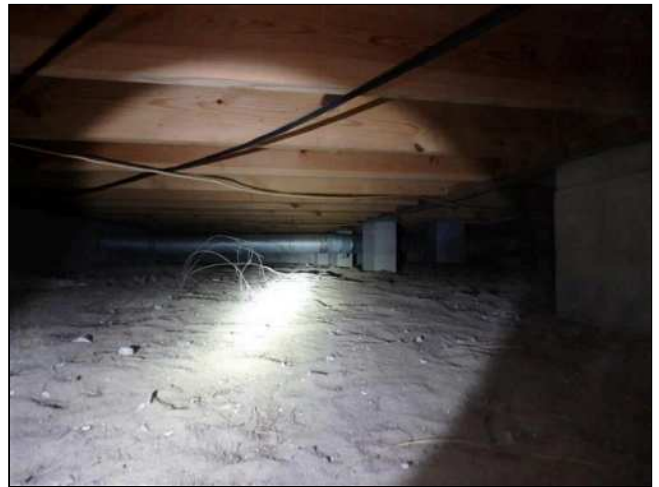
DUE TO DESIGN / HEIGHT LIMITATIONS & HVAC DUCTING / PLUMBING PROVISIONS, APPROXIMATELY 20% OF CRAWLSPACE WAS INACCESSIBLE & CRAWLSPACE & RELATED ELEMENTS WERE NOT PHYSICALLY REACHED / FULLY INSPECTED.

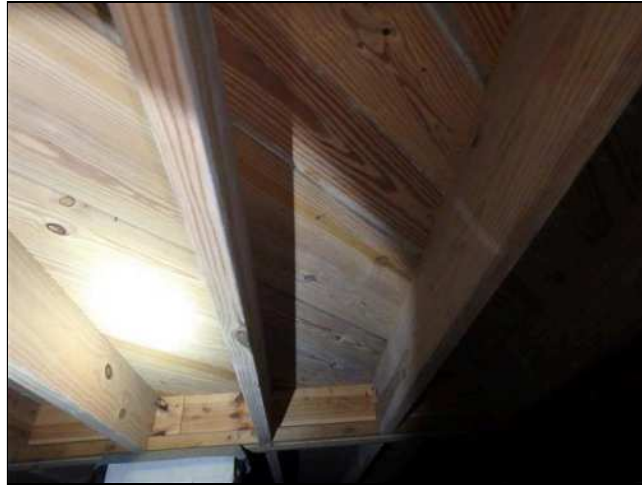
9.7 (Picture 1)

INSULATION MATERIALS WERE NOT PRESENT / OBSERVED AT TIME OF INSPECTION. *Lack of insulation may result in elevated levels of moisture / humidity & may promote energy loss.*

RECOMMEND HAVING A LICENSED HANDYMAN OR CONTRACTOR EVALUATE / REMEDY AS NEEDED.

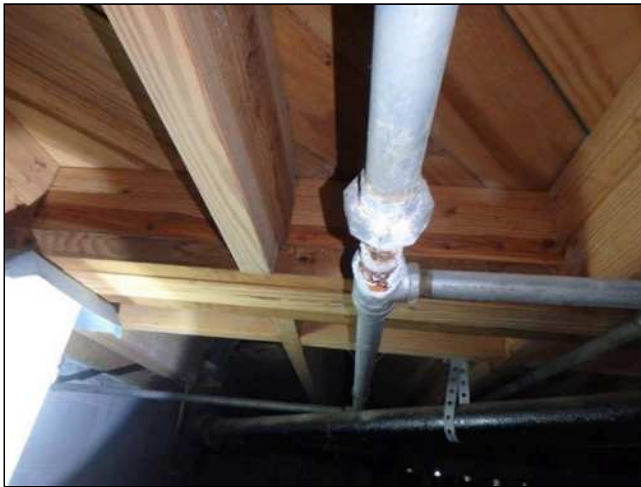
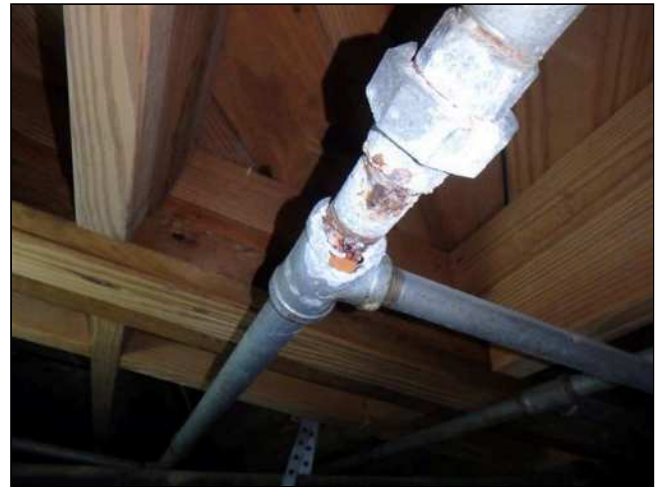
9.9 (1) CORROSION OBSERVED AT THE WATER SUPPLY PIPING LOCATED IN THE CRAWLSPACE. *Prolonged exposure to corrosion may result in premature wear / failure of affected components. No leaks observed at time of inspection; however, removal of corrosion may result in exposure of leak.*

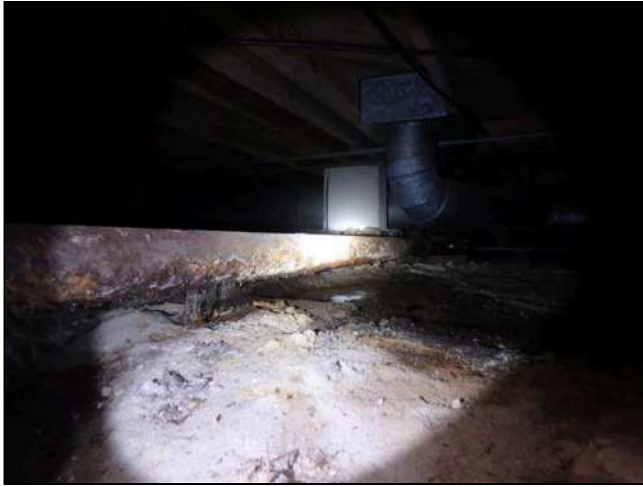
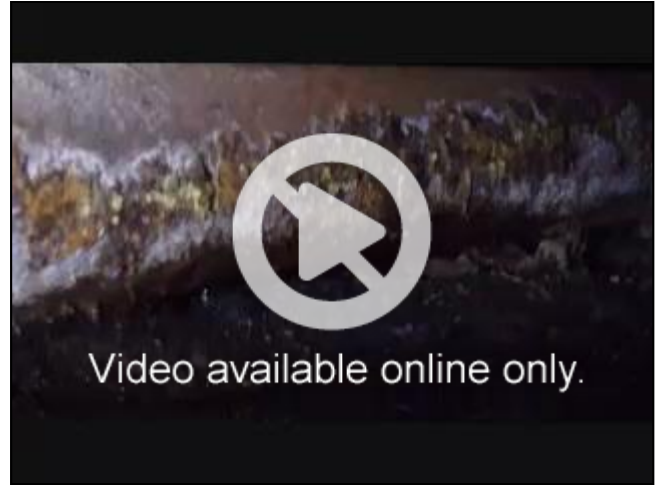
9.9 (2) ACTIVE LEAK(S) OBSERVED BELOW THE MAIN PLUMBING PROVISIONS. *Extent of leak(s) / damage was not determined / condition of latent materials was not visible & could not be fully inspected. Hidden damage may exist.*

RECOMMEND HAVING A LICENSED HANDYMAN OR CONTRACTOR EVALUATE / REMEDY AS NEEDED.

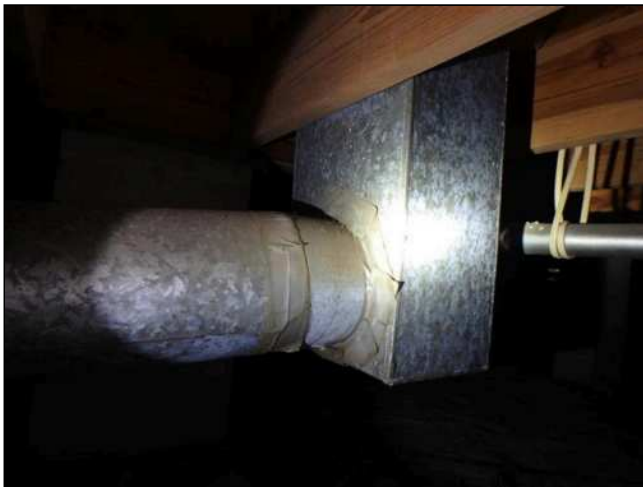
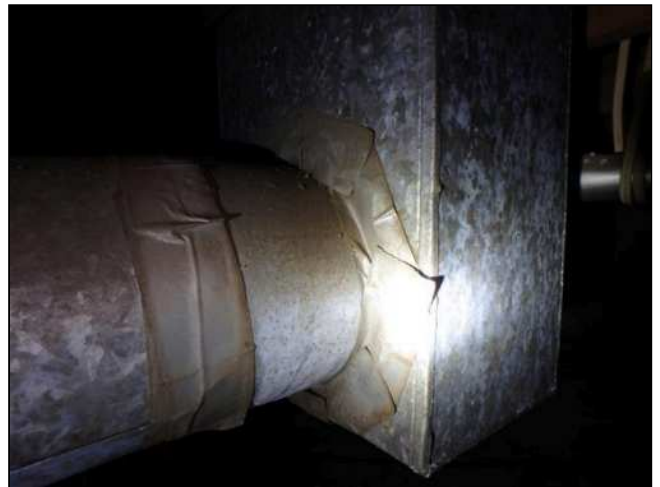
DUCT TAPE / IMPROPER SEALANT MATERIALS OBSERVED IN USE AT THE HVAC SYSTEM DUCTING & RELATED ELEMENTS. *Duct tape / improper sealant materials can loose adhesiveness due to the moisture content and heat found in Florida attics, which can lead to air leaks / energy loss.*

RECOMMEND HAVING A LICENSED HVAC COMPANY EVALUATE / REMEDY AS NEEDED.

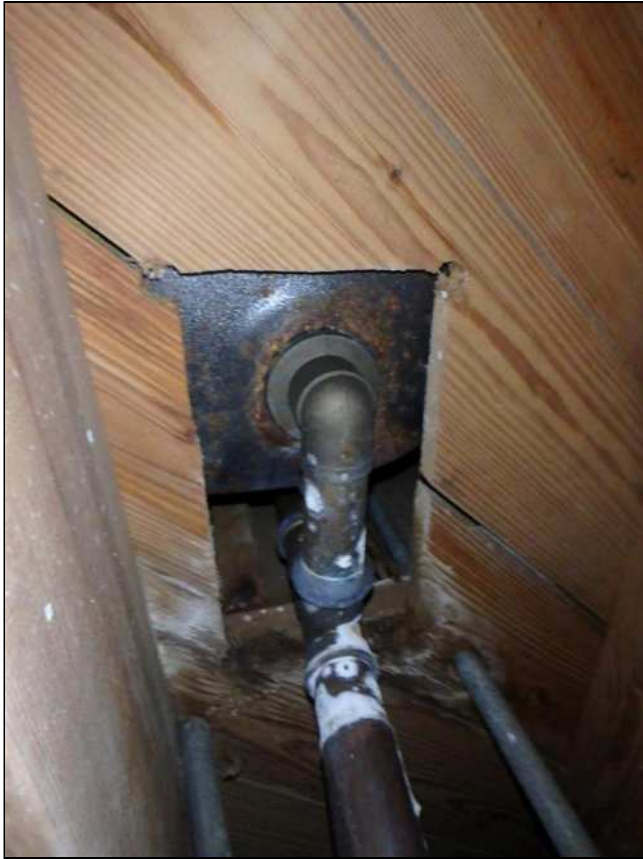
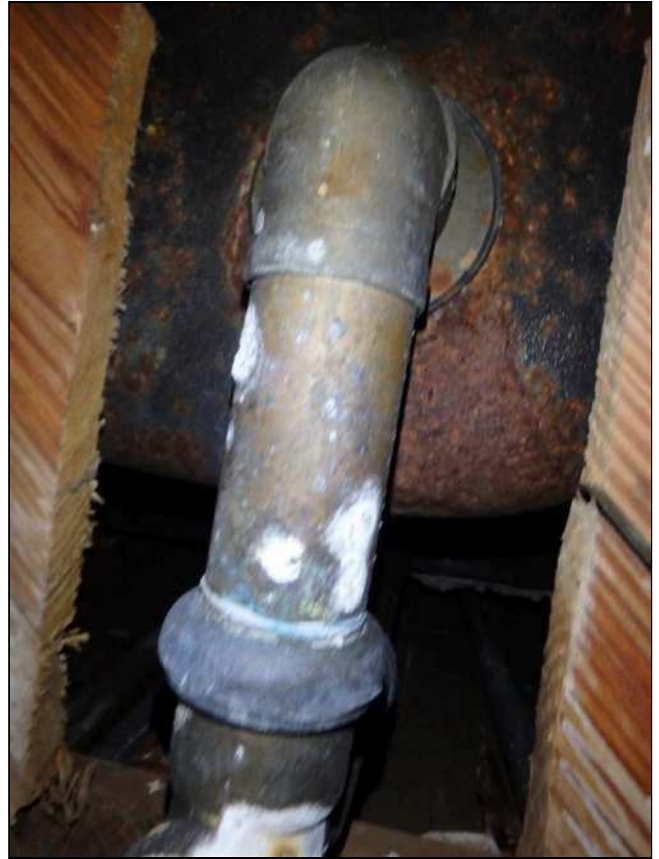
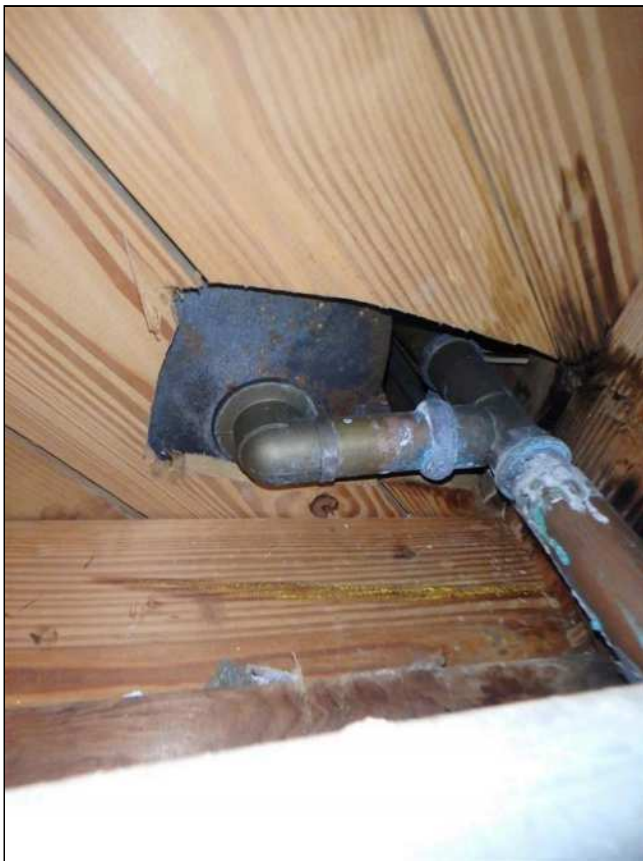
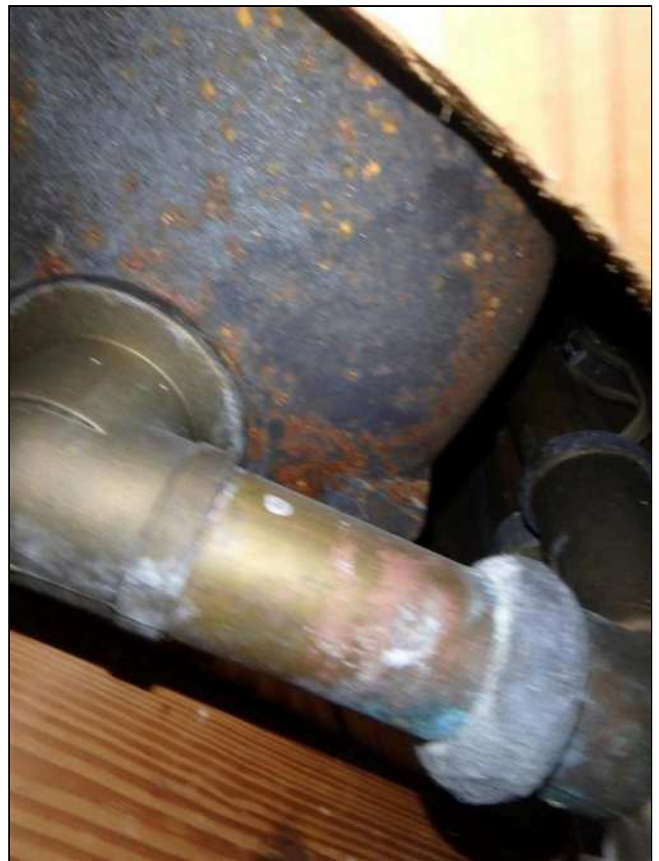
CORROSION OBSERVED AT THE UNDERSIDE OF MULTIPLE BATHTUBS. *Prolonged exposure to corrosion may promote premature wear / failure of affected components. Condition of latent materials was not visible & could not be fully inspected. Hidden damage may exist.*

RECOMMEND HAVING A LICENSED HANDYMAN OR CONTRACTOR EVALUATE / REMEDY AS NEEDED.

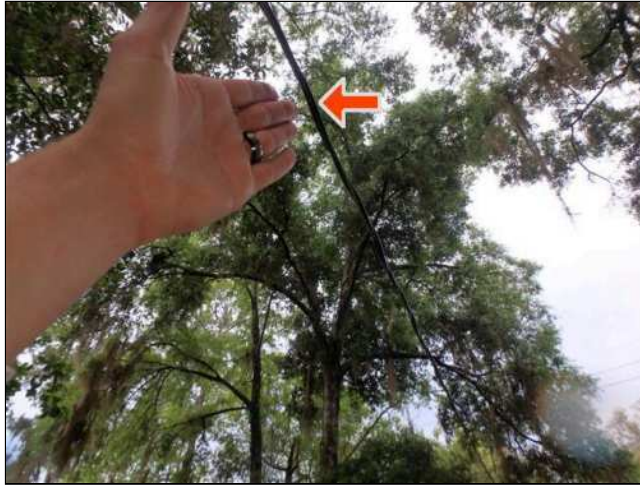
11.0 (1) INCOMING ELECTRICAL LINE ARE TOO LOW TO GROUND. *Electrical lines should be 12' above any potential walking path.*

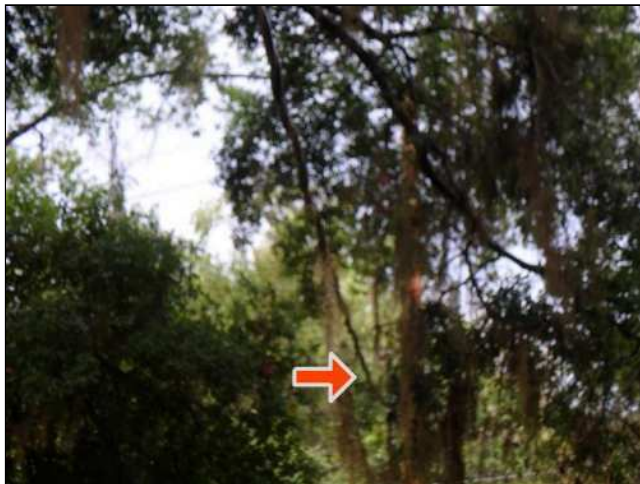
11.0 (2) SERVICE LINE IS IN CONTACT / CLOSE PROXIMITY TO TREE BRANCHES. *Condition may promote accidental damage to occur to incoming service / electrical lines.*

RECOMMEND CONTACTING UTILITY COMPANY FOR EVALUATION / REMEDY.

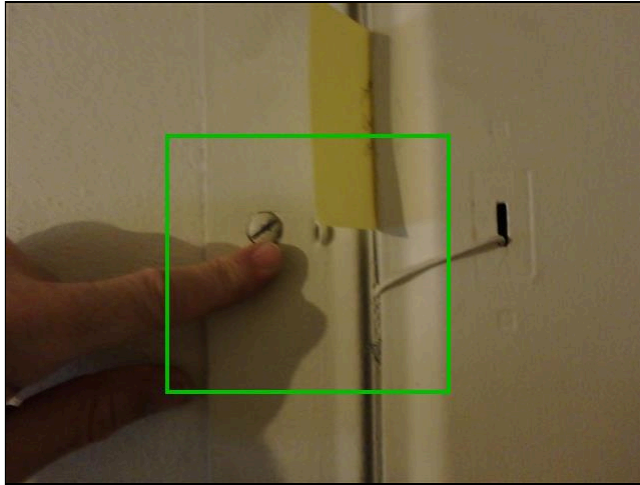
11.2 (1) LATCH AT PANEL DEAD-FRONT DOOR IS DAMAGED. *Door can not be secured shut.*

RECOMMEND HAVING A LICENSED ELECTRICAL CONTRACTOR EVALUATE AND REPAIR AS NEEDED.

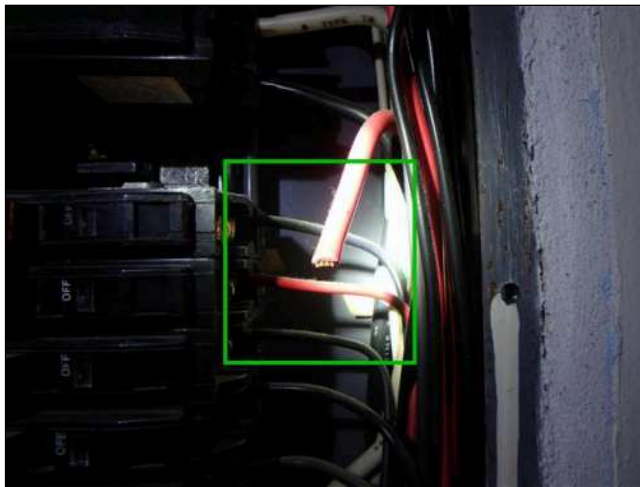
11.2 (2) IMPROPERLY ABANDONED WIRING OBSERVED IN PANEL. *Wiring should be capped in order to prevent related damage / arcing.*

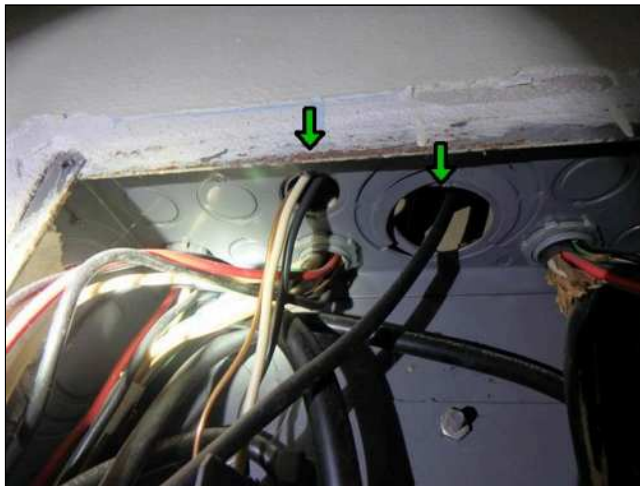
11.2 (3) MISSING STRAIN RELIEF BUSHINGS OBSERVED AT THE ELECTRICAL PANEL. *Condition may allow accidental damage to occur to conductors / surrounding components.*

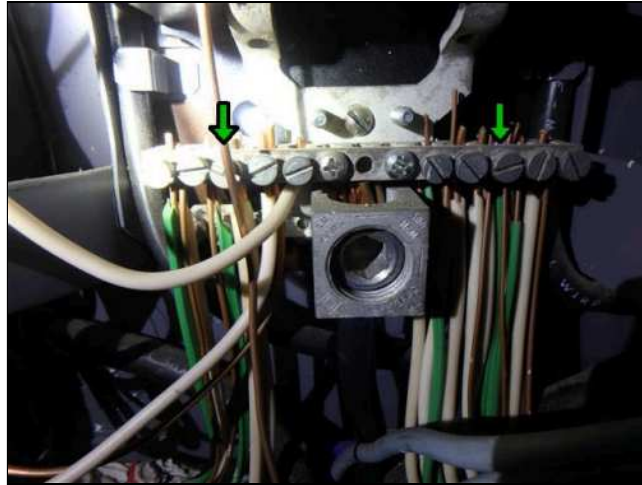
11.2 (4) **MULTIPLE-TAPPED** WIRING OBSERVED AT THE NEUTRAL BARS IN PANEL. *Condition may cause damage to the electrical system , over time.*

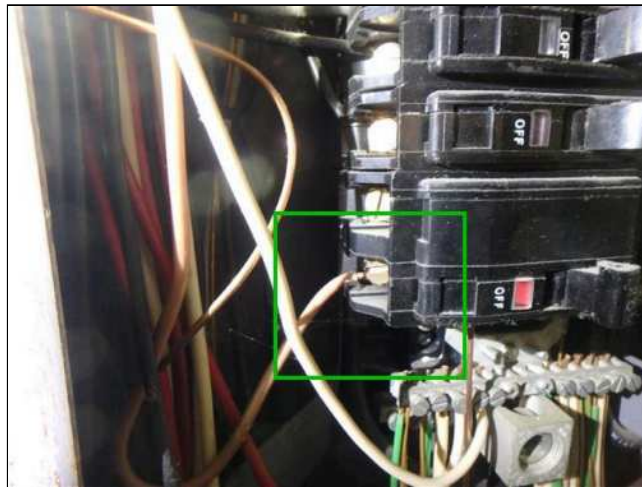
11.2 (5) ONLY HALF OF A DOUBLE POLE (240V) BREAKER IS IN USE AT THE ELECTRICAL PANEL AND THE WIRING APPEARS TO BE THE IMPROPER GAUGE. *Condition may cause improper electrical draw on the breaker / circuit potentially causing premature wear / failure of affected components.*

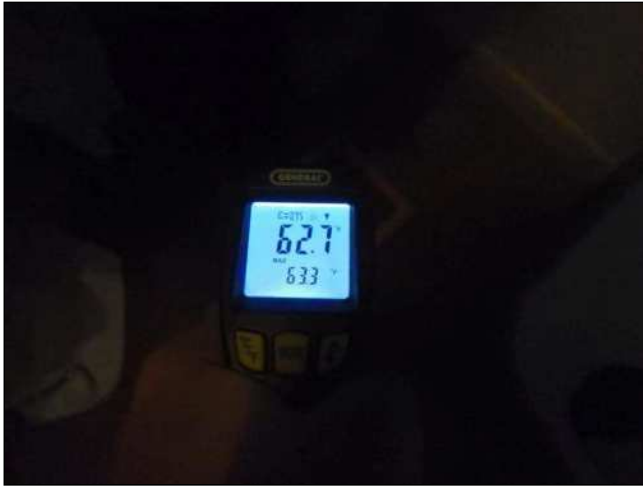
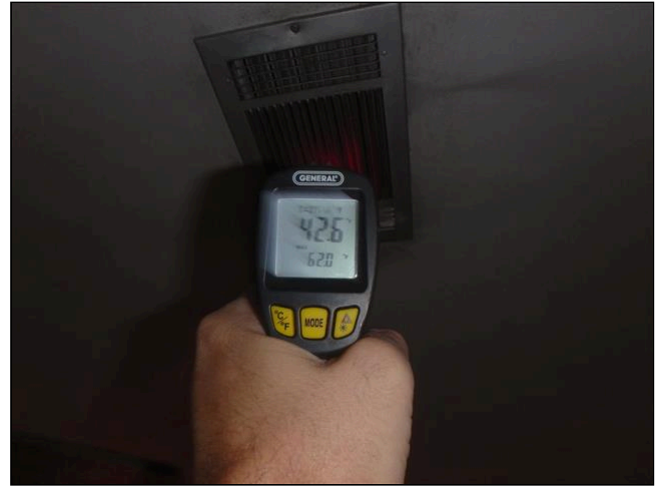
12.1 (1) ACCEPTABLE TEMPERATURE DIFFERENTIAL (14 ° F) WAS MET AT TIME OF INSPECTION. TEMPERATURES NOTED IN PICTURES.

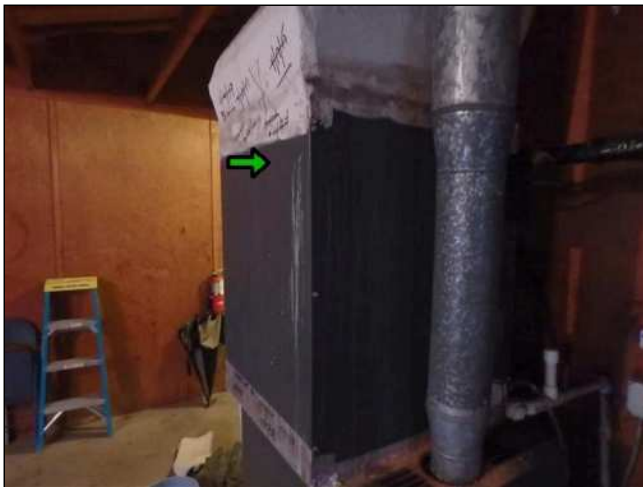
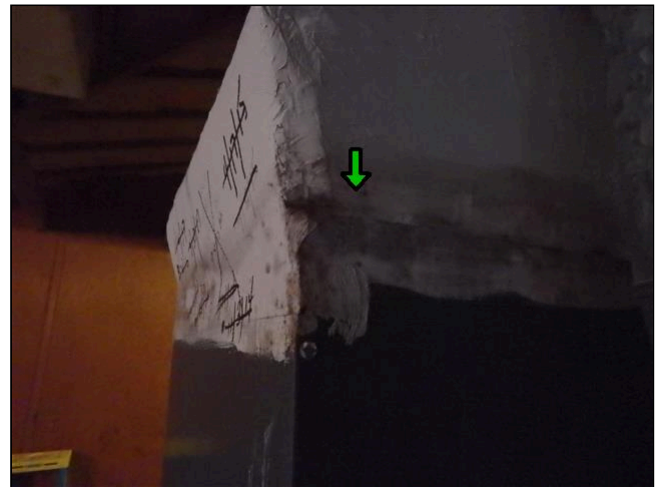
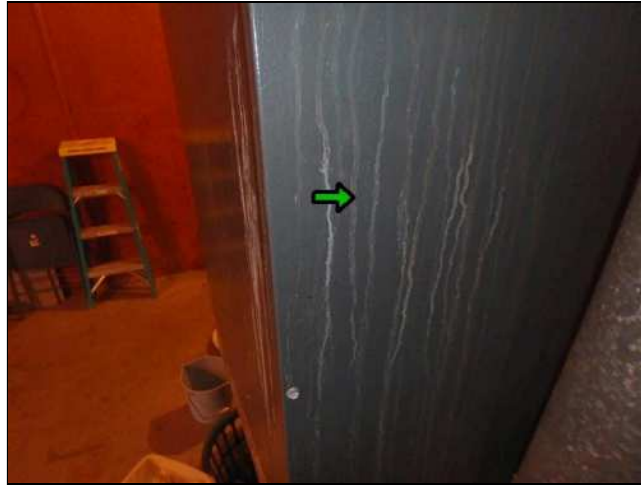
MOISTURE STAINING / MICROBIAL GROWTH OBSERVED AT THE DUCTWORK / COOLING COIL UNION. *Condition may be an indication of leak / previous leaks.*

RECOMMEND HAVING A LICENSED HANDYMAN EVALUATE AND REPAIR AS NEEDED.
