INSPECTION INFORMATION

Standard Home Inspection

Single Family Dwelling

51 Years

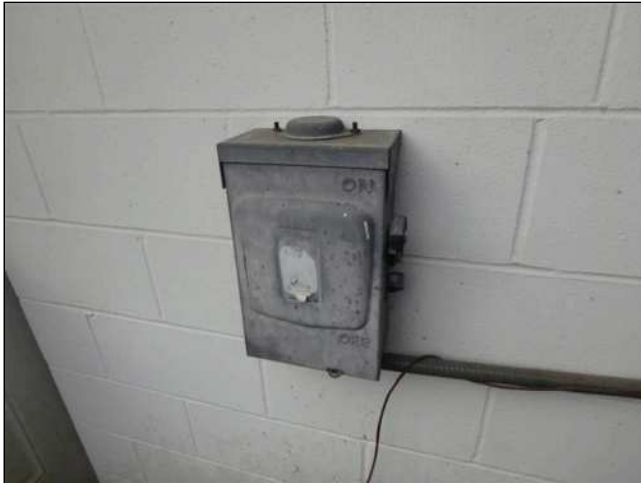
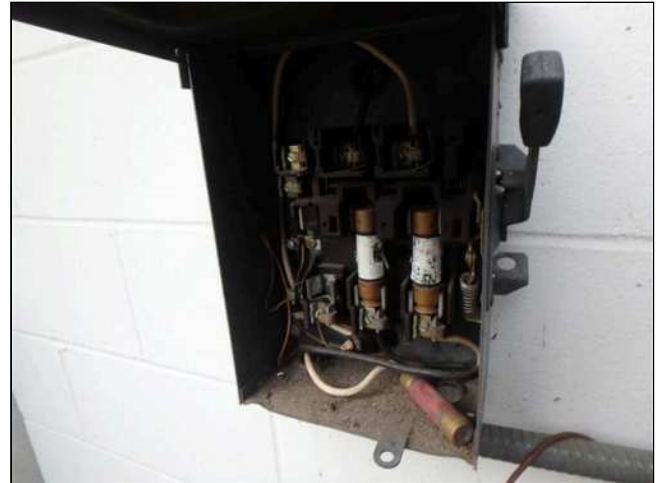
OLDER TYPE ELECTRICAL (FUSE) SCISSOR SHUT-OFF SWITCH OBSERVED IN USE AT THE EXTERIOR HVAC UNIT. *These types of electrical boxes usually do not have an internal safety cover. Due to lack of cover, these types of electrical boxes pose a potential shock hazard / liability risk.*

RECOMMEND HAVING ELECTRICAL BOX CHANGED OUT TO A MODERN CIRCUIT BREAKER TYPE OR PAD LOCK EXISTING ELECTRICAL BOX FOR SAFETY.

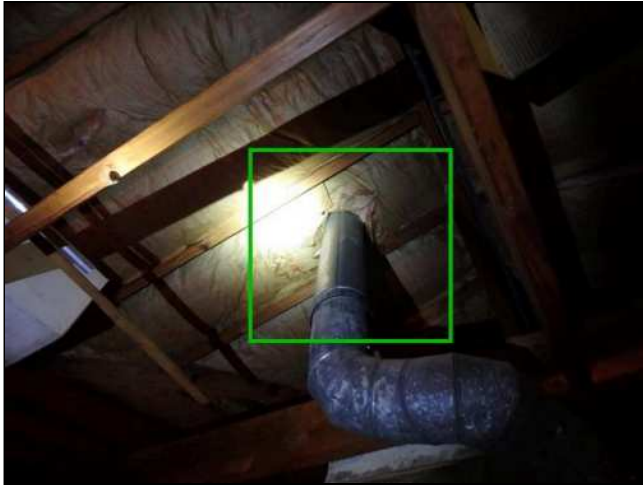
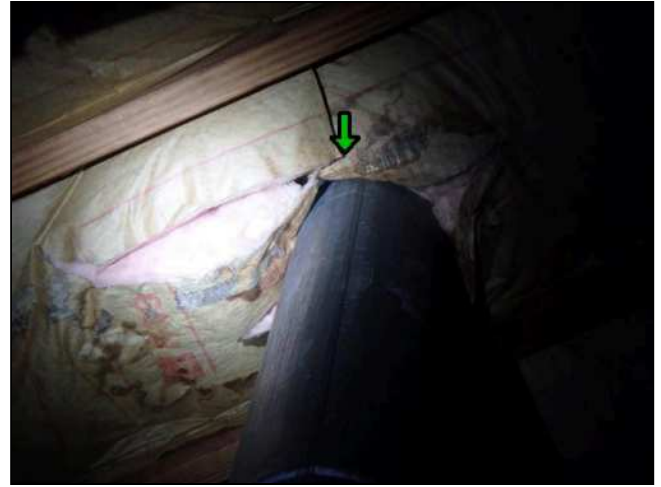
13.1 (2) FLUE EXHAUST PIPING FOR UNIT IS IN DIRECT CONTACT WITH INSULATION. *Flue piping usually requires a 1" clearance to all combustable materials. Condition may pose a fire hazard.*

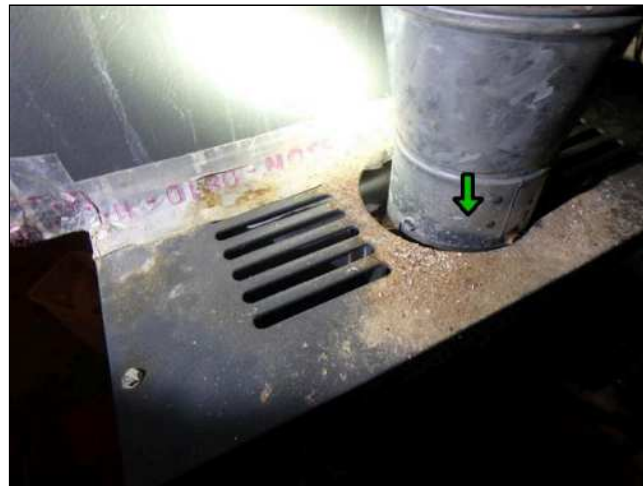
13.1 (3) MOISTURE STAINING / CORROSION OBSERVED AT THE TOP OF UNIT ADJACENT O FLUE PIPING. *Condition appear to be due to a leak / previous leak at the roof. Prolonged corrosion may result in further damage issues.* RECOMMEND HAVING HVAC COMPANY EVALUATE AND REPAIR AS NEEDED.

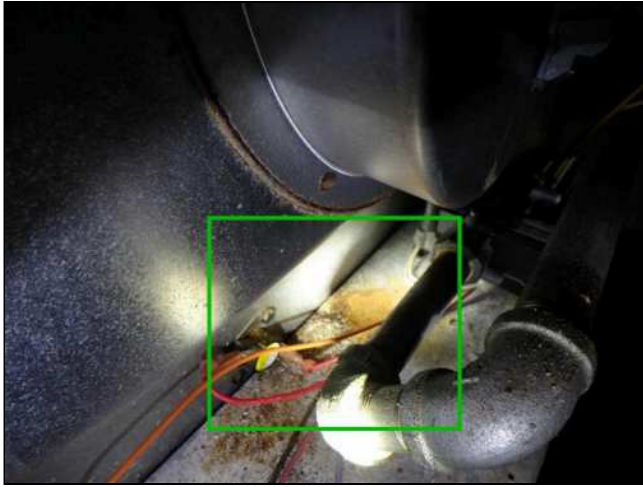
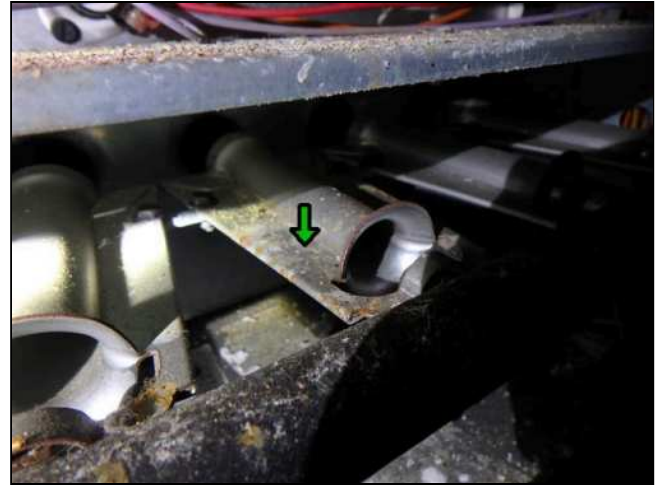
13.2 (1) MINOR CORROSION MOISTURE STAINING OBSERVED AT THE TOP OF BURNER CHAMBER AND AT BURNERS. *Condition is an indication of a leak and/or previous leak. Prolonged corrosion may result in further damage.*

RECOMMEND HAVING A LICENSED HVAC COMPANY EVALUATE AND REPAIR AS NEEDED.

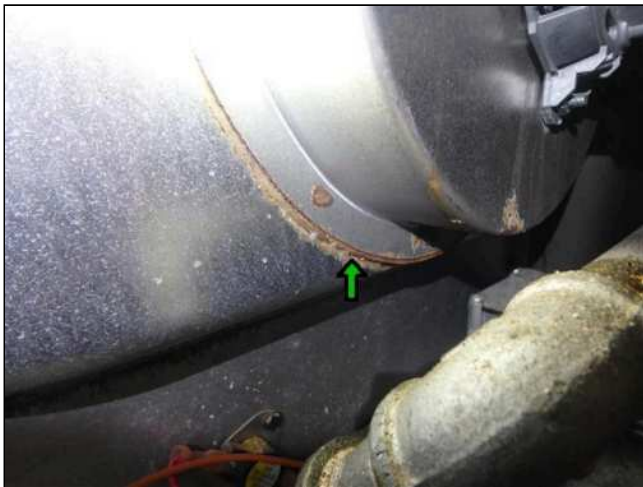
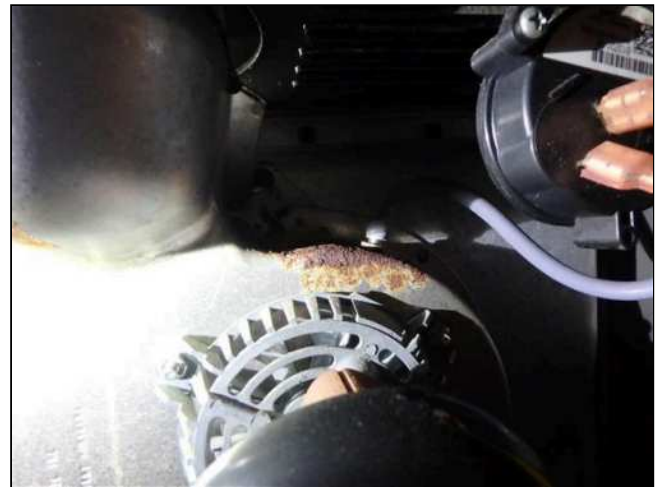
MINOR CORROSION OBSERVED AT THE TOP AND BASE OF BLOWER MOTOR. *Condition is an indication of a leak / previous leak and/or being stored in an unconditioned space. Prolonged corrosion may result further damage.*

RECOMMEND HAVING A LICENSED HVAC COMPANY EVALUATE AND REPAIR AS NEEDED.

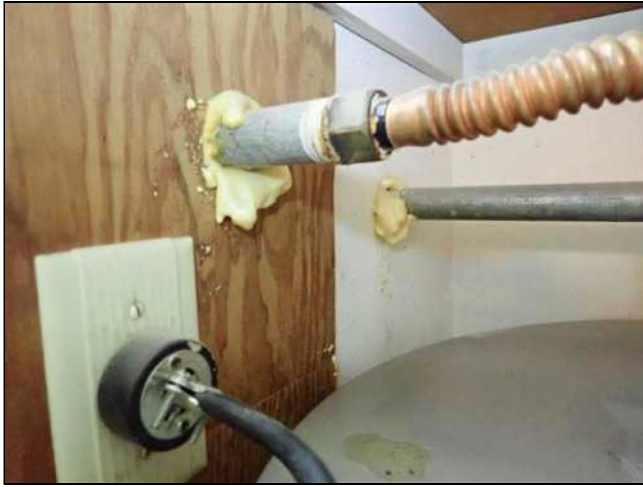
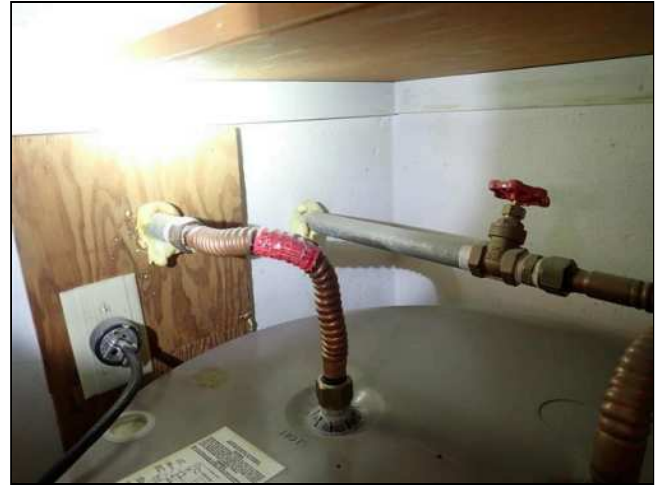
14.0 (1) GALVANIZED WATER PIPING OBSERVED IN USE AT THE PROPERTY OBSERVED MIXED WITH CPVC AS SEEN AT THE WASHER AND LAUNDRY SINK. *Old and / or mixed type water piping is subject to ongoing corrosion & leakage as it ages, particularly at points where galvanized & copper pipes are connected together. The loss of water volume / pressure is also a common occurrence with old piping, as build-up on the interior of the piping & fittings restricts the flow of water. Condition of latent materials was not visible & could not be fully inspected. Hidden damage may exist.*

SUGGEST HAVING A LICENSED PLUMBER OR CONTRACTOR EVALUATE AND REPAIR OR REPLACE AS NEEDED.

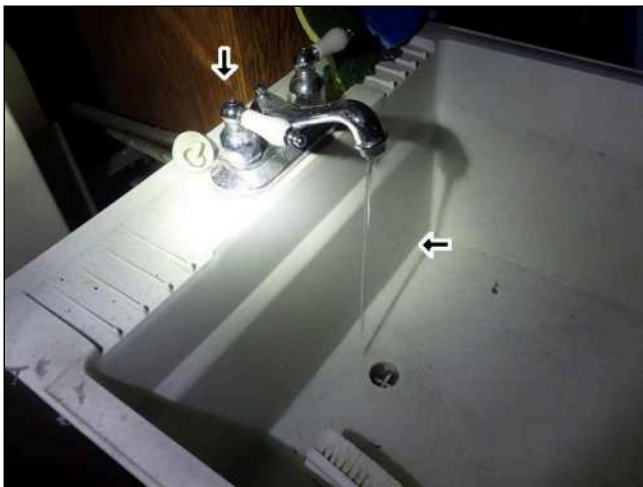
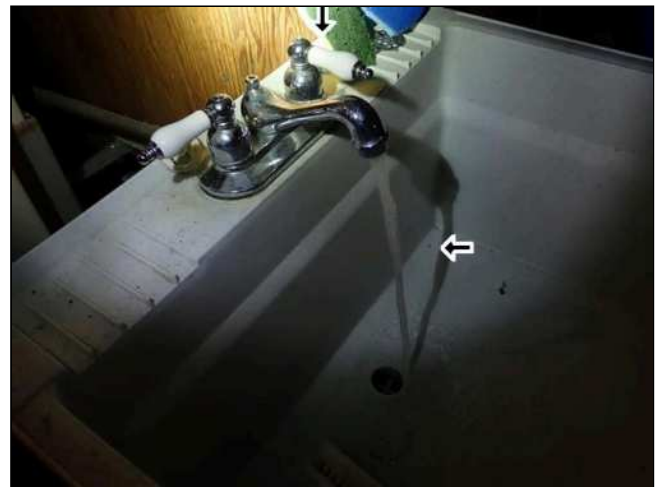
14.5 (1) HOT WATER PRESSURE IS POOR WHILE COLD WATER PRESSURE IS SATISFACTORY. ALSO SEE ABOVE COMMENTS.

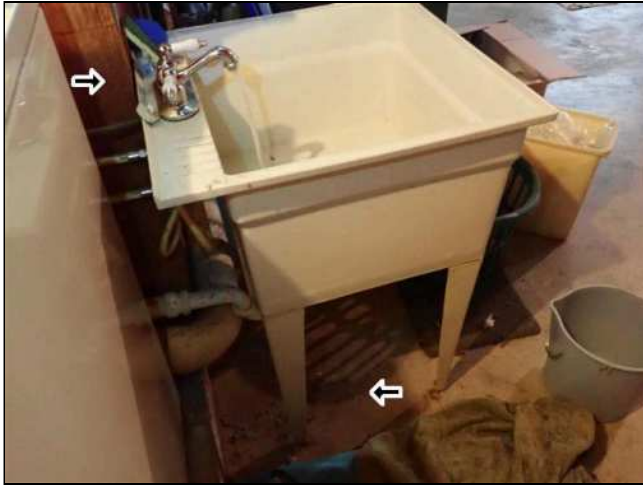
14.5 (2) LAUNDRY SINK IS NOT SECURE TO WALL NOR FLOOR AND HAS WHAT APPEARS TO BE PREVIOUS REPAIRS AT LEG(S.)

SUGGEST HAVING A LICENSED PLUMBER OR CONTRACTOR EVALUATE AND REMEDY AS NEEDED.

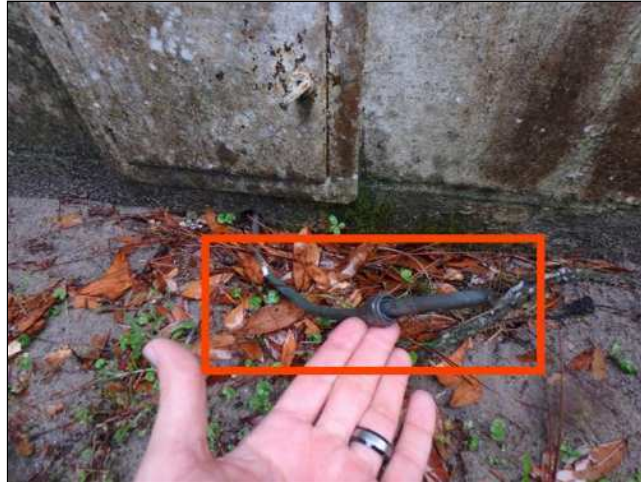
14.6 (1) EXPOSED / IMPROPERLY ABANDONED GAS LINE OBSERVED ADJACENT TO THE CHIMNEY. *Unsecured /*

improperly abandoned piping may pose a potential trip hazard.

RECOMMEND HAVING A LICENSED HANDYMAN OR CONTRACTOR EVALUATE / REMEDY AS NEEDED.

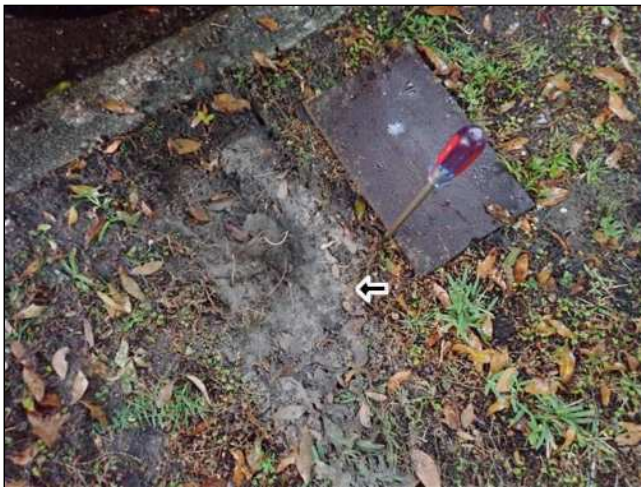
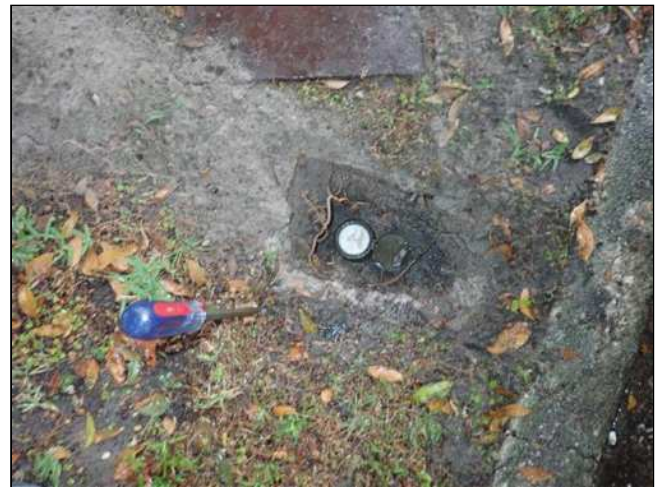
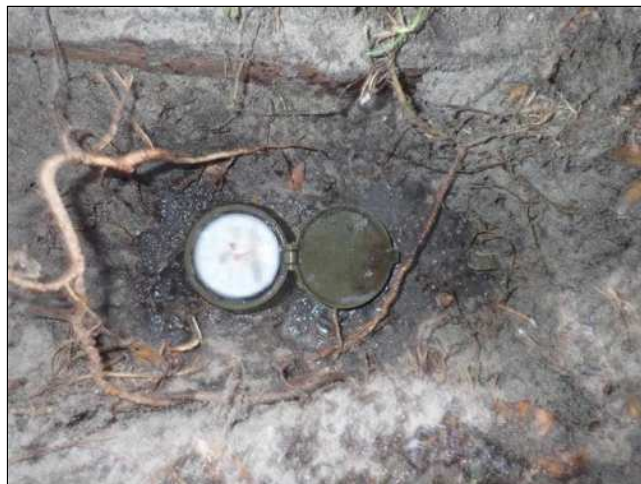
14.7 WATER METER

14.7 (1) WATER METER BOX OBSERVED TO BE COMPLETELY COVERED WITH DIRT / DEBRIS. *Meter was un-covered to check for movement / leaks without any fixtures running & movement was not observed. The utility company usually states that the meter box is the homeowner's responsibility.*

RECOMMEND PERIODICALLY MONITORING / CLEANING METER BOX TO ENSURE PROPER GAUGE & MAIN SHUT OFF SWITCH ACCESSIBILITY.

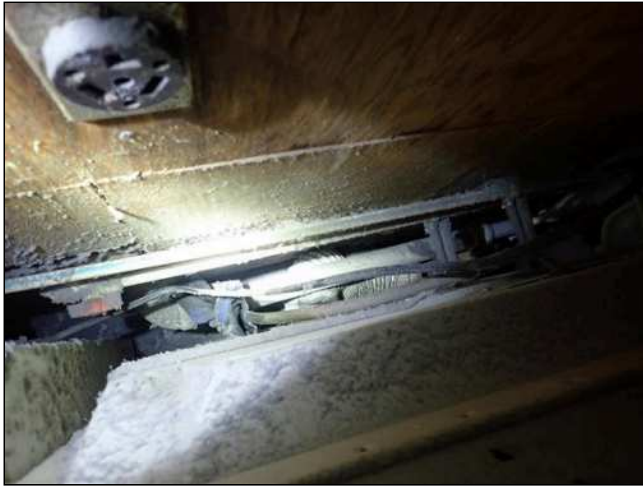
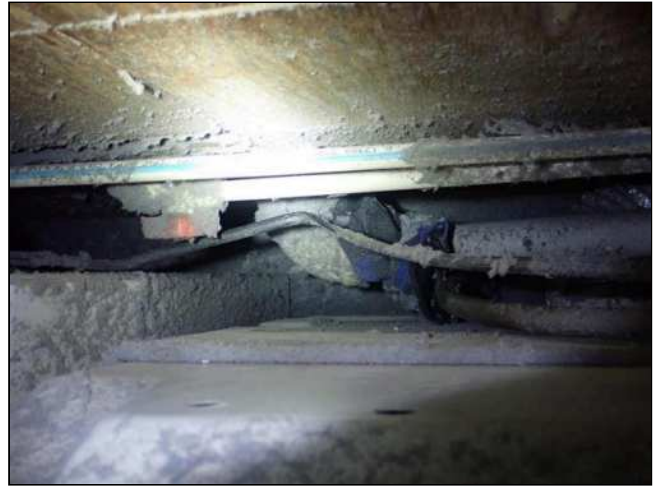
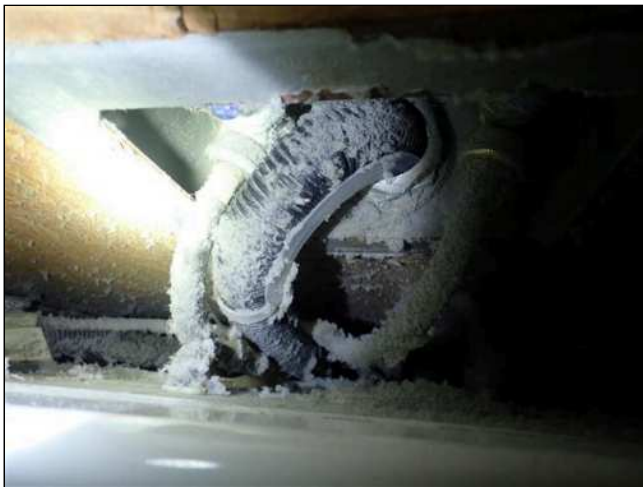
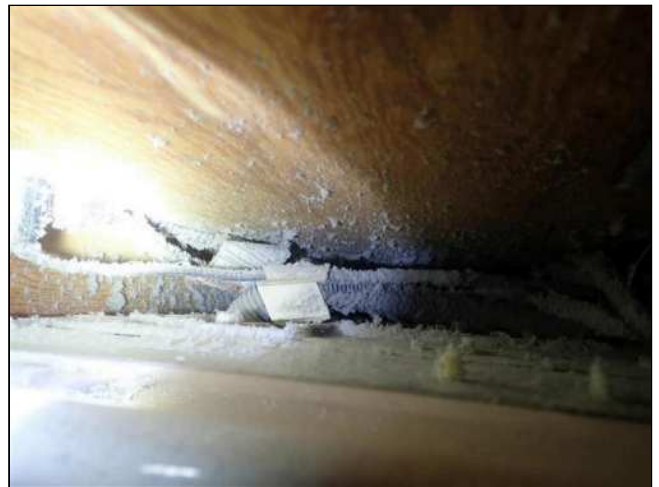
14.8 (1) LINT ACCUMULATION OBSERVED BEHIND THE CLOTHES DRYER. *Condition is indicative of a damaged / not fully secured lint discharge tube. Excessive lint accumulation may pose a potential fire hazard.*

14.8 (4) FAIR RATING ALSO DUE TO AGE & CONDITION AS WELL AS RUST/CORROSION OF UNITS. SUGGEST HAVING A LICENSED APPLIANCE SERVICE COMPANY OR CONTRACTOR EVALUATE AND REMEDY AS NEEDED.

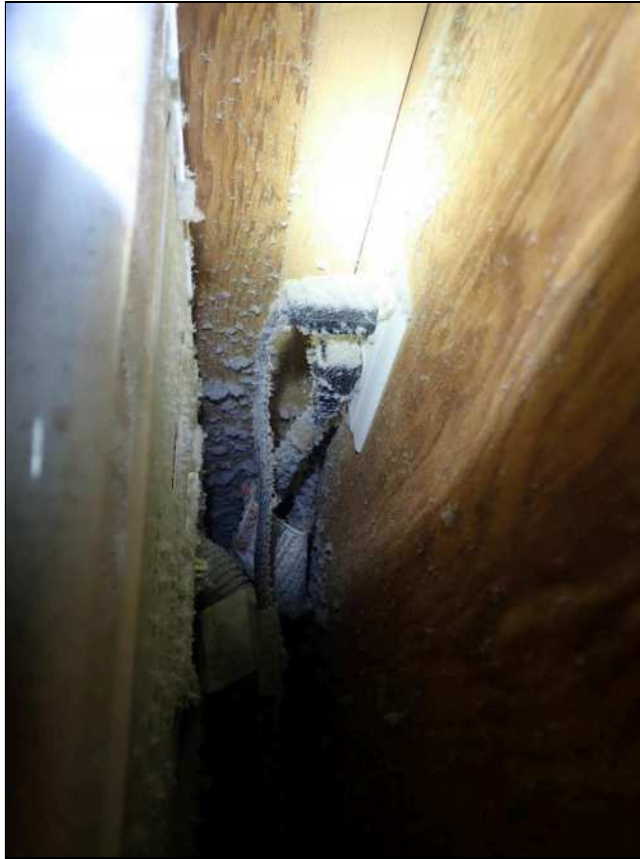
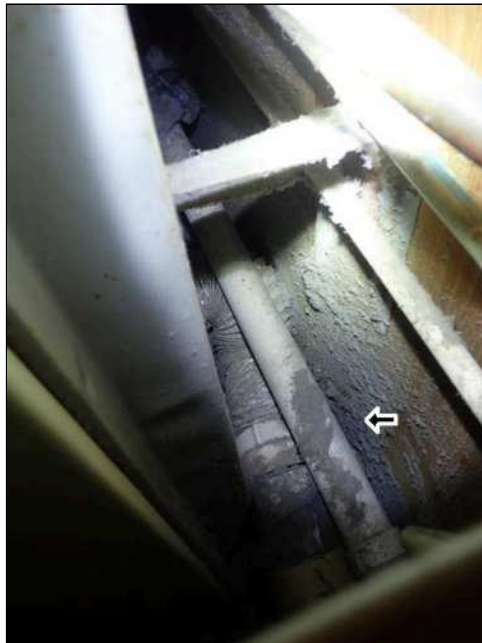
14.8 (2) DRYER LINT DISCHARGE TUBE / VENT COMPONENTS ARE DISCONNECTED - HOT AIR CAN BE FELT BEHIND DRYER WHEN UNIT IS RUNNING. *Improper interface union may promote excessive lint accumulation which may pose a potential fire hazard.*

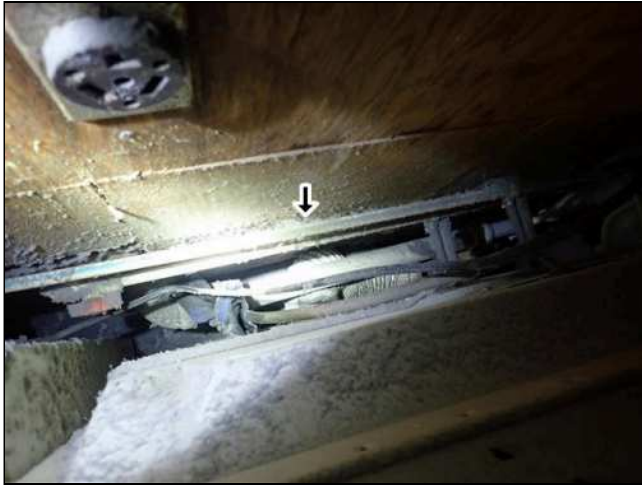
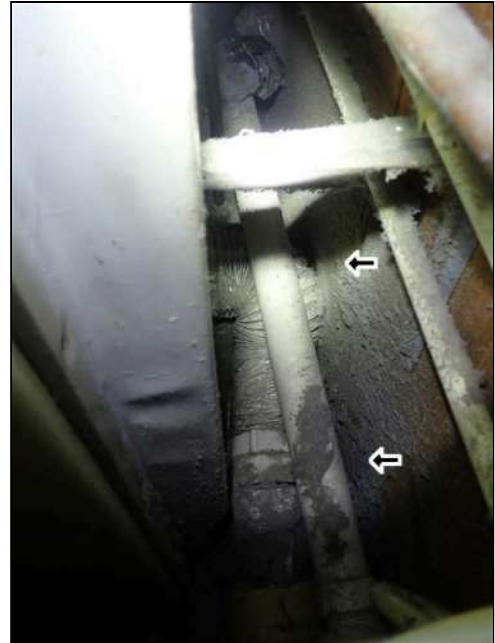
14.8 (3) EXTERIOR DRYER LINT DISCHARGE TUBE VENT COVER IS LOOSE / UNSECURED. *Current condition may promote moisture / pest intrusion.*

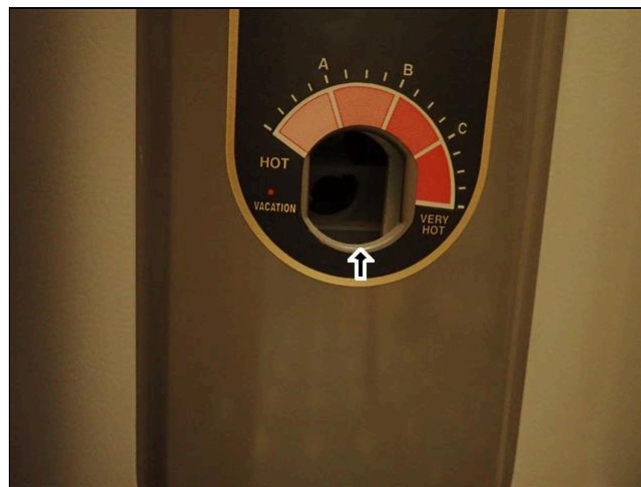
15.1 (2) IT APPEARS AS THOUGH THE THERMOSTAT OR CONTROL IS MISSING OR HAS BROKEN.

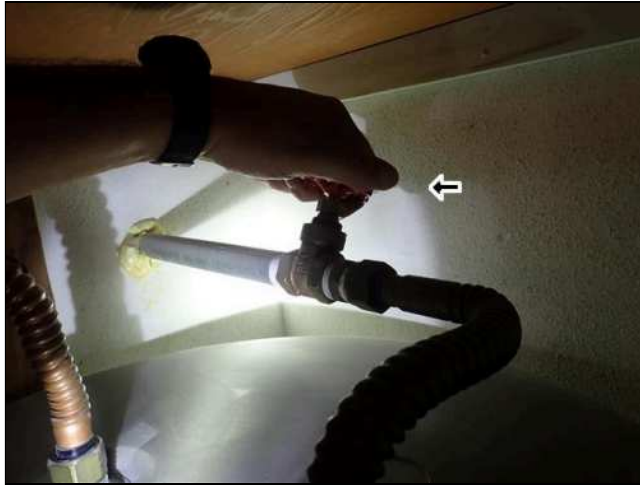
15.1 (3) MAIN WATER SUPPLY SHUT-OFF VALVE IS STUCK / FROZEN IN THE **OPEN** POSITION. *Condition may cause difficulty for the homeowner / occupants to shut water off to the unit in case of emergency.*

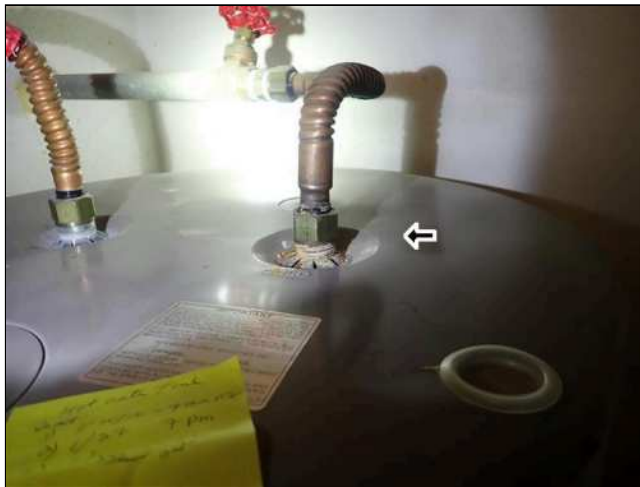
15.1 (4) CORROSION OBSERVED AT THE WATER LINE(S) & RELATED COMPONENTS AT THE TOP OF WATER HEATER. Prolonged exposure to to corrosion may result in premature wear / failure of unit components. No leaks observed at time of inspection; however, removal of corrosion may result in exposure of leaks.

SUGGEST HAVING A LICENSED PLUMBER OR CONTRACTOR EVALUATE AND REPAIR OR REPLACE AS NEEDED.
